Care and Maintenance of the Steam Turbine Generator

Observations from First Overhaul Since Installed

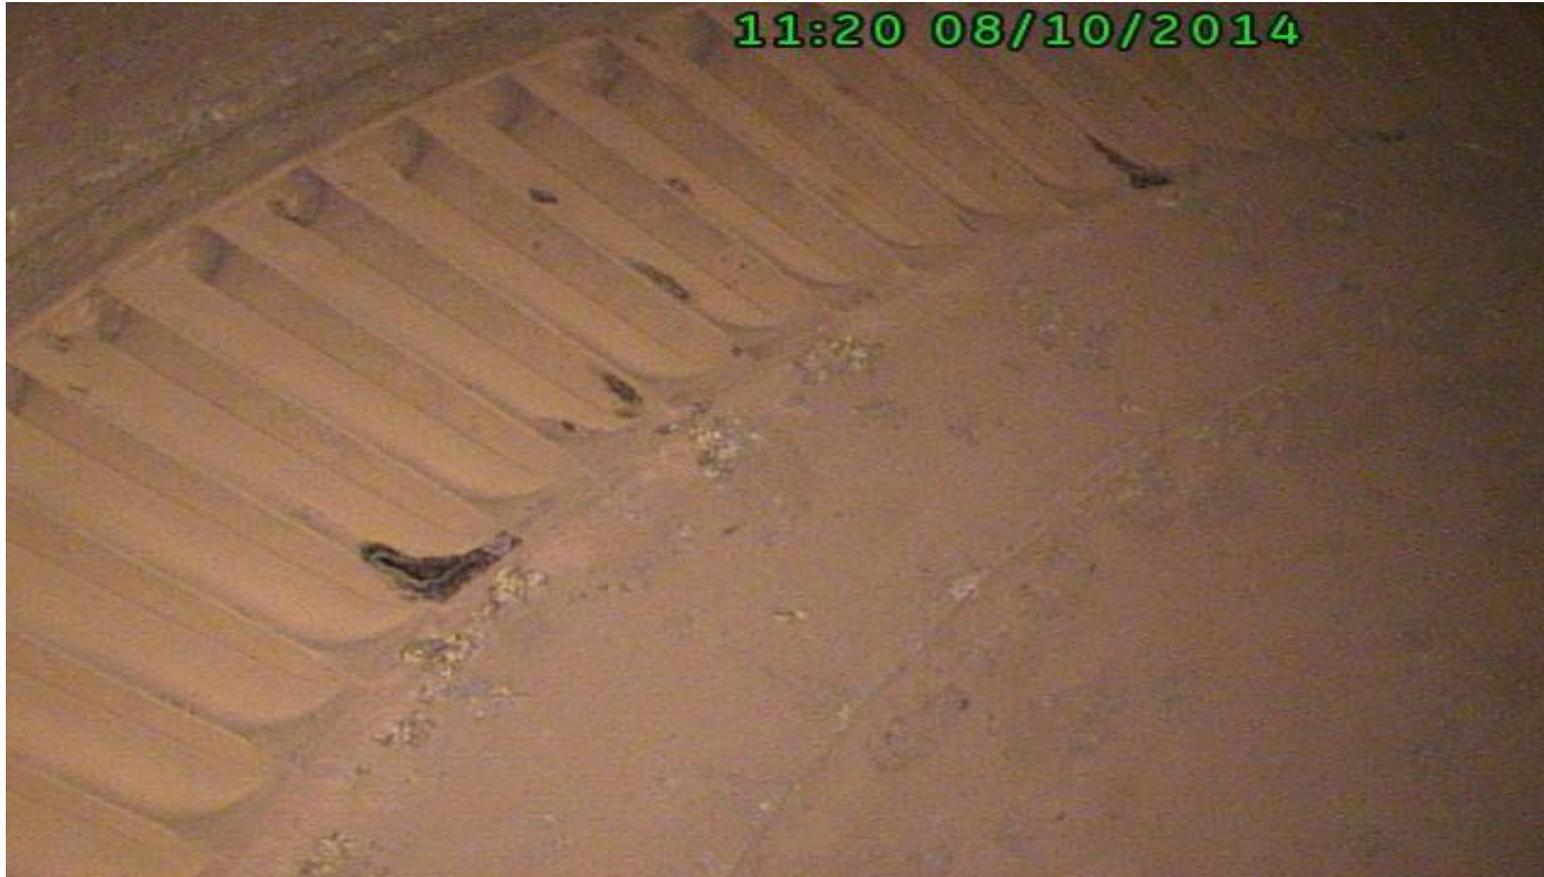
LP Blade Shroud Deposits

Borescoping of turbine in October of 2014. This borescoping helped convince facility management that a through internal inspection was warranted.

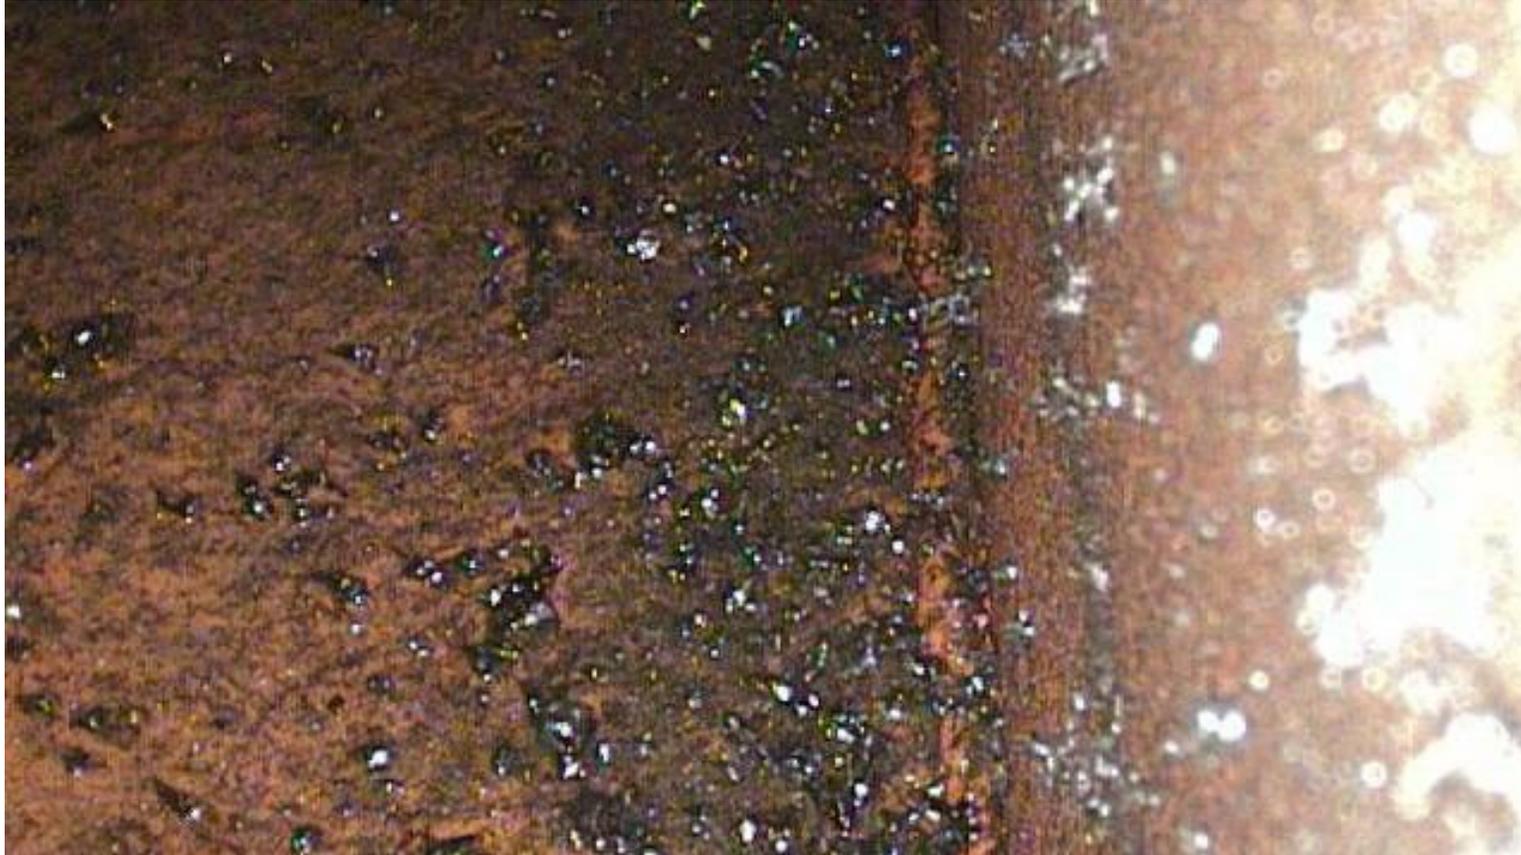
Generator

Interior of the generator. This is the floor showing oil and debris.

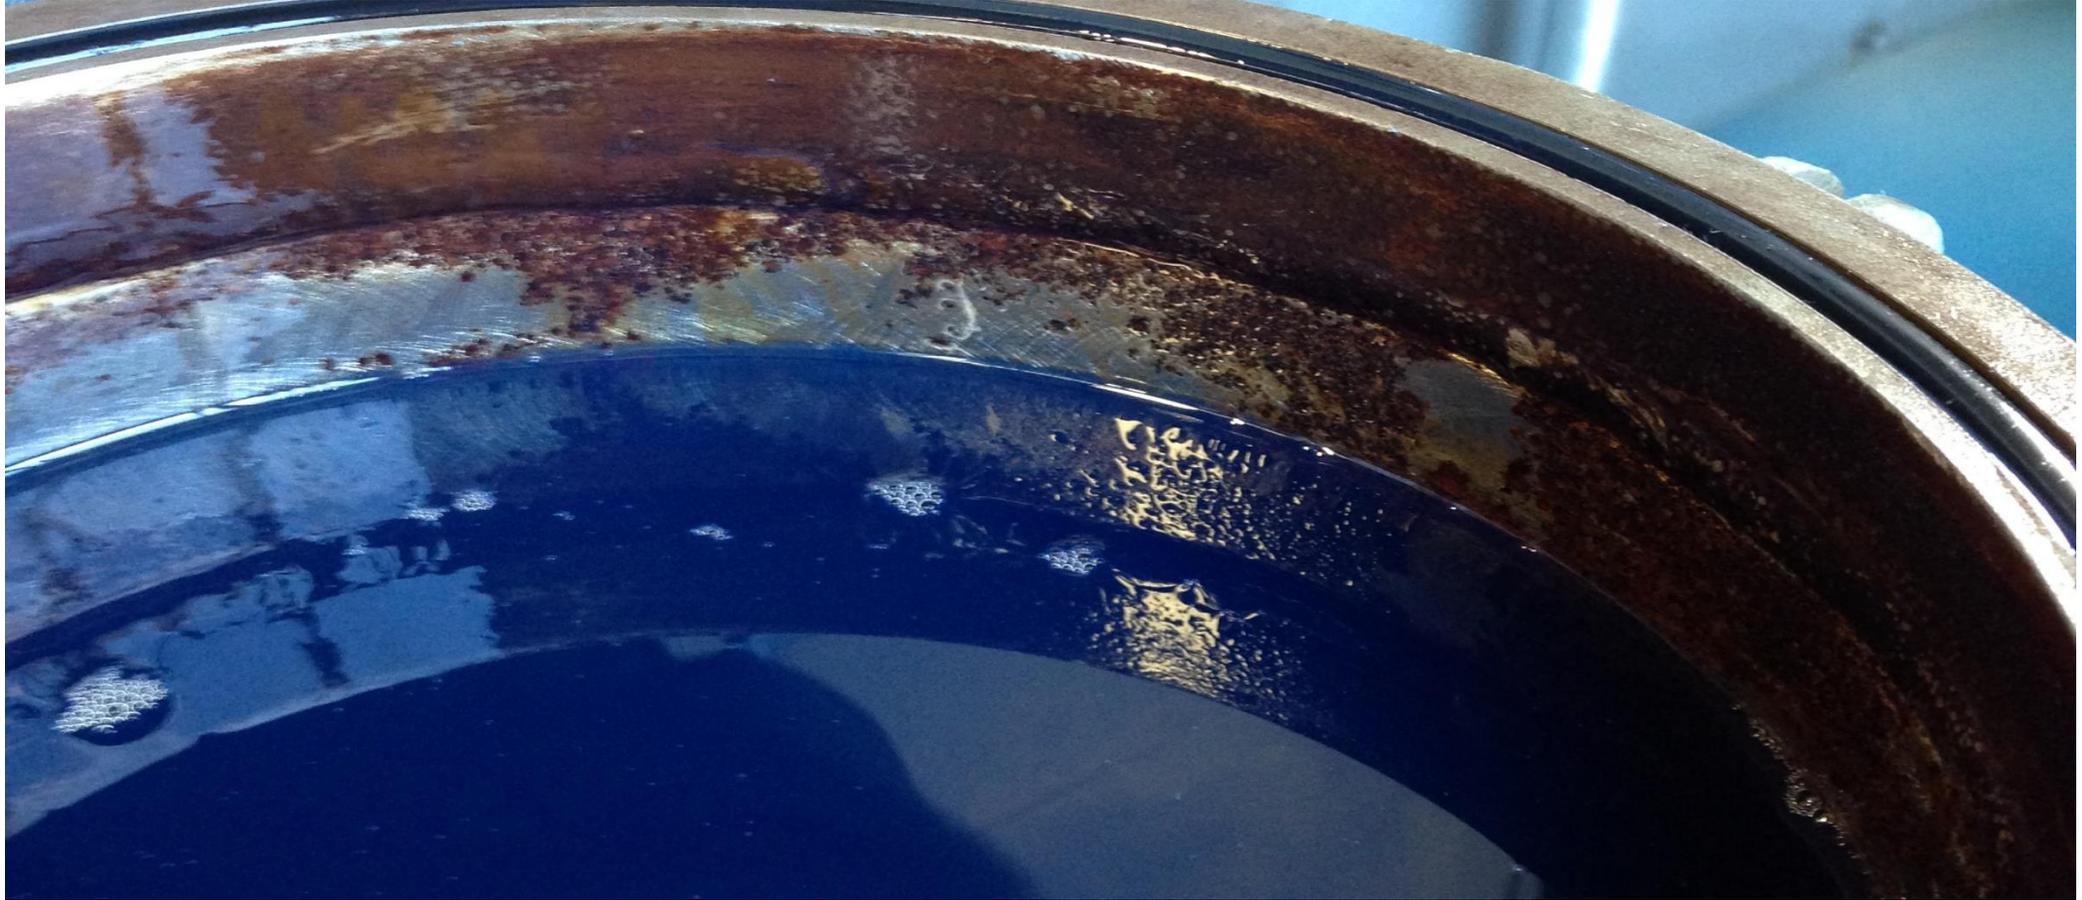
Inside of Duplex Strainer

Lube oil was never conditioned or changed. Filters were never replaced and turbine was never properly laid up from April until November. Moisture in the lube oil from steam seals plated out on filter walls and pitted cylinder walls.

- The oil sump will have a side stream filter that will be installed to circulate the oil through two filters, one for particulates, and the other for moisture.
- The oil sump breather vents have a 'button' type filter and will be replaced with a Rebuildable desiccant breather to eliminate moisture from entering when unit is down.
- Oil sump was designed for an oil heater, but none was installed when the unit was purchased. A new immersion heater will be purchased and installed to keep the oil warm, and to help eliminate lengthy roll times to heat the oil on start ups.

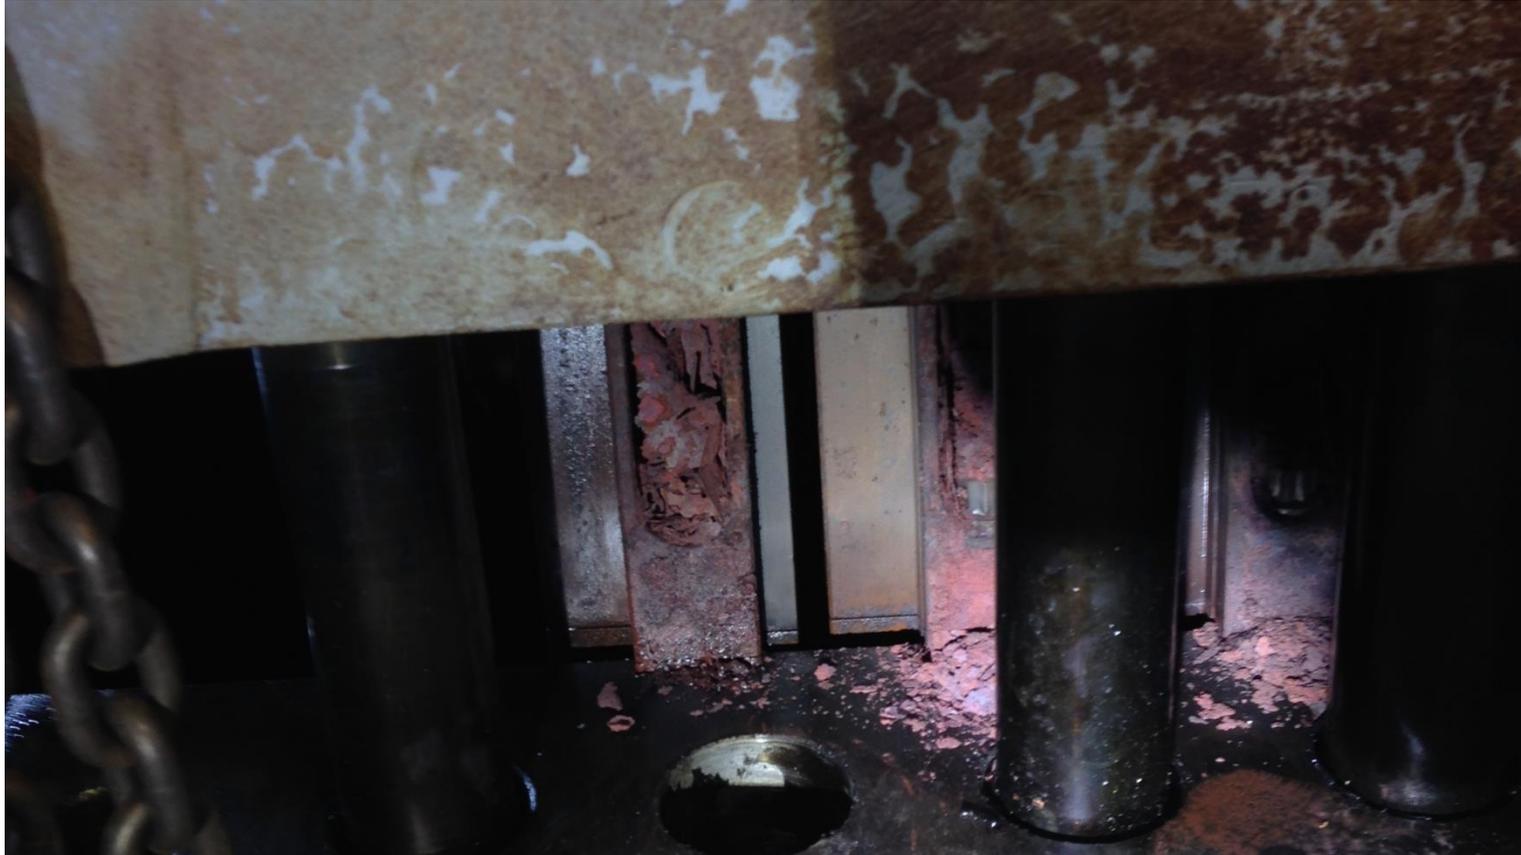
Top Half of Casing Lifted

It took three days to lift the top half of the turbine casing. When it was lifted rust flowed out like sand in an hour glass.

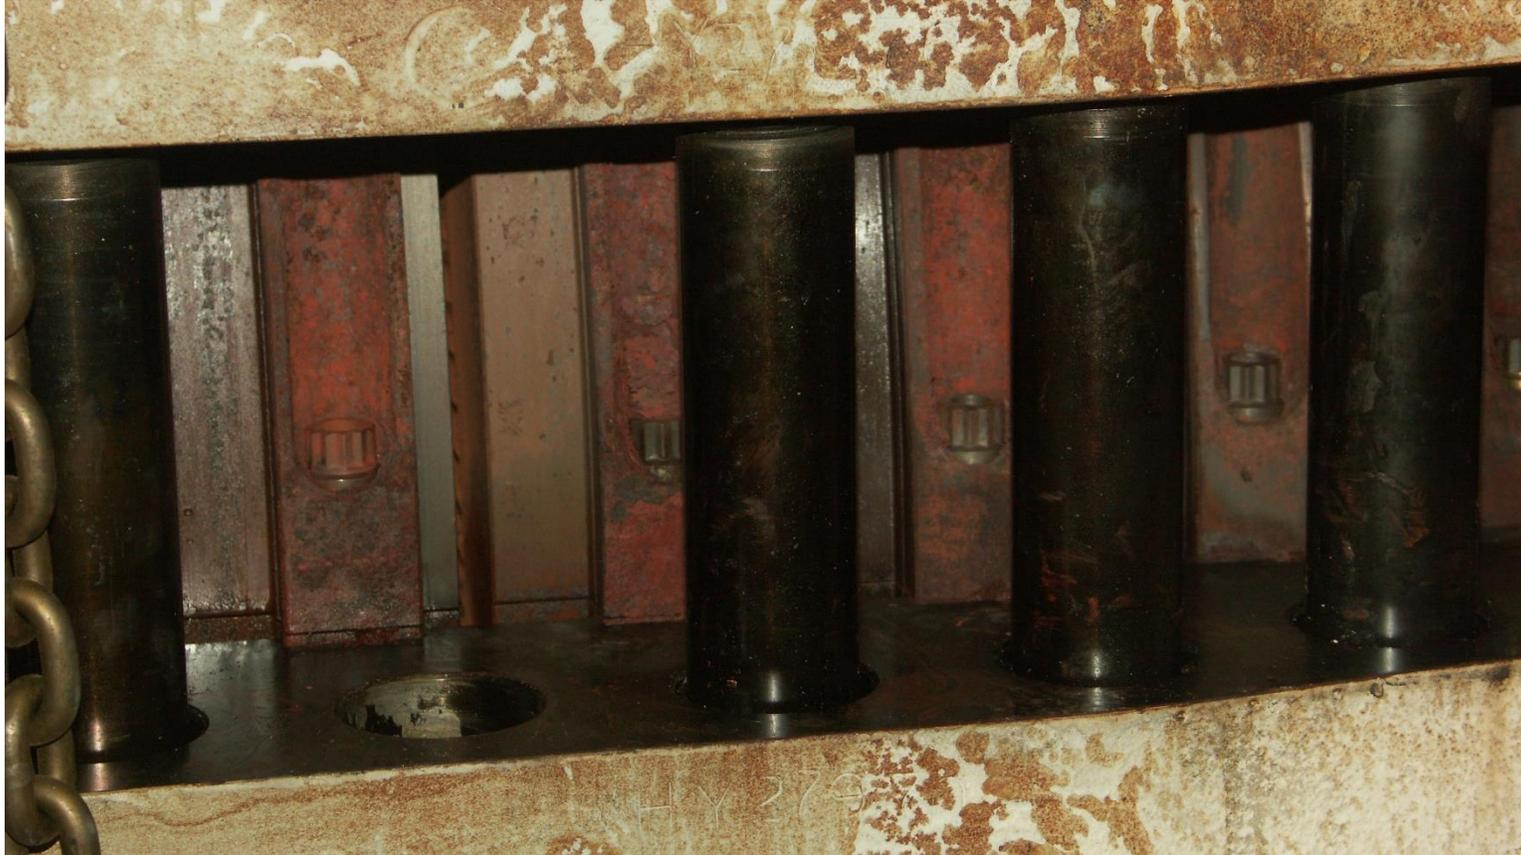
Top Half of Turbine Separated

This is what the blades and diaphragms looked like after the rust was cleaned up.

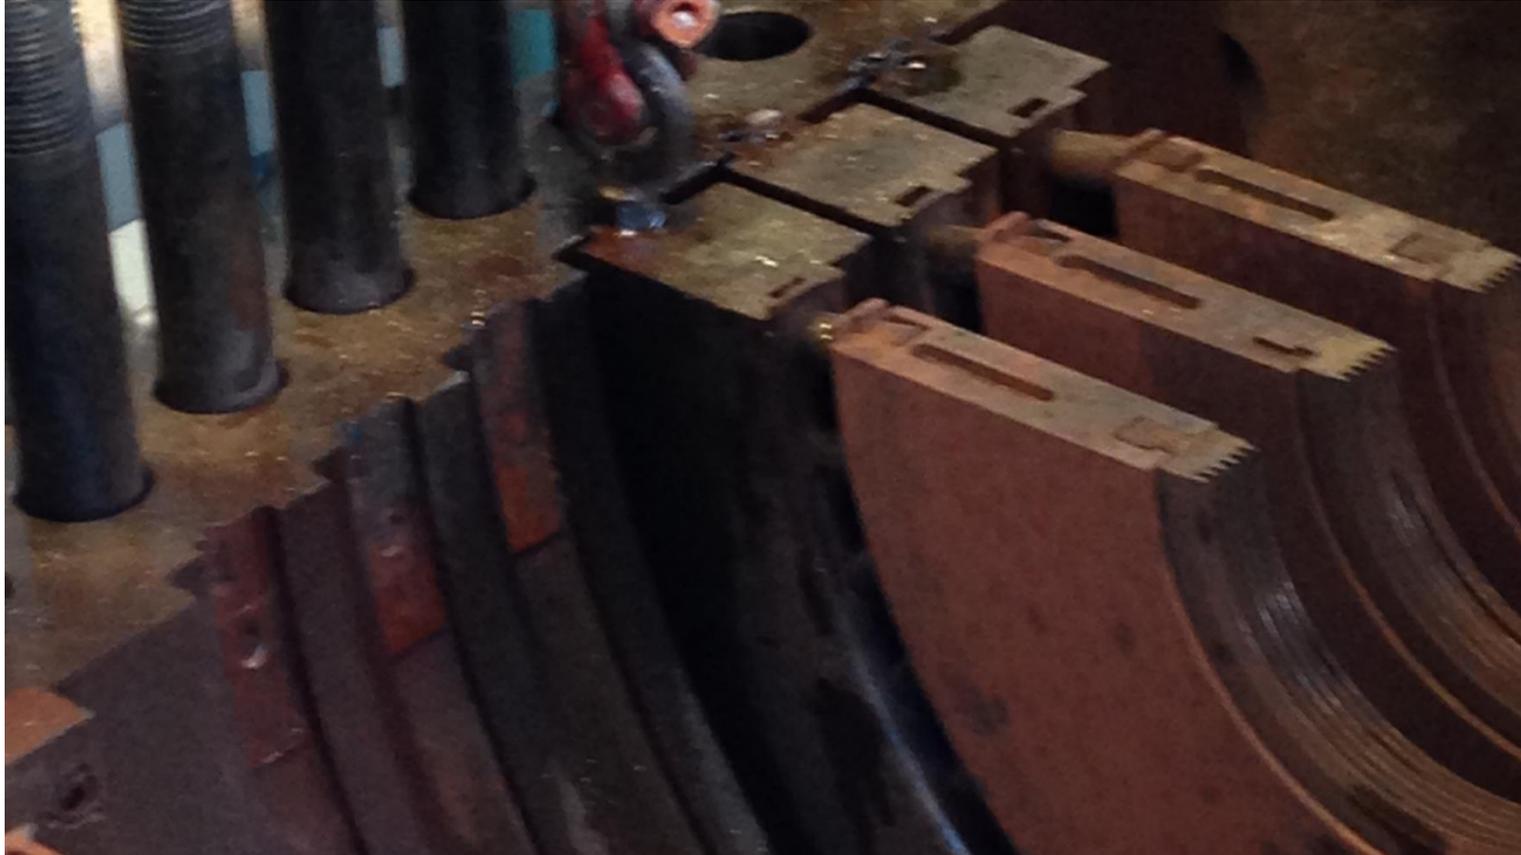
This is the 4th, 5th and 6th Diaphragms on the bottom half of the turbine. All set screws were corroded and unable to be turned out, they had to be drilled out. Then the diaphragms had to be rocked back and forth using chain falls to loosen and break free.

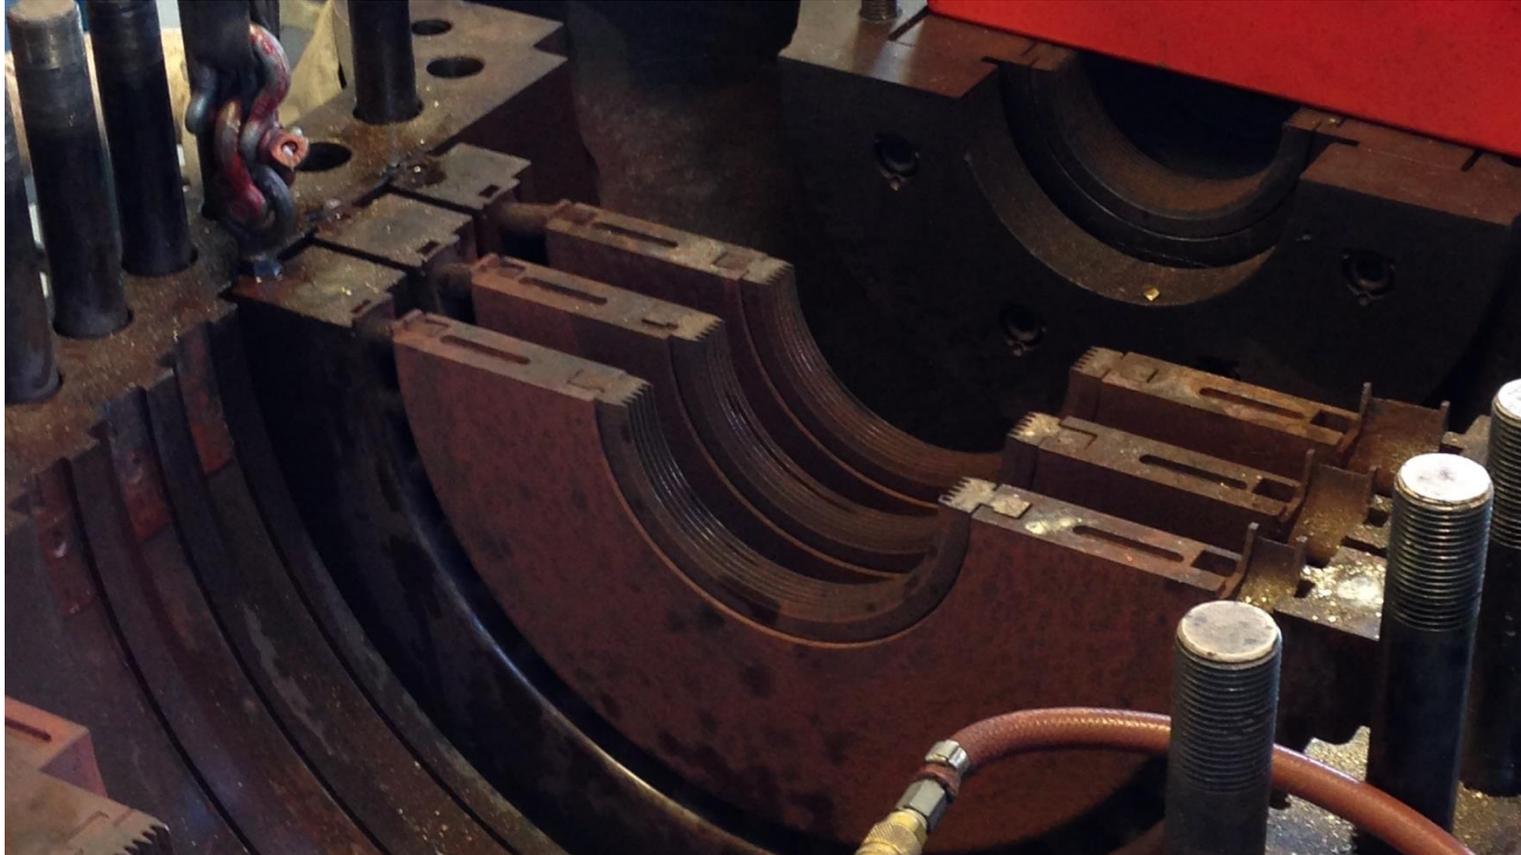
Diaphragms

Turbine company used porta-power to try and dislodge diaphragms and had over 40K/# of pressure, still did not move.

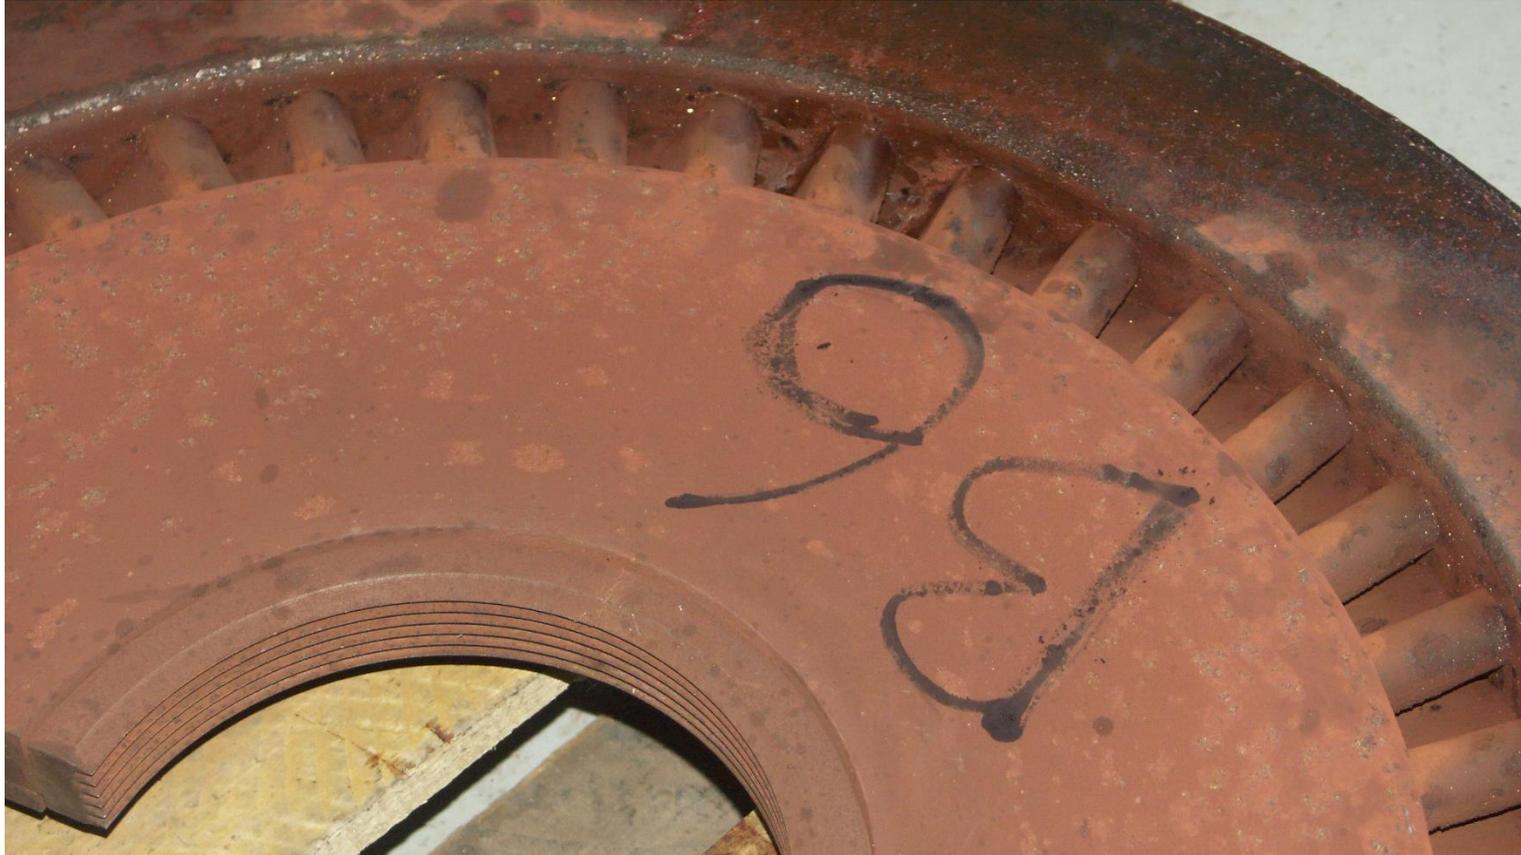
Diaphragm

Every diaphragm had radial cracks that had to be ground out and built up with welds, then ground flush.

- All diaphragms were cleaned and NDT inspected.
- The cracks on the diaphragms were ground out, built up with welding, then ground flush again.
- The Trip and Throttle Valve was completely overhauled and rebuilt.
- All instruments and gauges were calibrated and replaced if found to be bad.
- Oil was drained, sump swabbed out and all gaskets replaced on access doors.

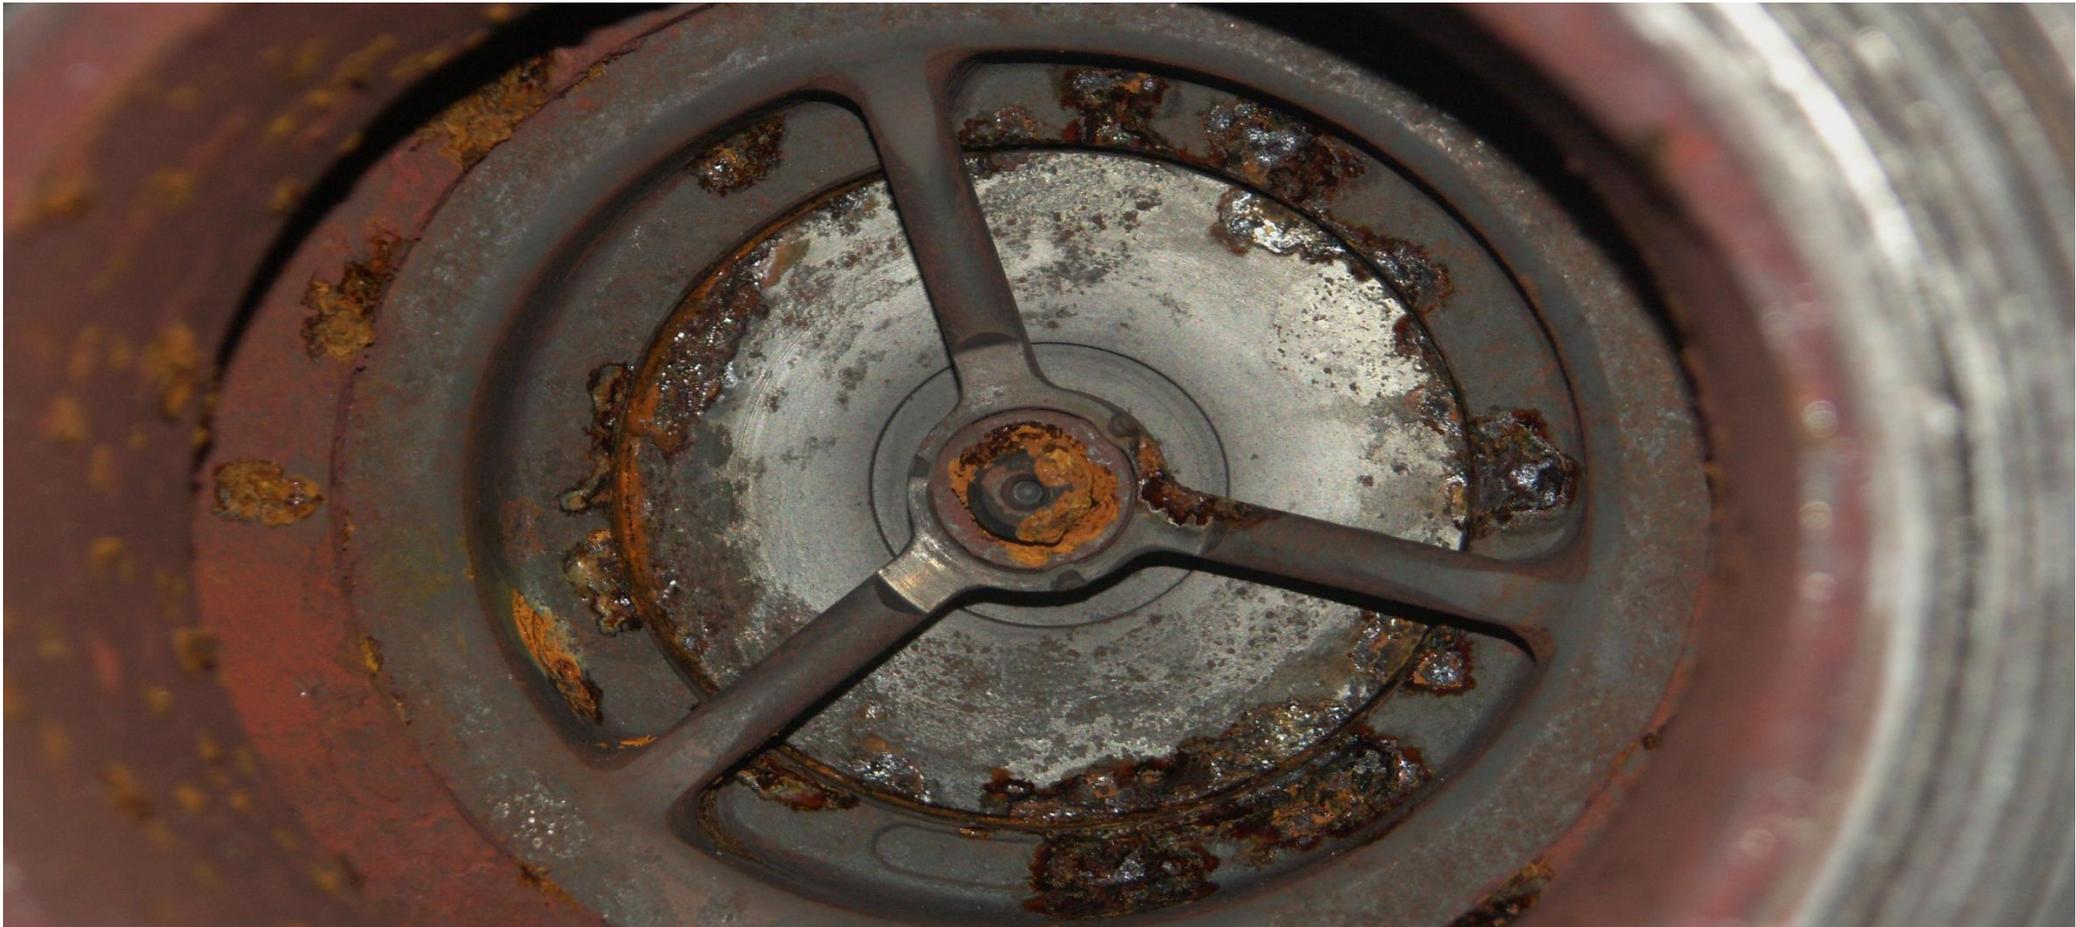
Throttle Valve Seat

The throttle valve seat, stem, and cage were all worn and had to be replaced with OEM parts. Even after replacing all the parts, the valve did not pass a hydro due to steam cuts in the valve body that had to be ground, built up with weld and ground down again.

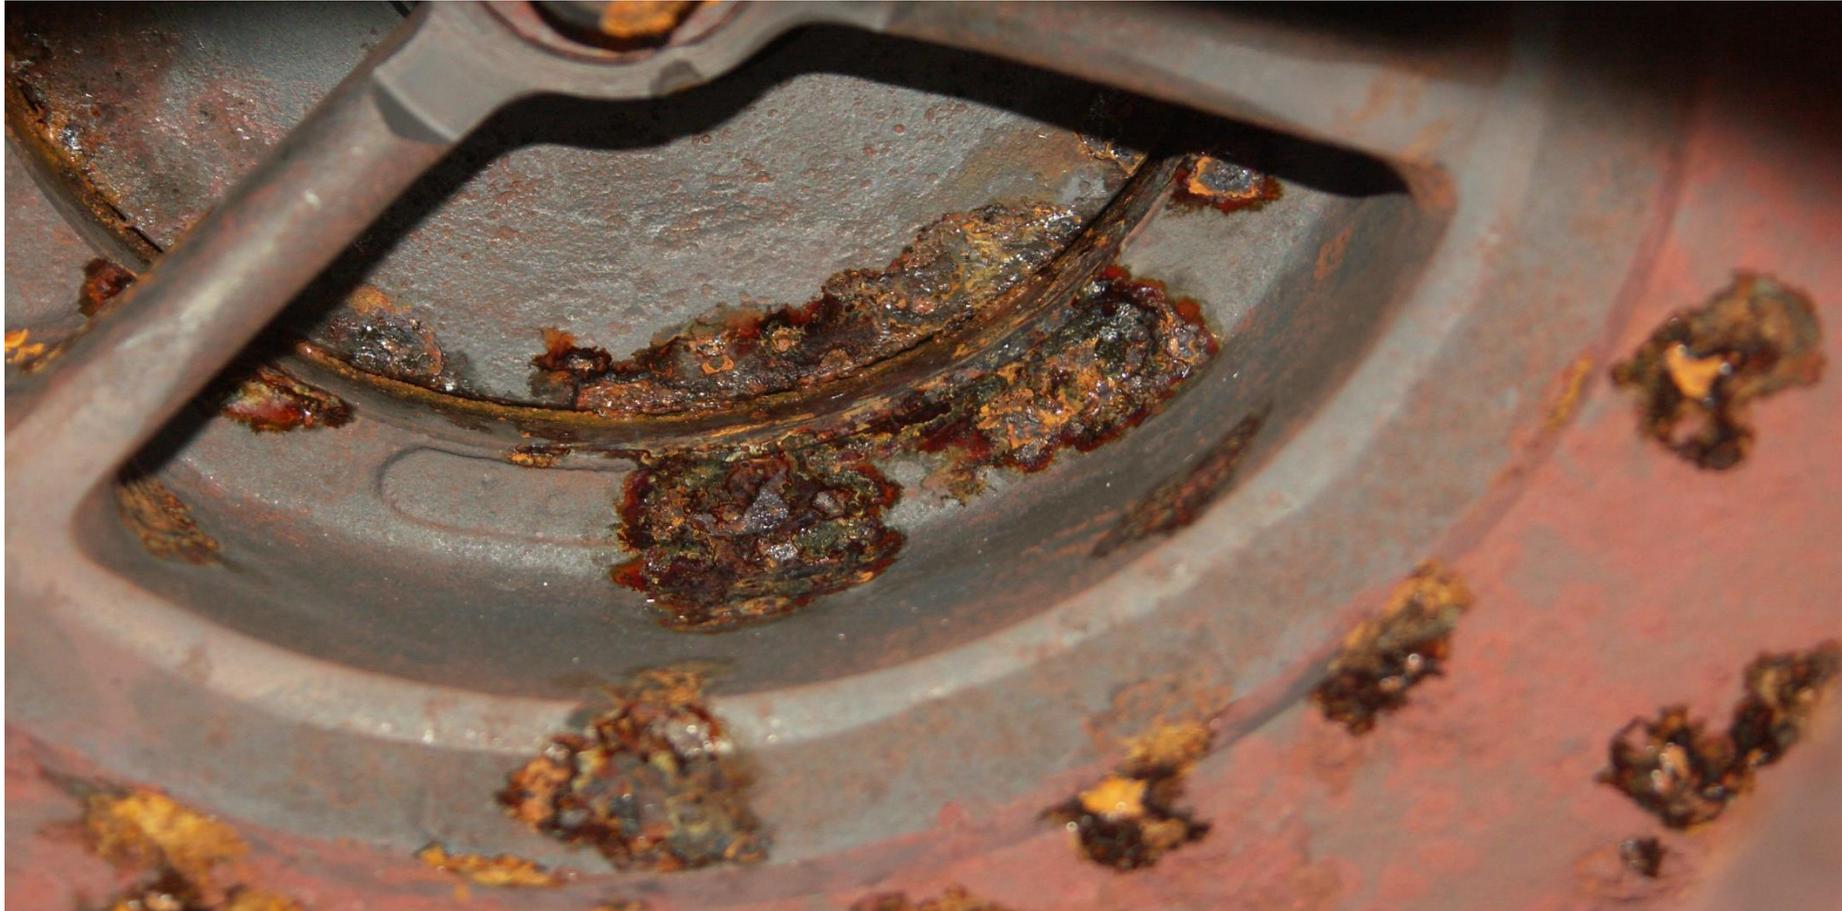
Throttle Valve Seat

More Pictures showing corrosion.

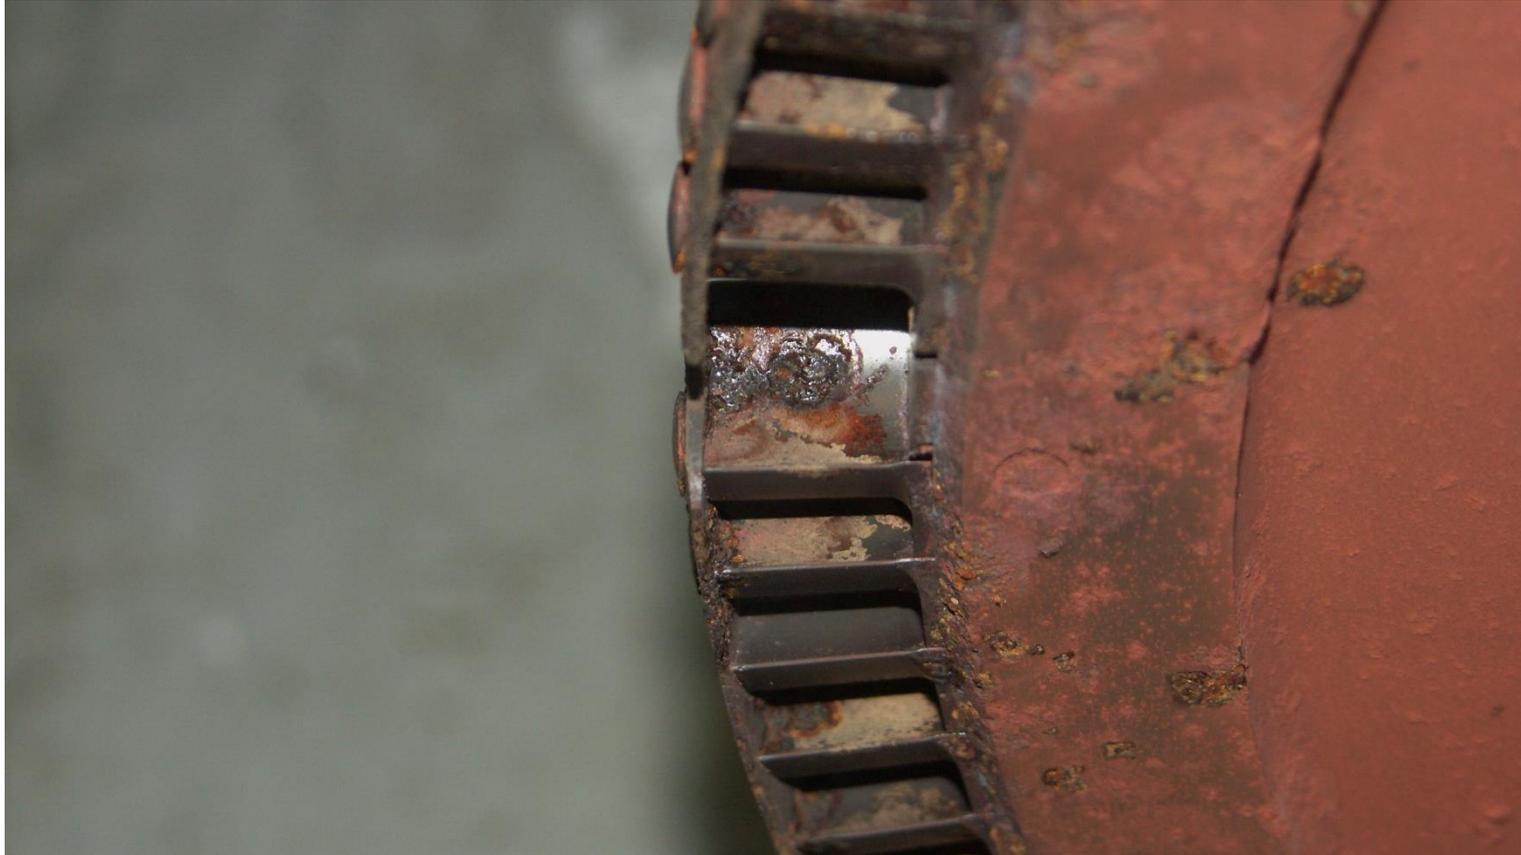
High Pressure Blade – Inlet Side

- OEM manual and operational curve specifies that the turbine should not be run below 600 Kwh. The old Plant Manager would routinely operate the turbine at less than 100 Kwh for days. Below 300 Kwh and the turbine counter stops working, so even though it operated for 24 hours, only a fraction of those hours would be counted.
- The throttle valve would be opened less than 1% admitting less than 8K#/hr of steam. This was barely enough steam to keep the turbine online and cool.
- The throttle valve seat became worn and the turbine would ramp up to 1100 RPM on start up instead of stopping at 500 RPM hold point.
- By the time the steam traveled through to the 7th stage, it was condensed and turned the last stages into a water wheel. (see Pictures)

Evidence of steam and moisture erosion

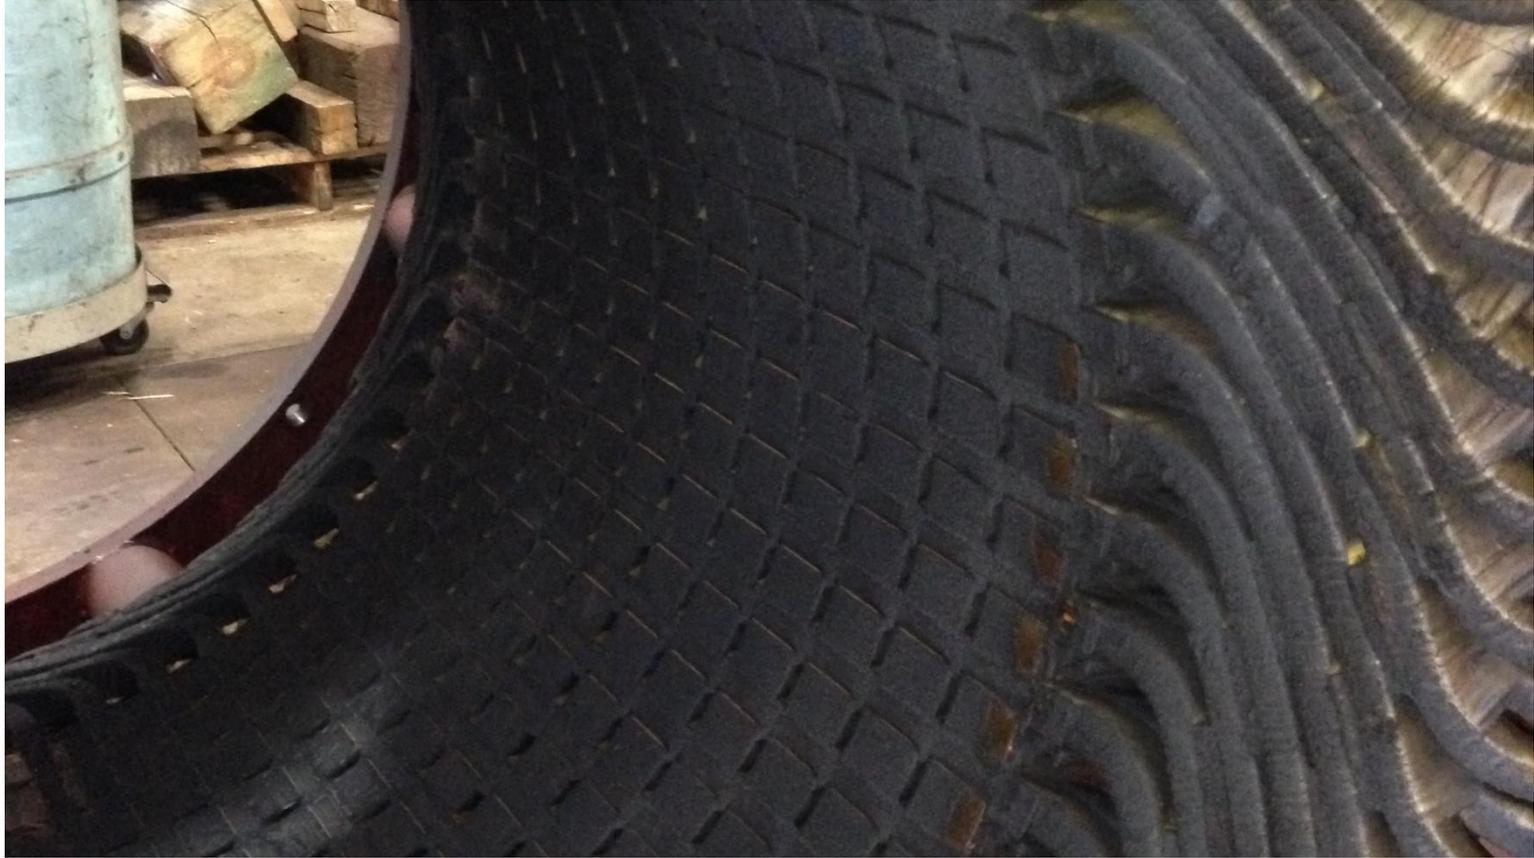
Generator Internal Inspection

Windings covered in oil and caked with dirt and debris.

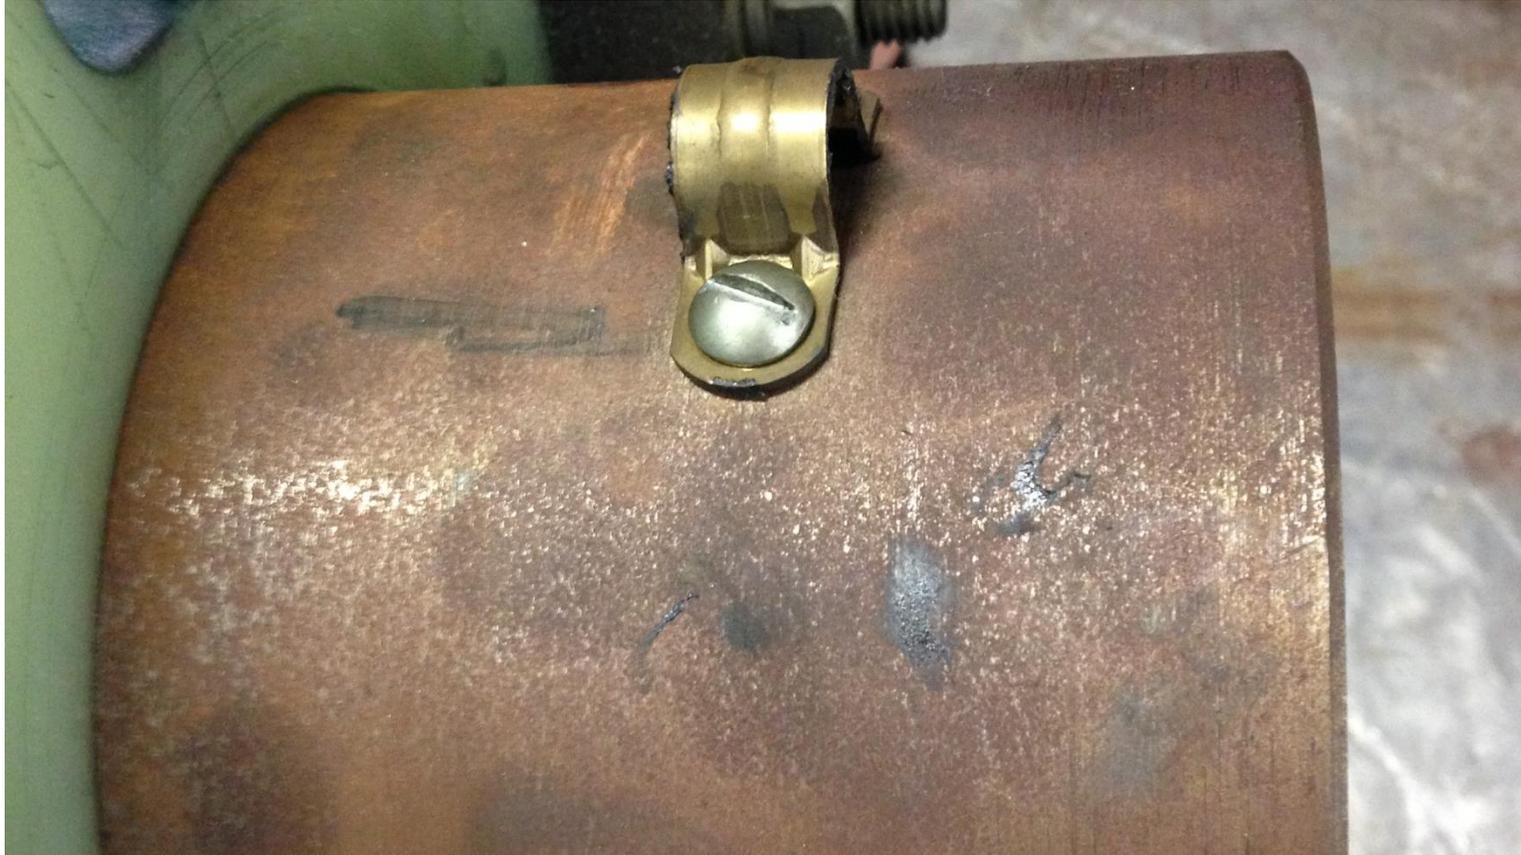
Exciter Shaft

The shaft on the exciter end was covered in rust deposits.

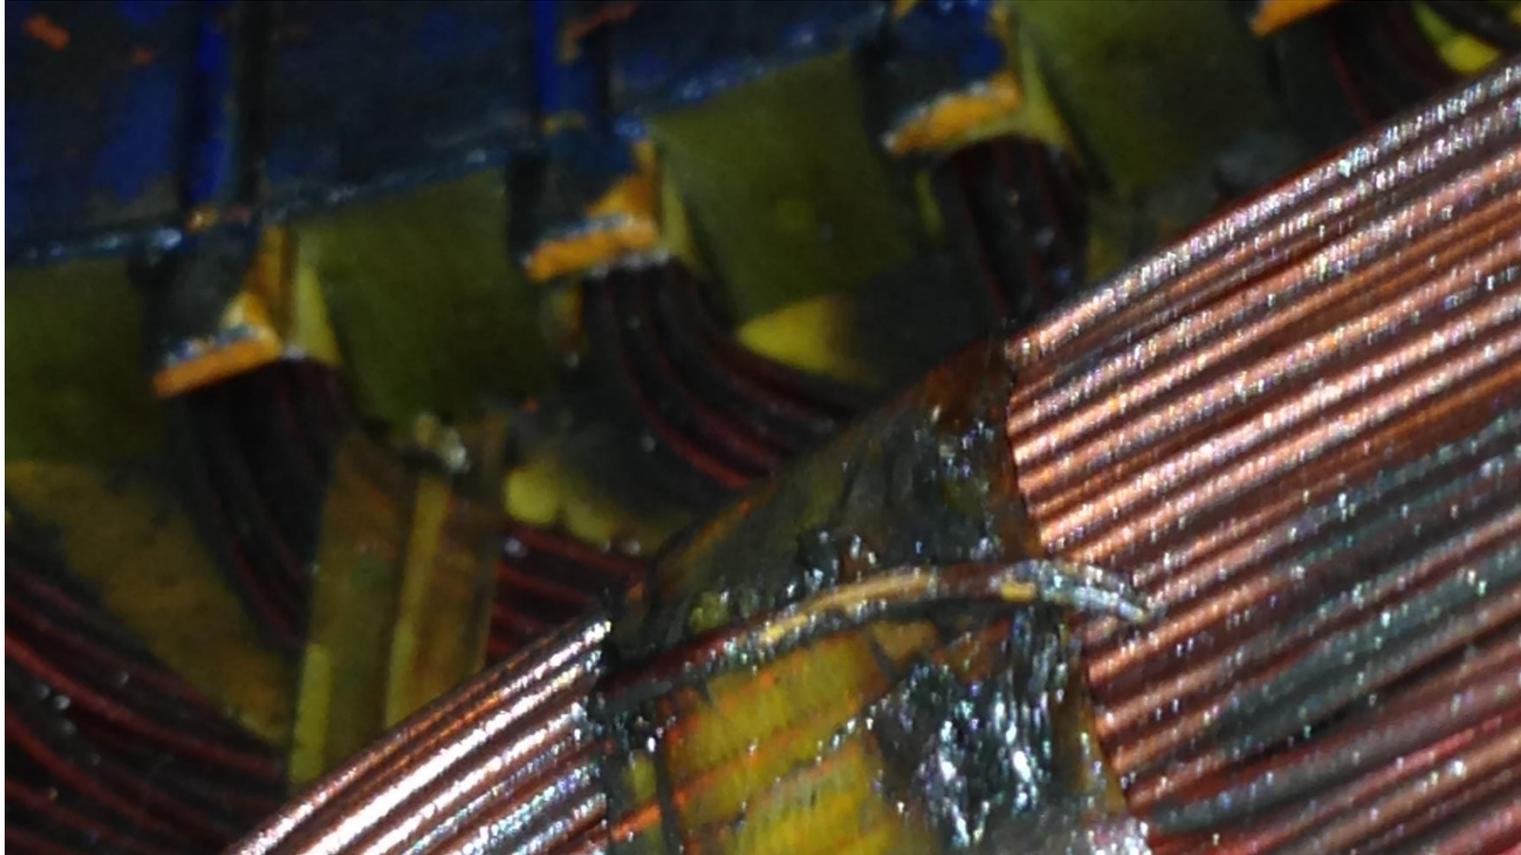
Broken Exciter Wire

This wire on the exciter was found to be broken and the entire exciter had to be rewound. According to the electrical shop, we would never have been able to generate full load with this broken wire.

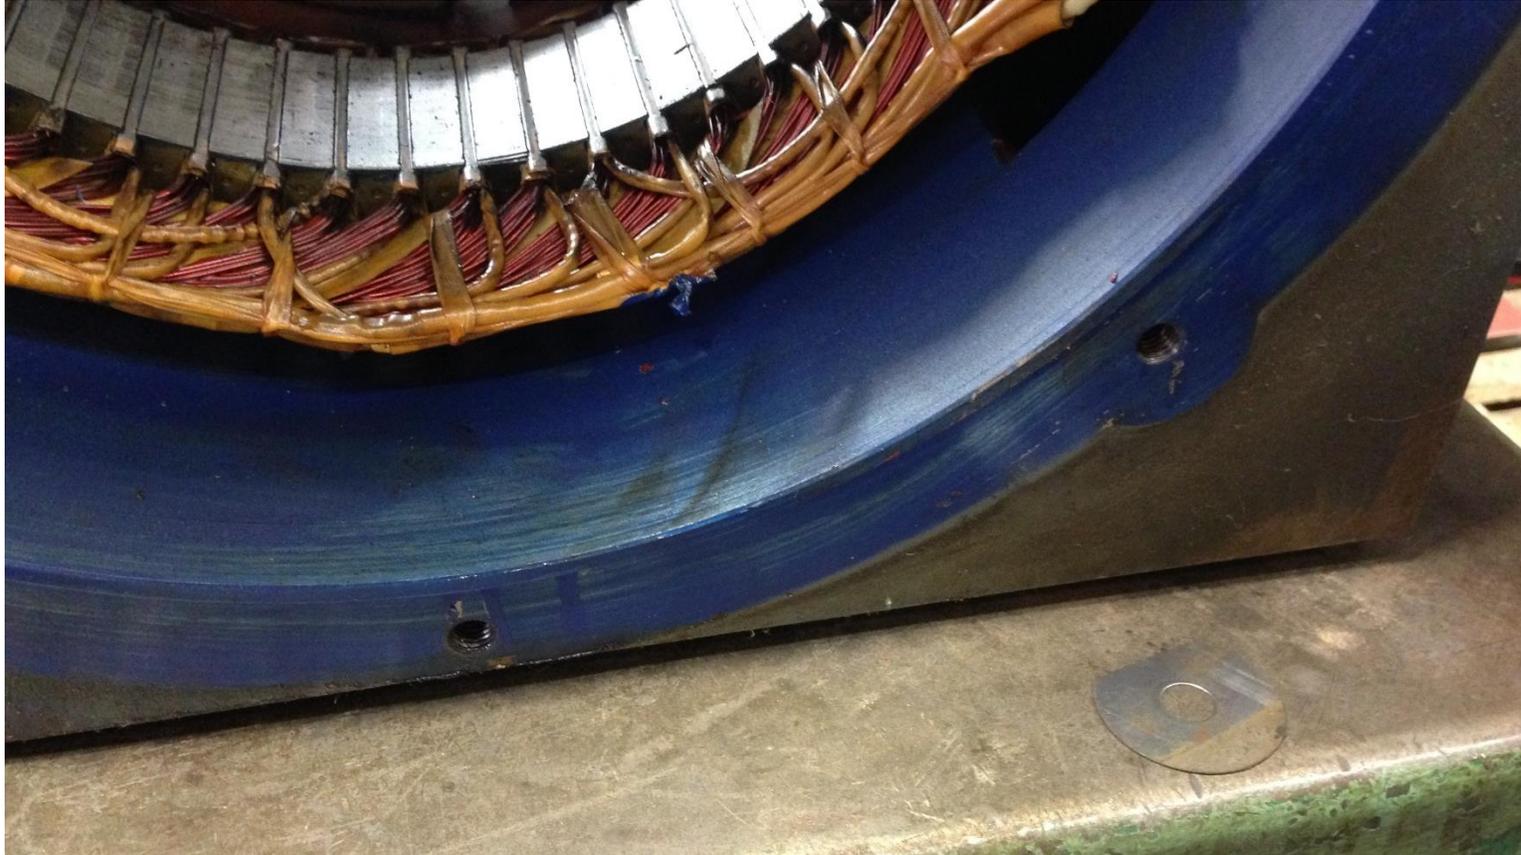
Rotor to Stator Contact

This picture shows where at one time the rotor and stator had made contact.
