RESPOND, REBUILD, & REDIRECT

Ashley Energy Plant

Emergency Event

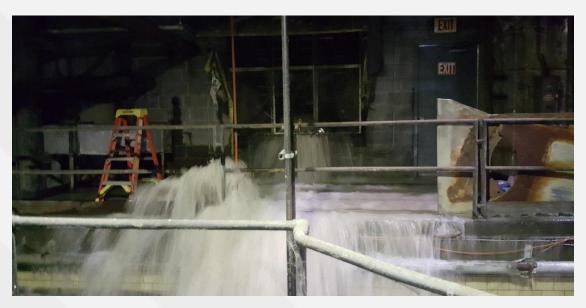
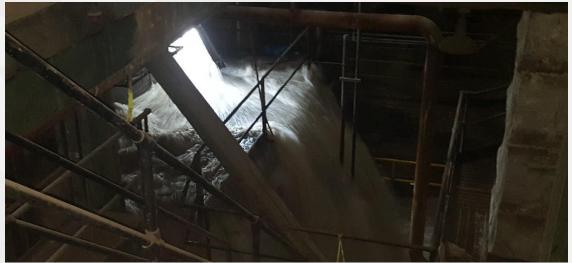
- June 1, 2019 Sanitary and Stormwater Pumping Station failed
- > > 5 million gallons of sanitary/stormwater entered the plant
- ► 11+ hour event, 25" of water per hour, filled plant to Elevation 29 (23+ feet)

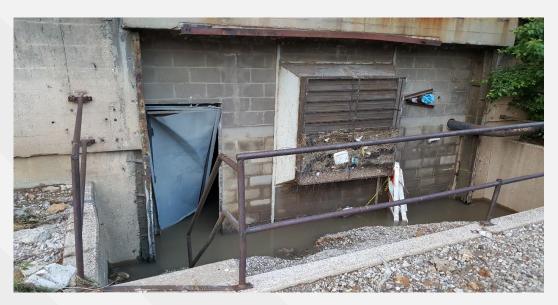
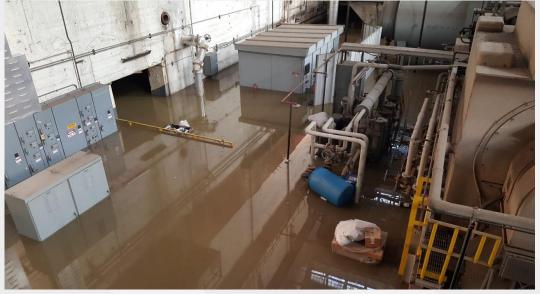
- Emergency Management
- Coordination with City/Utility Co's/Clients
- Initial Rental Equipment
- Early Damage Assessment

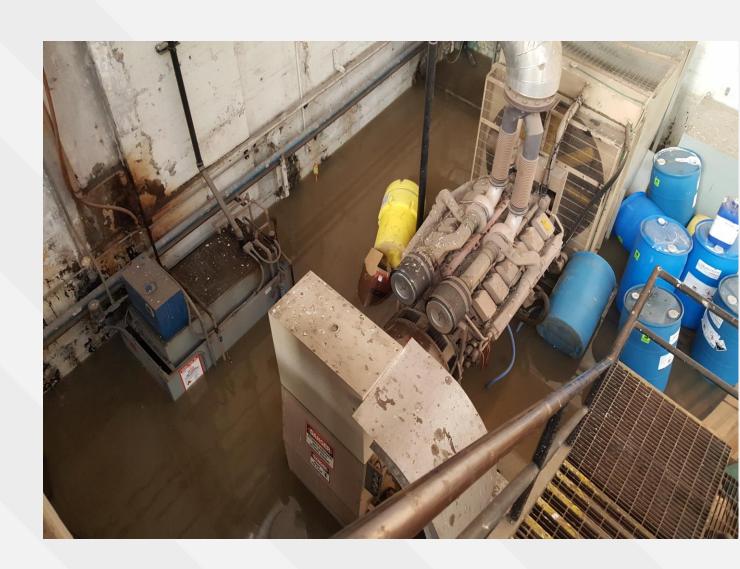
- Personnel Safety
- ▶ Remove Water from Plant
 - 14 Day Removal Period
- Compile Plant Logs, event documentation
