HOW THE UNIVERSITY OF FLORIDA DOCUMENTED 75 YEARS OF UNDERGROUND ASSETS USING GIS

MECHANICAL MANHOLE: MH-3D3-9
SYSTEM CONDITION

UTILITIES INFRASTRUCTURE ASSESSMENT

Mechanical Manhole:
MH-3D3-9

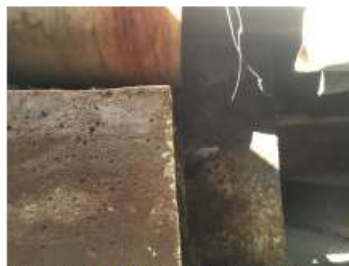
Date of Entry:	3/7/2017	Job Team:	JML, ALS, VGB, JM
Access Cover Condition:	Good	Access Cover Urgency:	N/A
Manhole Condition:	Cracks: <input checked="" type="checkbox"/>	Spalling: <input checked="" type="checkbox"/>	Exposed Rebar: <input type="checkbox"/>
Neck Condition:	Good	Ladder Condition:	Good
Excessive Surface Temperature?	<input checked="" type="checkbox"/>	Notes:	140 deg F
Water Present?	<input type="checkbox"/>	Obsv./ Perm Depth:	0"/18"
Piping Leaks?	<input type="checkbox"/>	Source:	Manway lids and MH-3D3-13
Debris?	<input checked="" type="checkbox"/>	Debris Notes:	Broken insulation, dirt, and sand
Pipe Hangers Cond.:	Good	Pipe Hangers Urgency:	N/A
Pipe Anchors Condition:	Poor	Pipe Anchors Urgency:	Immediate

**Rusted and Broken Anchor Plate on
6" 70S**
