Steam Piping Condition Assessments at Princeton University Using Ultrasonic Guided Wave Testing

Roger L. Royer Jr. and Fred DeGroot
Structural Integrity Associates, Inc.

Princeton District Steam System Background and Objectives

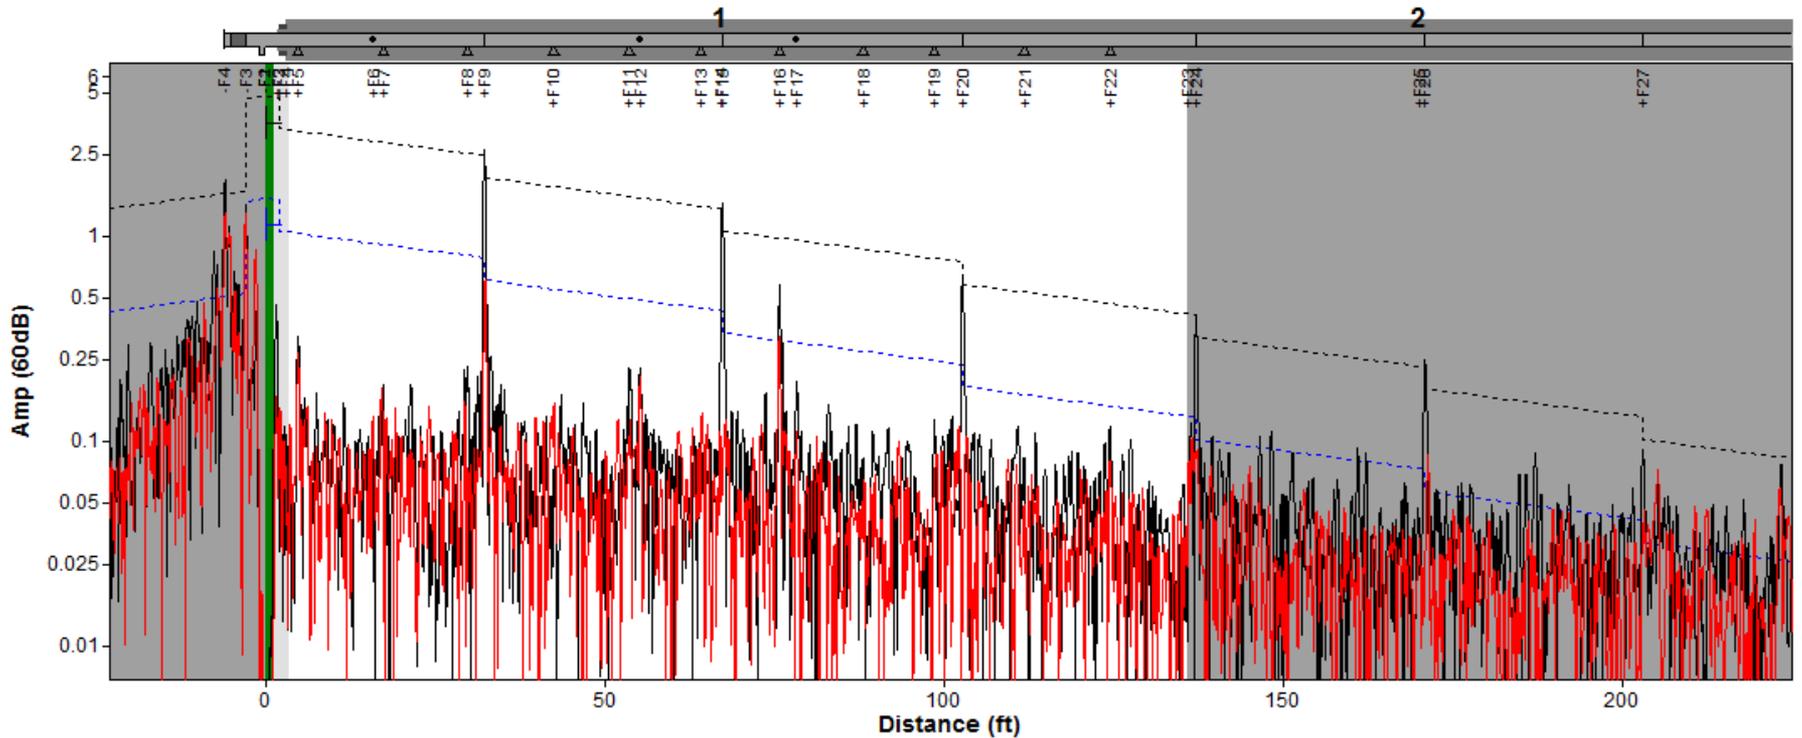
Princeton GWT Sample File

Sample GWT data filed from Princeton Steam Line showing good penetration with ~135 ft. of coverage in one direction.

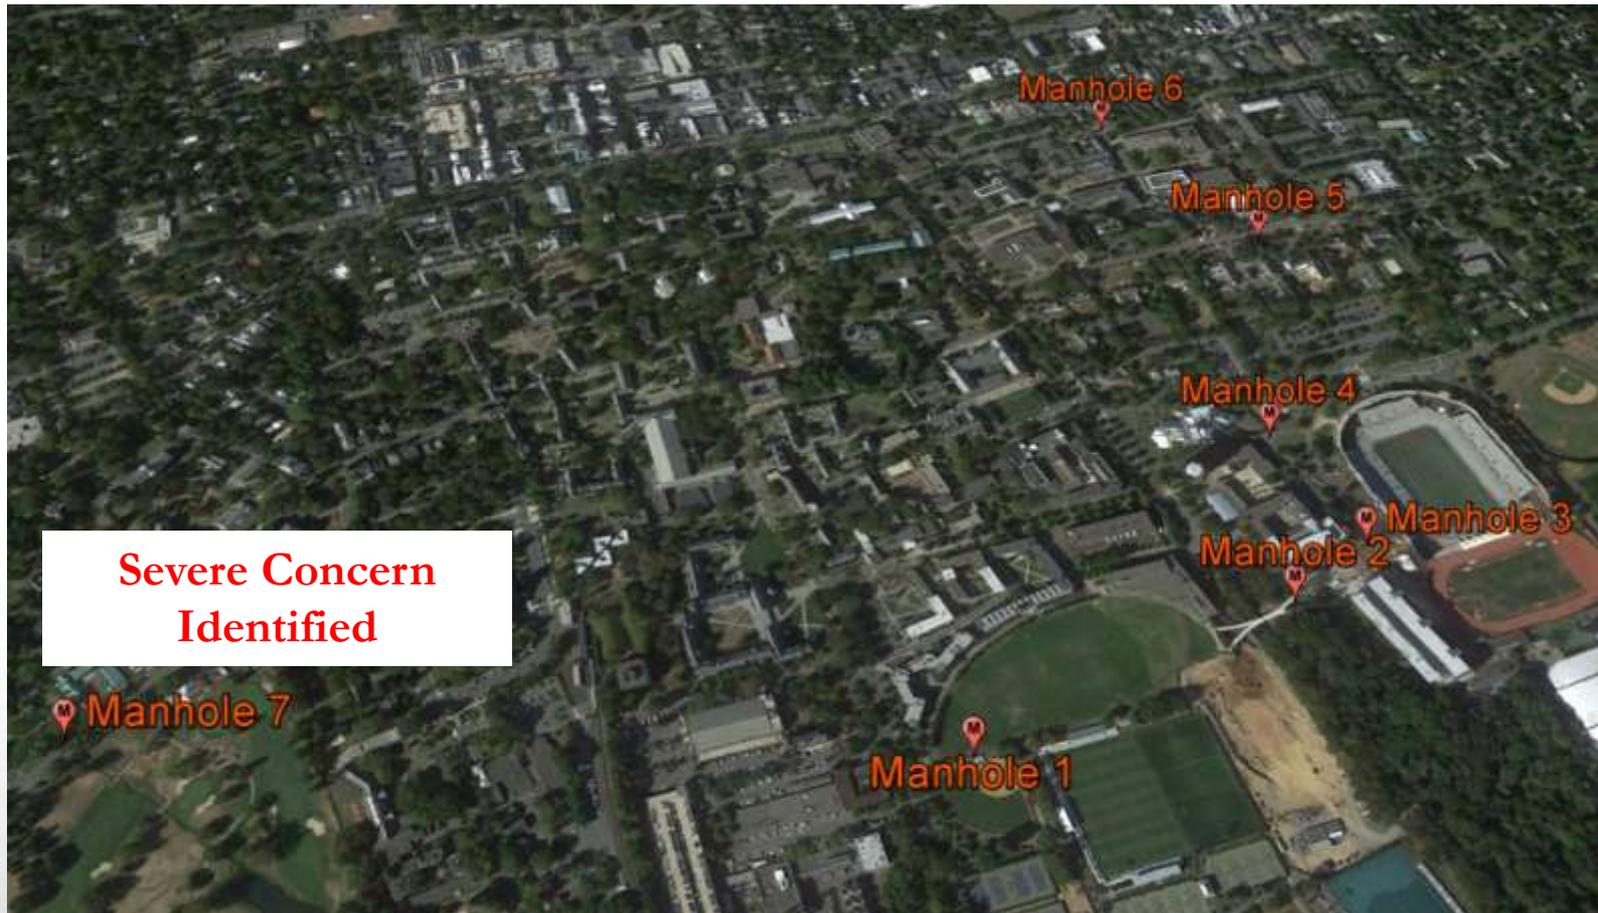
Mobilization 1 Test Locations

- GWT and UT conducted inside 5 manholes to screen 671 ft. of pipe. Grad School Line (Item 21/Manhole 7) targeted for more inspections based on findings.

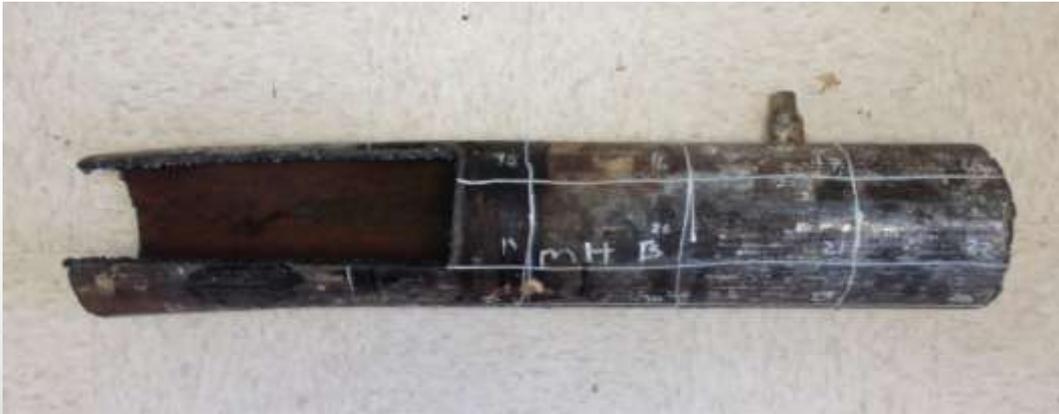
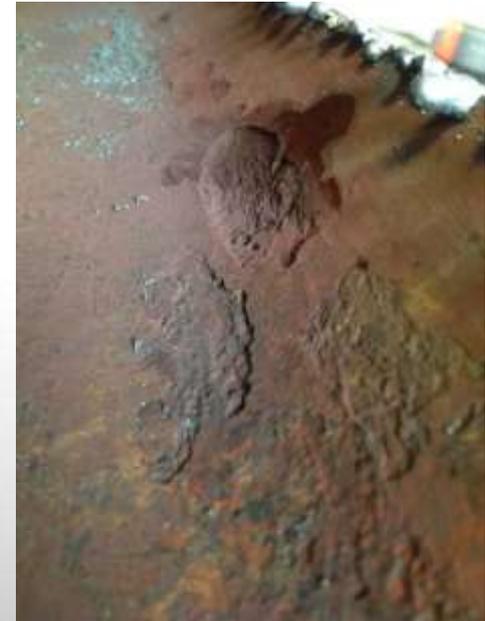
Pipe Replacement from Manhole B

Based on the Mobilization 1 findings, a section of pipe was cut out and replaced in inside Manhole B. The cut out section was sent to SI's Material Research Center for further "destructive" analysis.

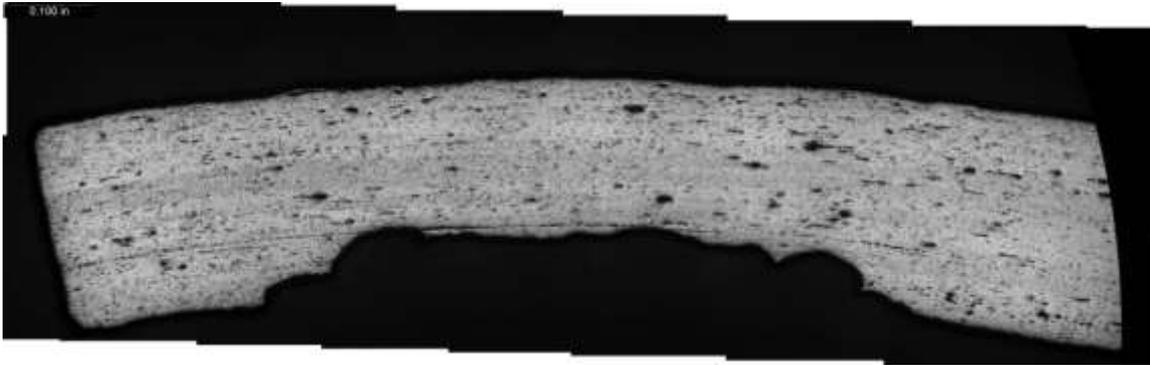
6 Inch Pipe Internal Corrosion

- The material is very “dirty” steel with a large amount of non-metallic inclusions, questionable chemistry, and relatively low hardness.
- Internal corrosion (36% wall loss) was present and concentrated to the region of the pipe near the pulled bend, likely the result of steam condensation collecting at a low point at the start of the bend.
- The corrosion is localized in nature, but it does not appear to be preferentially attacking any specific microstructural features.
- It cannot presently be determined why the corrosion is affecting localized areas, but a possible explanation might be that these areas contained inclusions near to or breaching the ID surface.

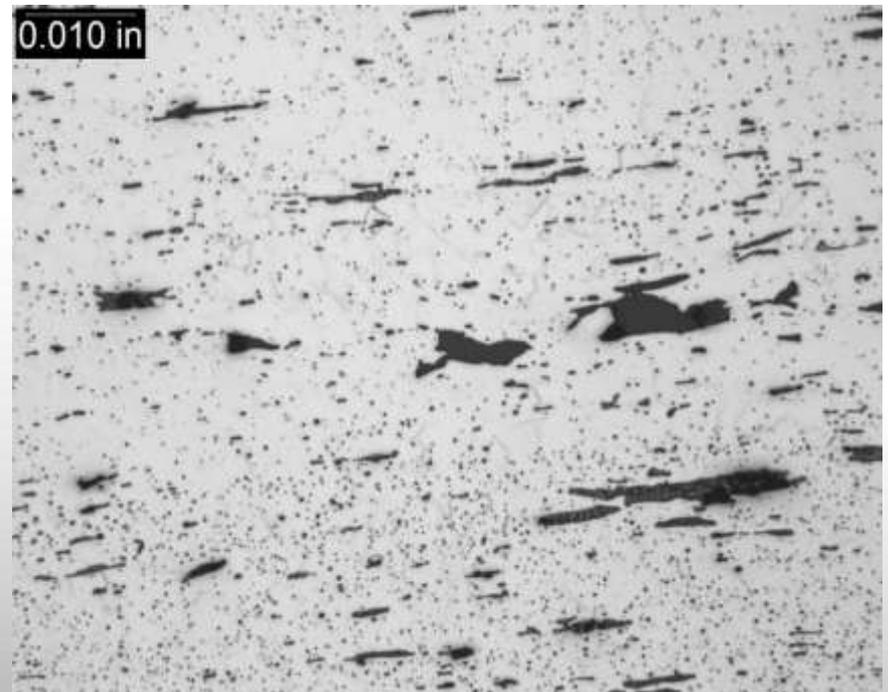
Un-etched cross-section of the ID corrosion observed on the 6 inch pipe segment. The material contains a high concentration of non-metallic inclusions

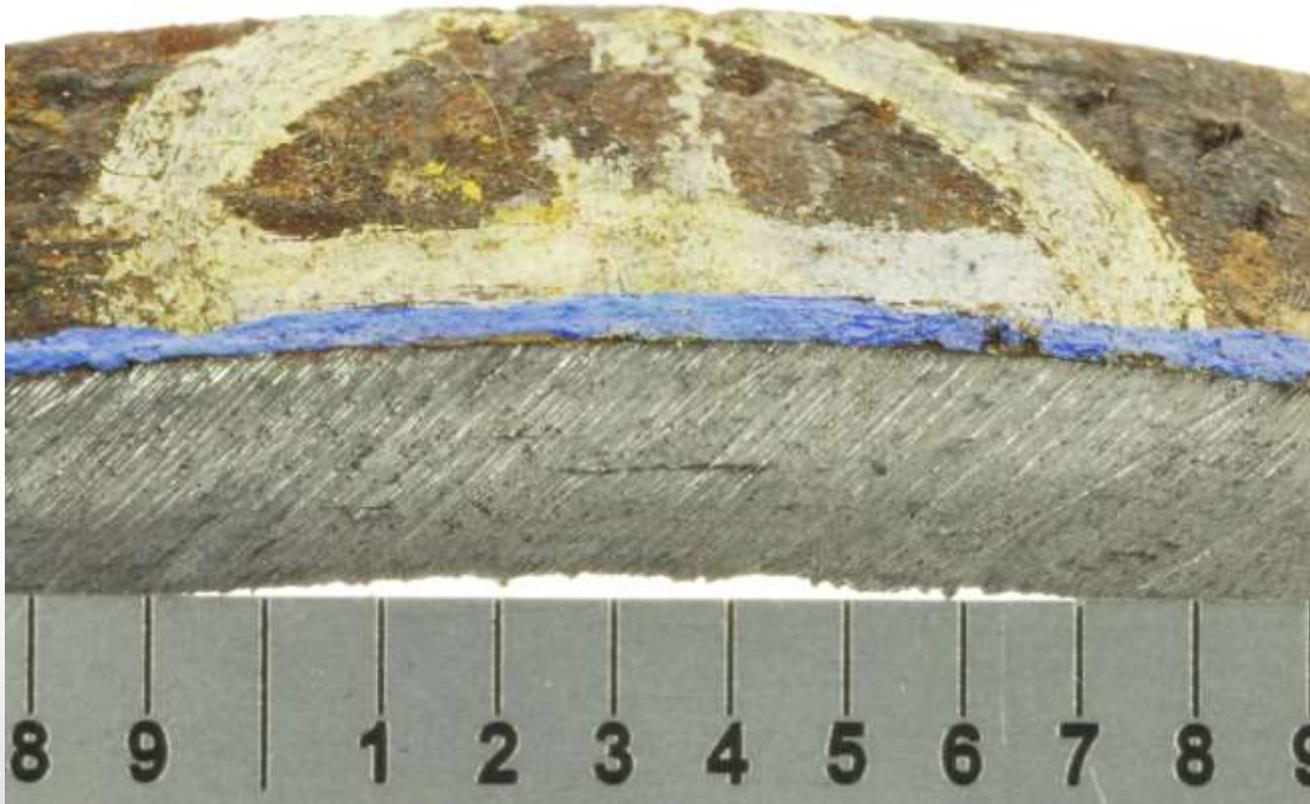
6 Inch Pipe Mid-wall Inclusion

This macro inclusion was detected with UT and confirmed with metallography.
