Using Advanced Monitoring for Leak Detection and Increased System Reliability

District Energy St. Paul Pipeline

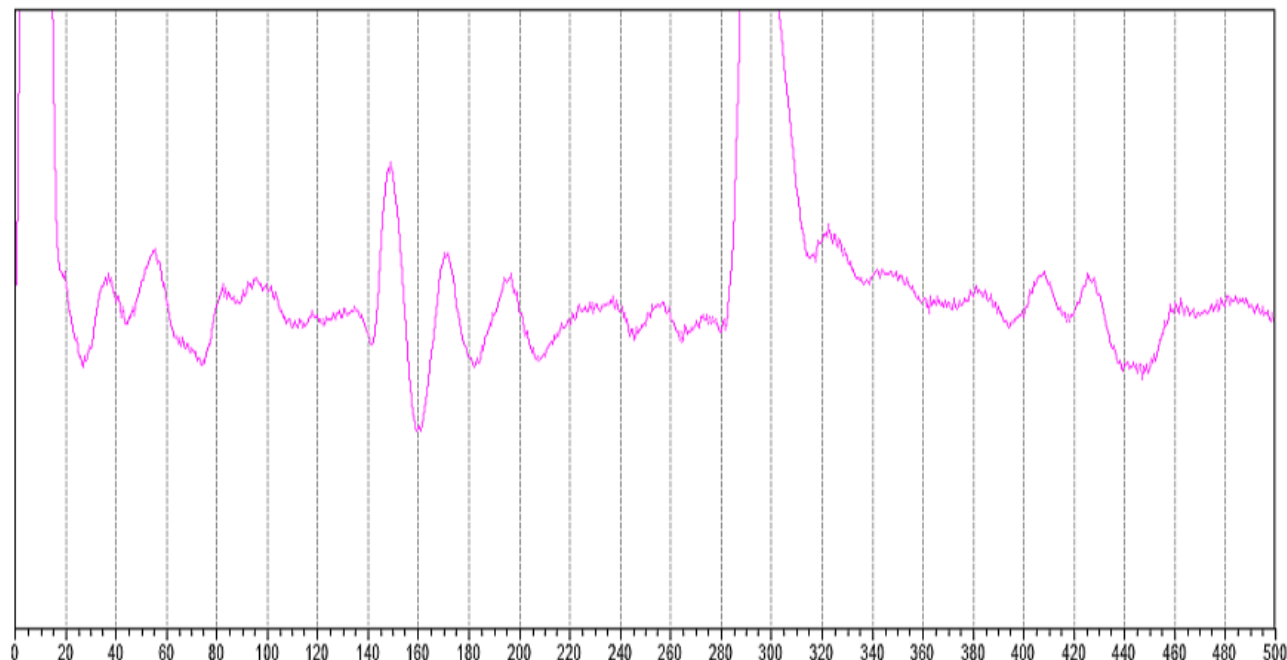
Status 0 & TDR Curve - Baseline

Status 0

OK

No remarks

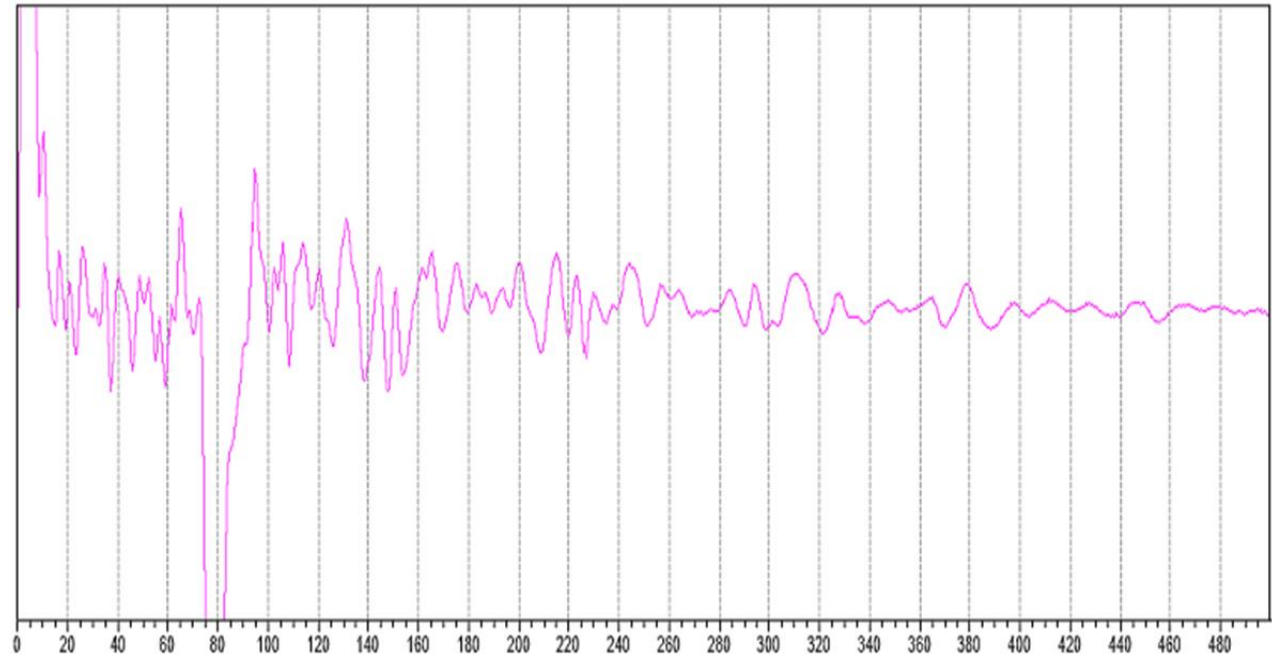
Status 20 & TDR Curve – Evidence of Pipe Leak

Status 20

Very clear indication of H2O (not located)

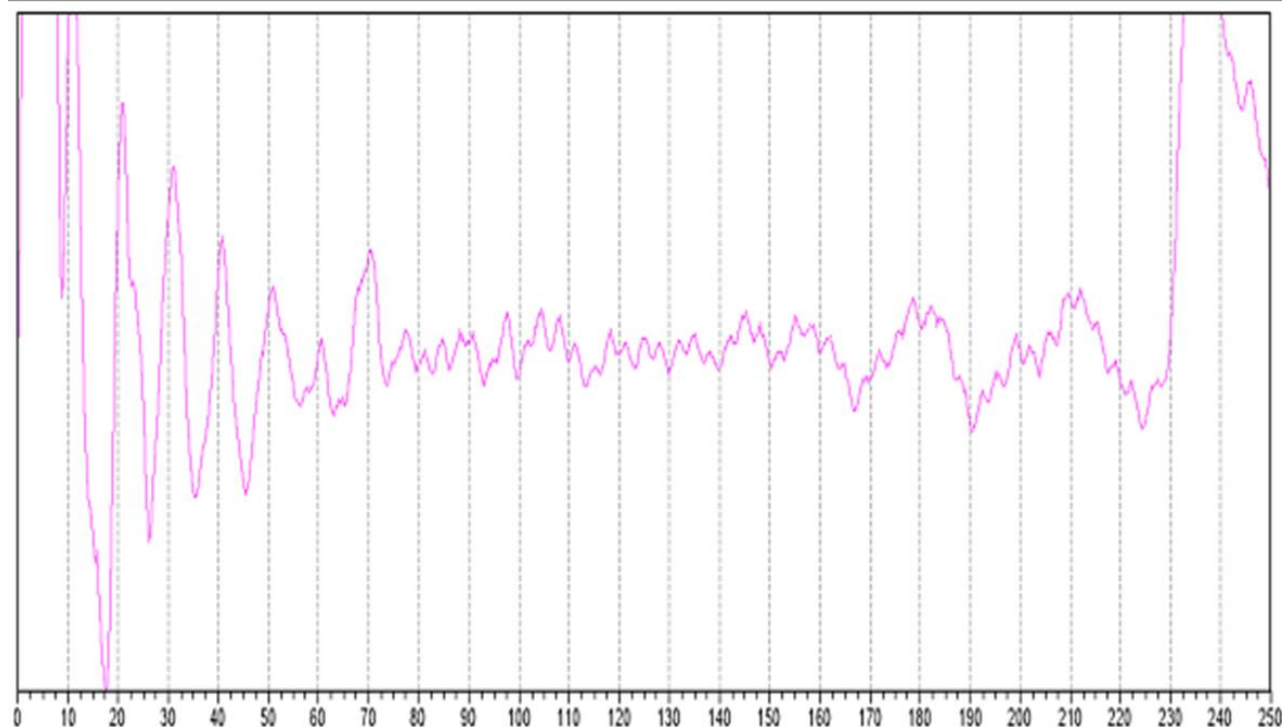
Early Detection – Status 11

Status 11

Indication of H2O (not located)

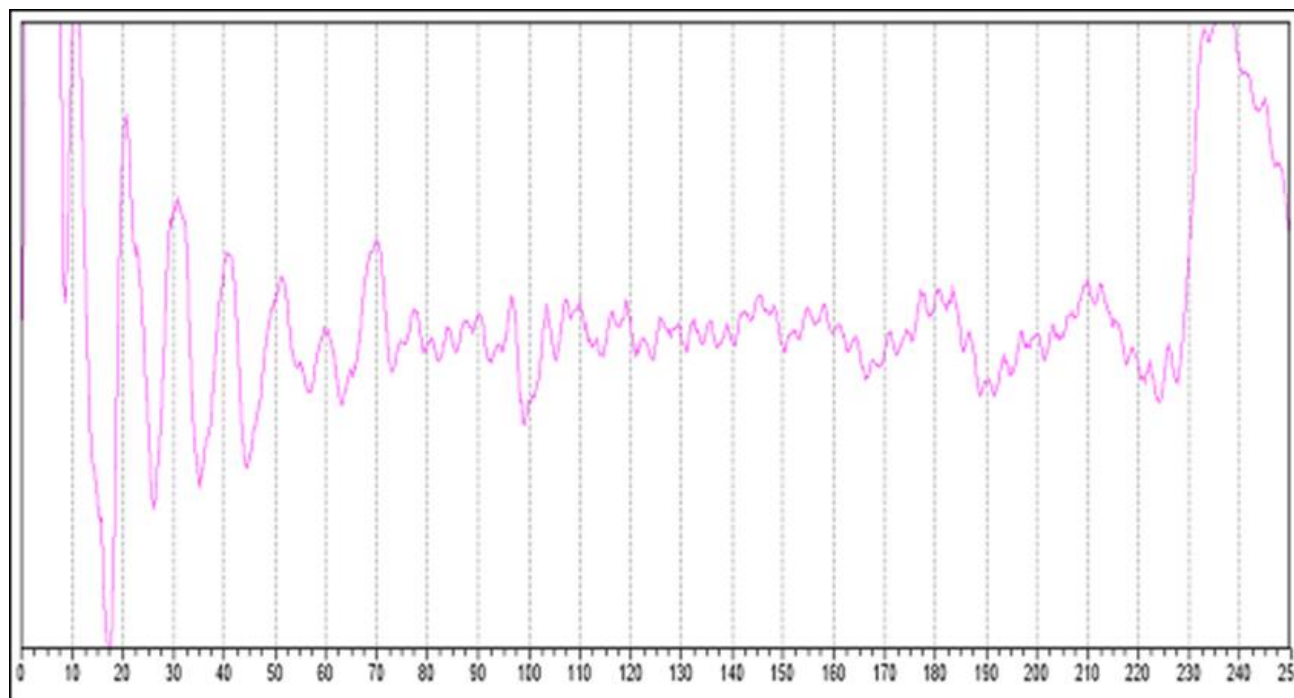
Early Detection – Status 17

Status 17

Very clear indication of H2O (not located)

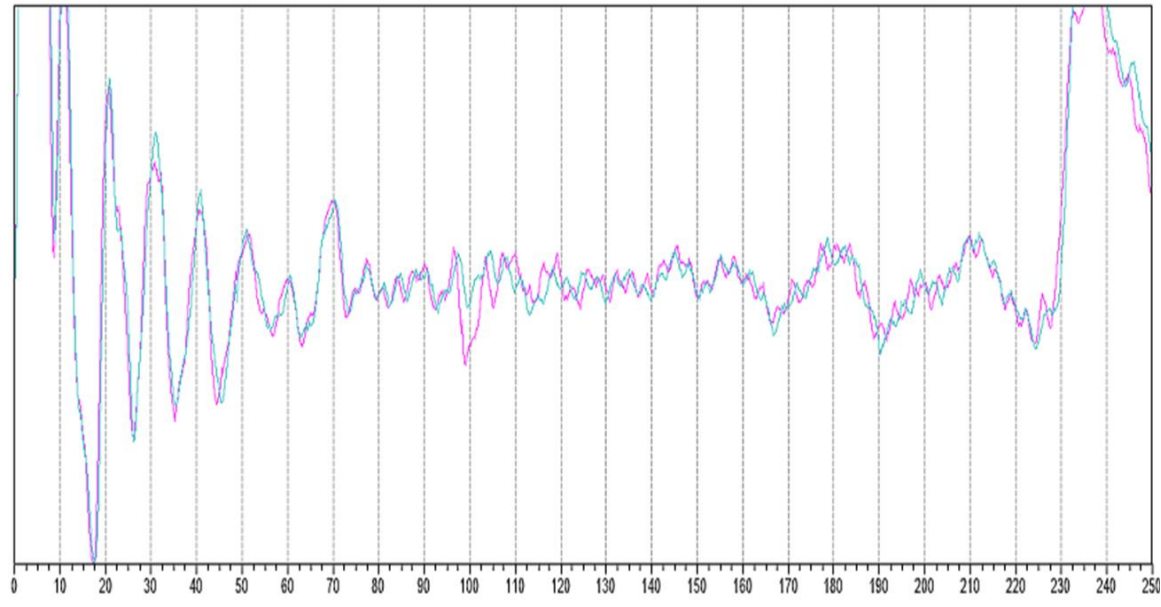
Early Detection – Comparison of Progression

Measure place bethesda				Measure place bethesda			
Loop return		Pipe right		Loop return		Pipe right	
Pipe type		Wire 1		Pipe type		Wire 1	
Direction				Direction			
Measured 12/17/2009 12:24:08PM				Measured 1/12/2011 1:21:22PM			
Measurement after repair				Kontroll, se anmärkning			
Normal curve				Normal curve			
Measured by Gerry Gubash				Measured by Gerry Gubash			
Range	Gain	Pulse	Vel	Range	Gain	Pulse	Vel
250	20	20	930	250	20	20	930
Loop res		99999 Ω		Loop res		99999 Ω	
Galvanic voltage		411 mV		Galvanic voltage		508 mV	
DC res		1		DC res		1	
AC res		3080 k Ω		AC res		203 k Ω	
Megger		M Ω		Megger		M Ω	
Manual status		No		Manual status		No	
Status		11		Status		17	
Indication of H2O (not located)				Very clear indication of H2O (not located)			
Observation				Observation

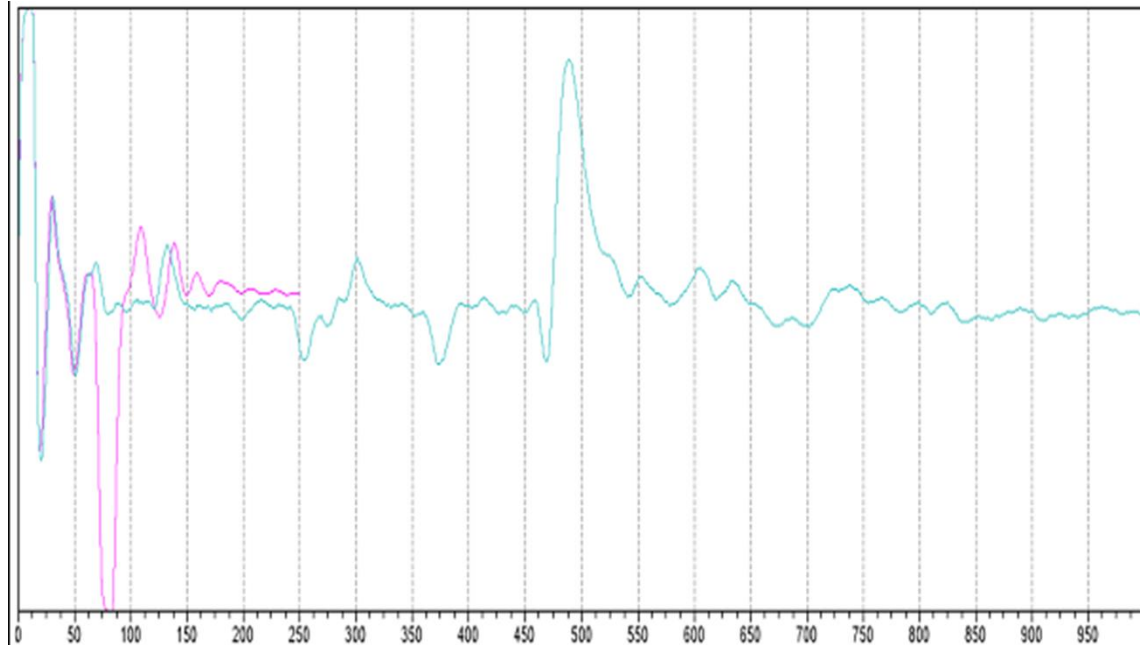
Water Main Failure – Comparison of Progression

Measure place Straus			
Loop supply	Pipe left		
Pipe type	Wire 1		
Direction			
Measured 11/9/2007 11:38:10AM			
Troubleshooting			
Close up			
Measured by Gerry Gubash			
Range	Gain	Pulse	Vel
500	20	20	930
Loop res 99999 Ω			
Galvanic voltage 201mV			
DC res 1			
AC res 1290 k Ω			
Megger M Ω			
Manual status No			
Status 12			
Indication of H2O (not located)			
Observation			
Remark

Measure place Straus			
Loop supply	Pipe left		
Pipe type	Wire 1		
Direction			
Measured 1/23/2009 10:02:43AM			
Measurement after repair			
Normal curve			
Measured by Gerry Gubash			
Range	Gain	Pulse	Vel
250	20	20	930
Loop res 99999 Ω			
Galvanic voltage 471mV			
DC res 1			
AC res 6 k Ω			
Megger M Ω			
Manual status No			
Status 20			
Very clear indication of H2O (not located)			
Observation			
Remark
