CAMPUS ENERGY 2016

USING INTELLIGENT PREDICTIVE CONDITION-BASED MONITORING FOR DETECTING & PREDICTING EQUIPMENT FAILURE AT THE UNIVERSITY OF TEXAS- AUSTIN

**UNIVERSITY OF TEXAS-AUSTIN, UTILITY &
ENERGY MANAGEMENT (UT-UEM)**

BNF TECHNOLOGY INC.

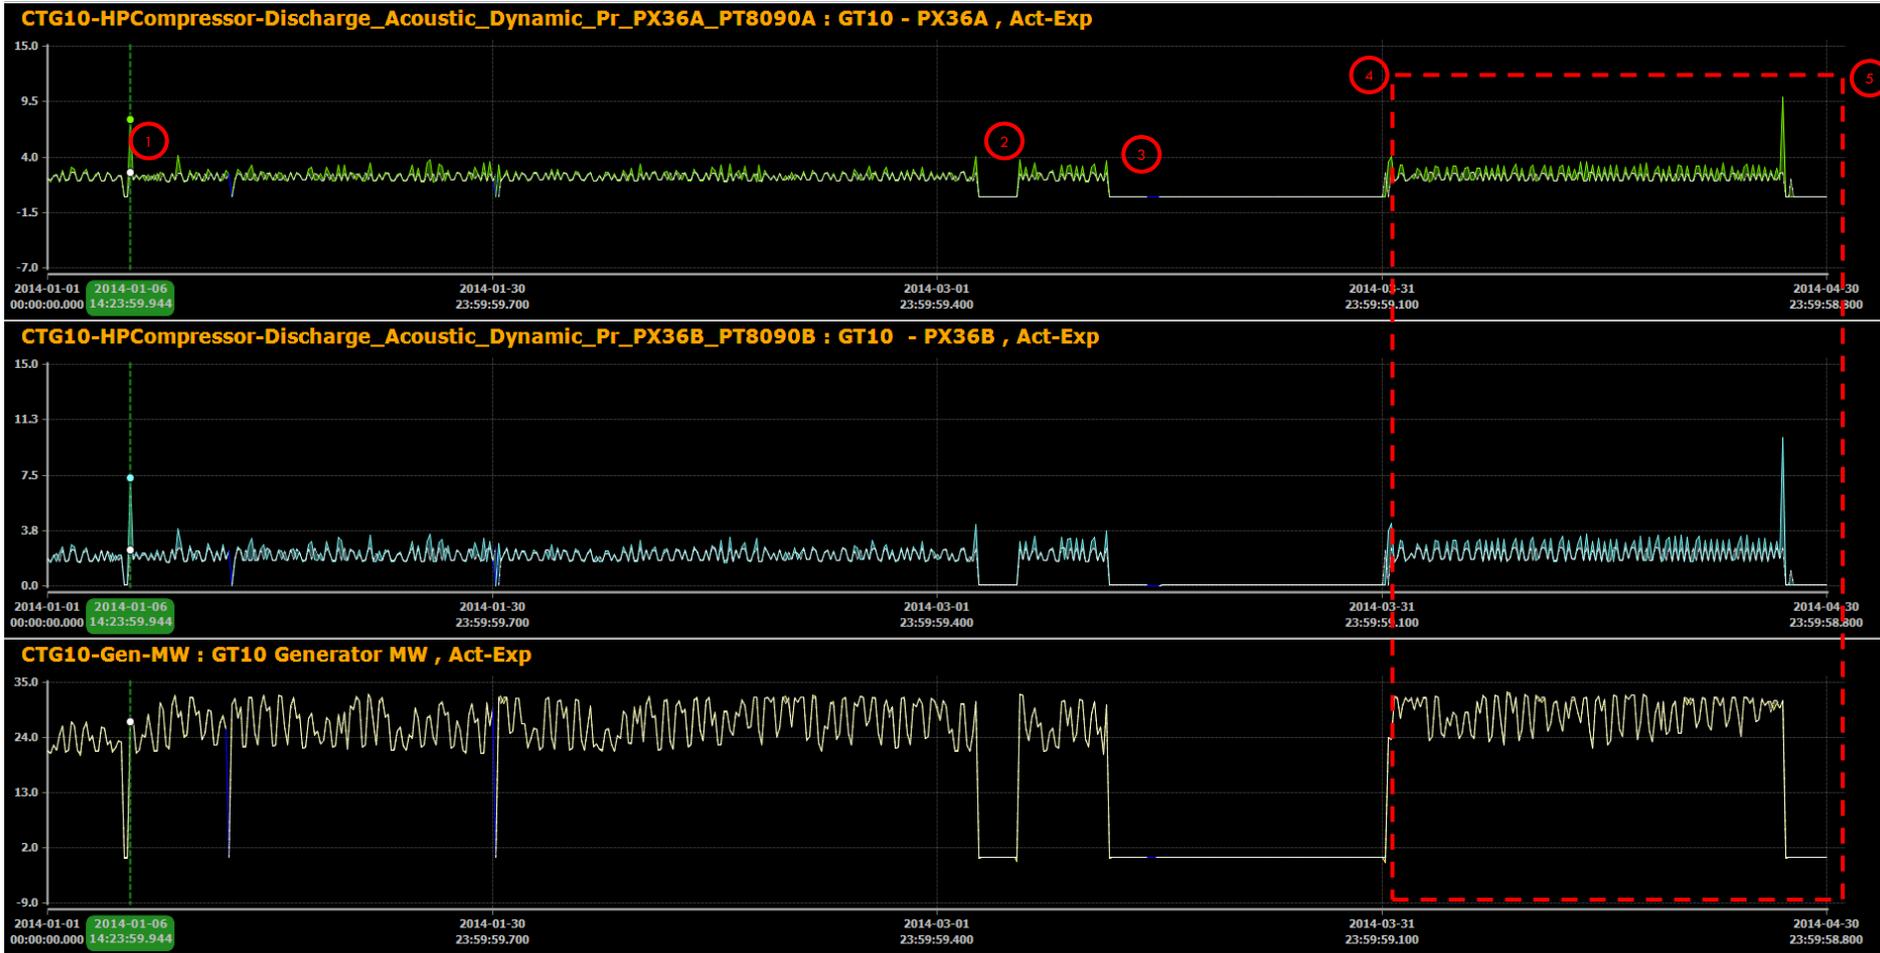
- **Plant :** UT-UEM
- **Issue :** CTG10 – Compressor Inlet Temperature Control – T2
- **Anomalies Observed :** HP Compressor Discharge Acoustic Dynamic Pressure was unstable and changing between 1.7 to 10.5 (PSID) during 21:45 to 22:00 hours on 27th April 2014. Large fluctuations in CTG10 speed and acoustic vibration levels were also observed. after that the CTG10 was stopped/tripped.
- **Action:** GE Aero was contacted to discuss reason for trip which was related to unit speed. According to GEK 112767 Volume I; the VSV system senses gas generator speed and compressor inlet temperature, and positions the VSV's. For any temperature and any speed, the VSV's take one position and remain in that position until the NGG or T2 changes. After the failure UT-UEM, corrected the control logic to control T2 at a steady temperature.

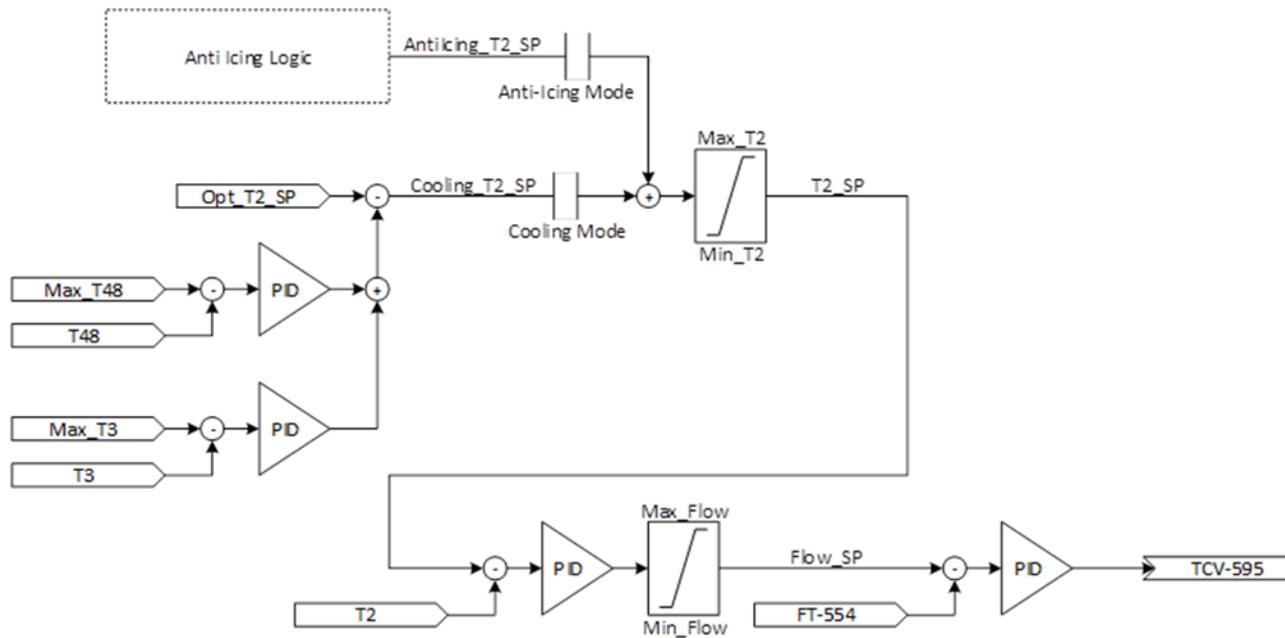
- The control diagram below depicts what was implemented to control T2 at a steady temperature.

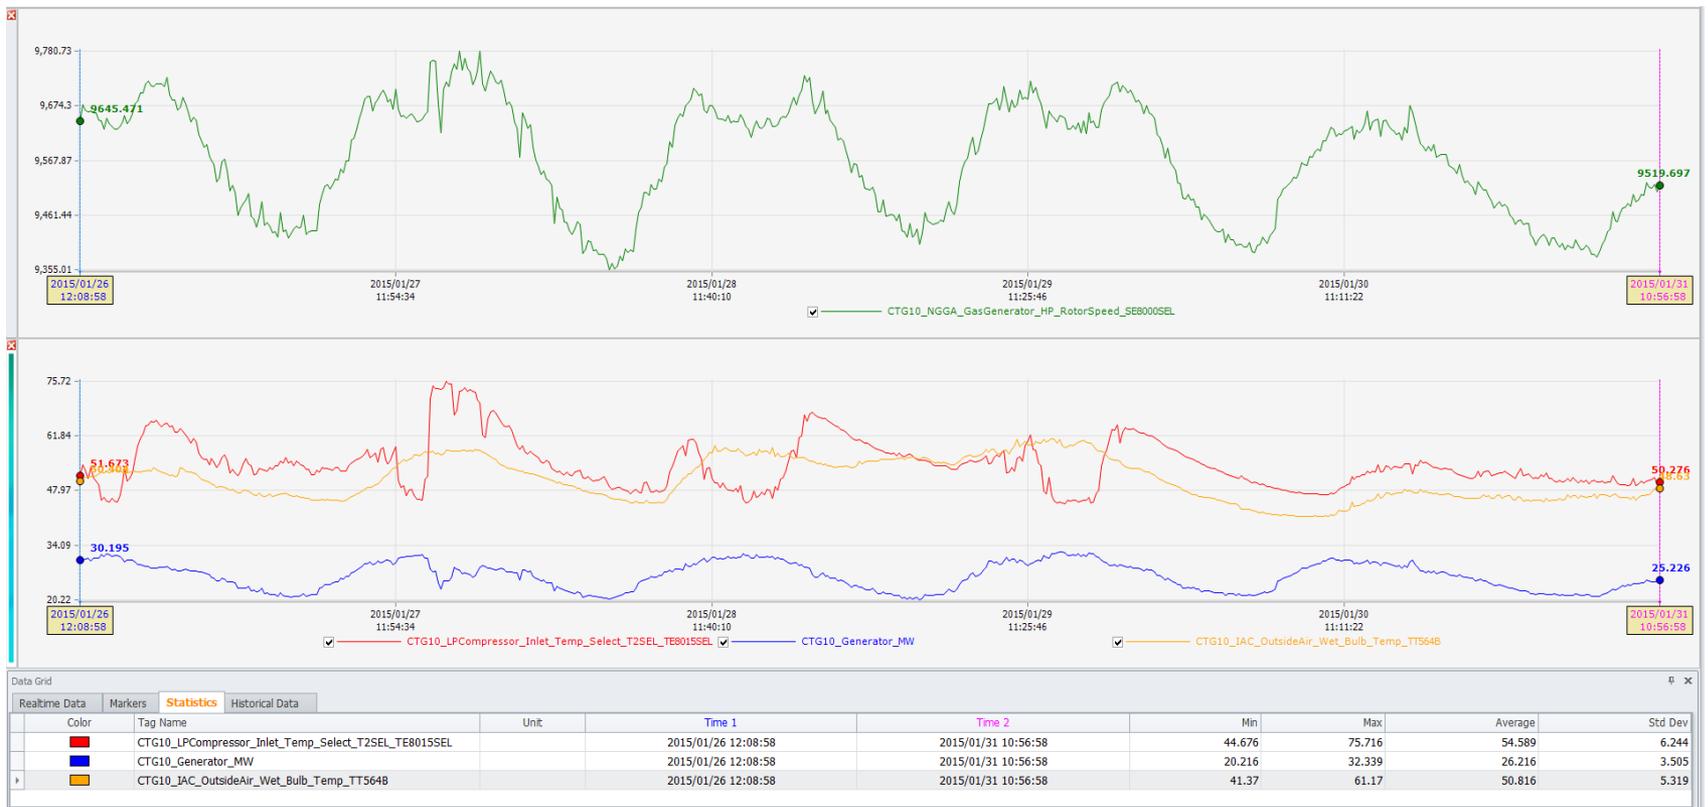
- The trend below depicts behavior before control scheme implementation

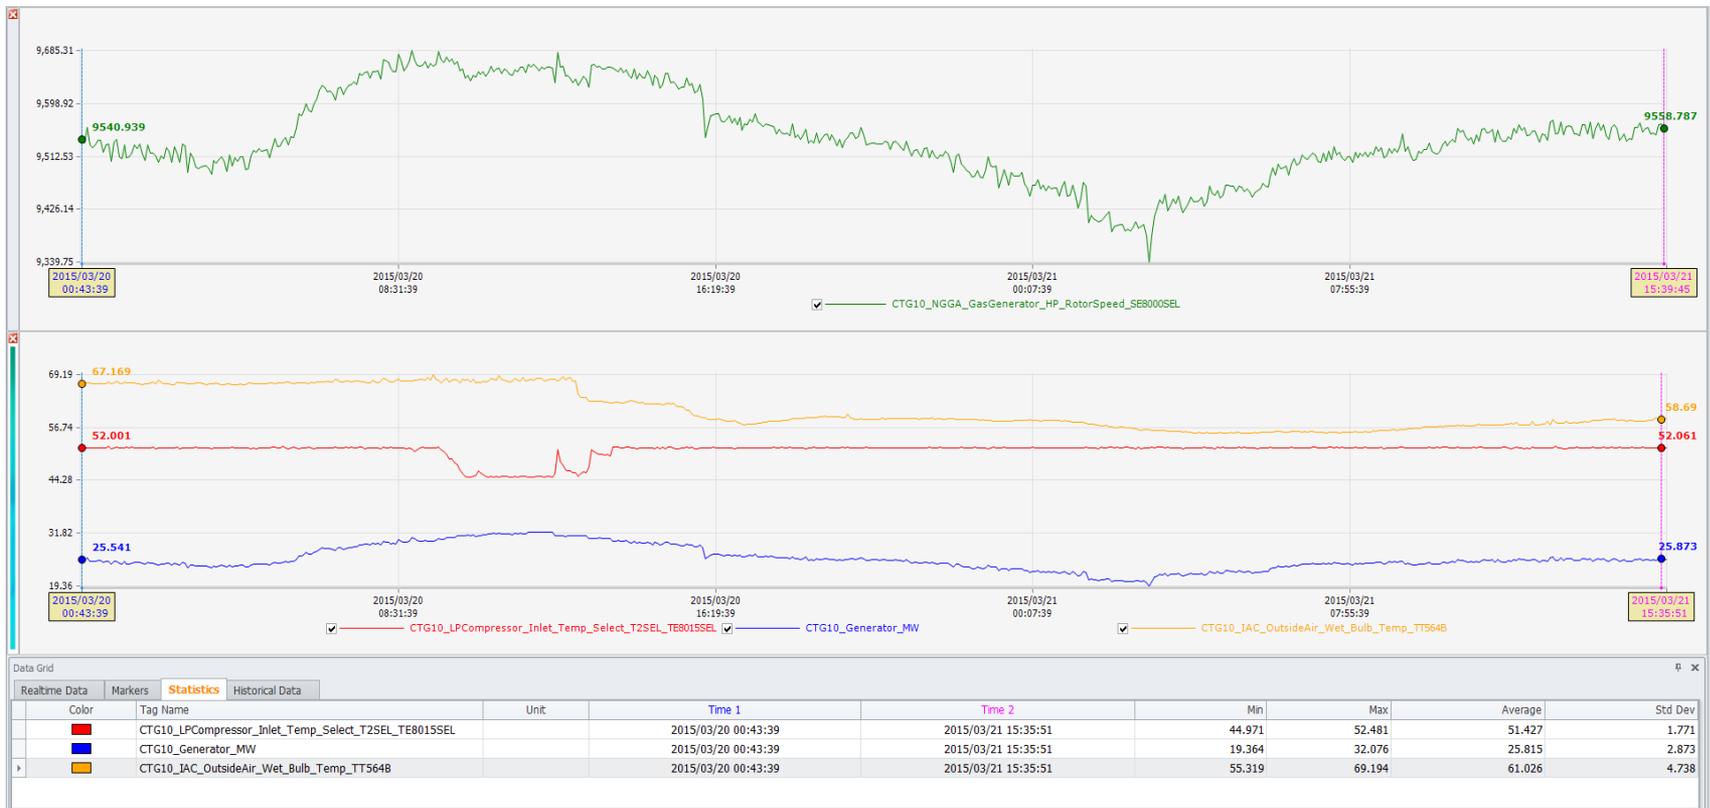
- The trend below depicts behavior after control scheme implementation

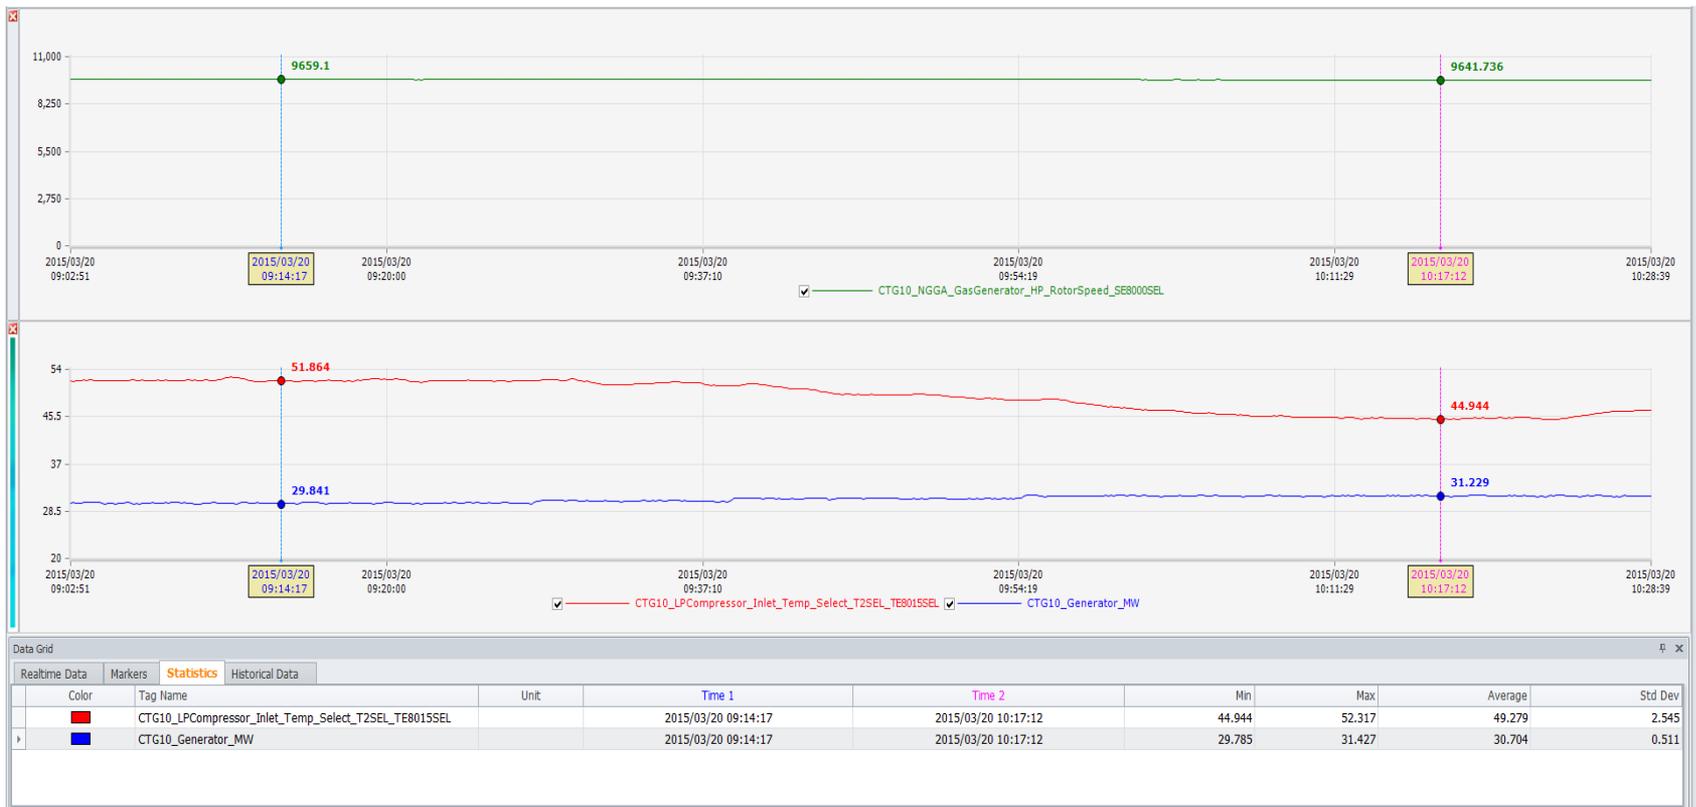
- The trend below depicts behavior after control scheme implementation - detailed

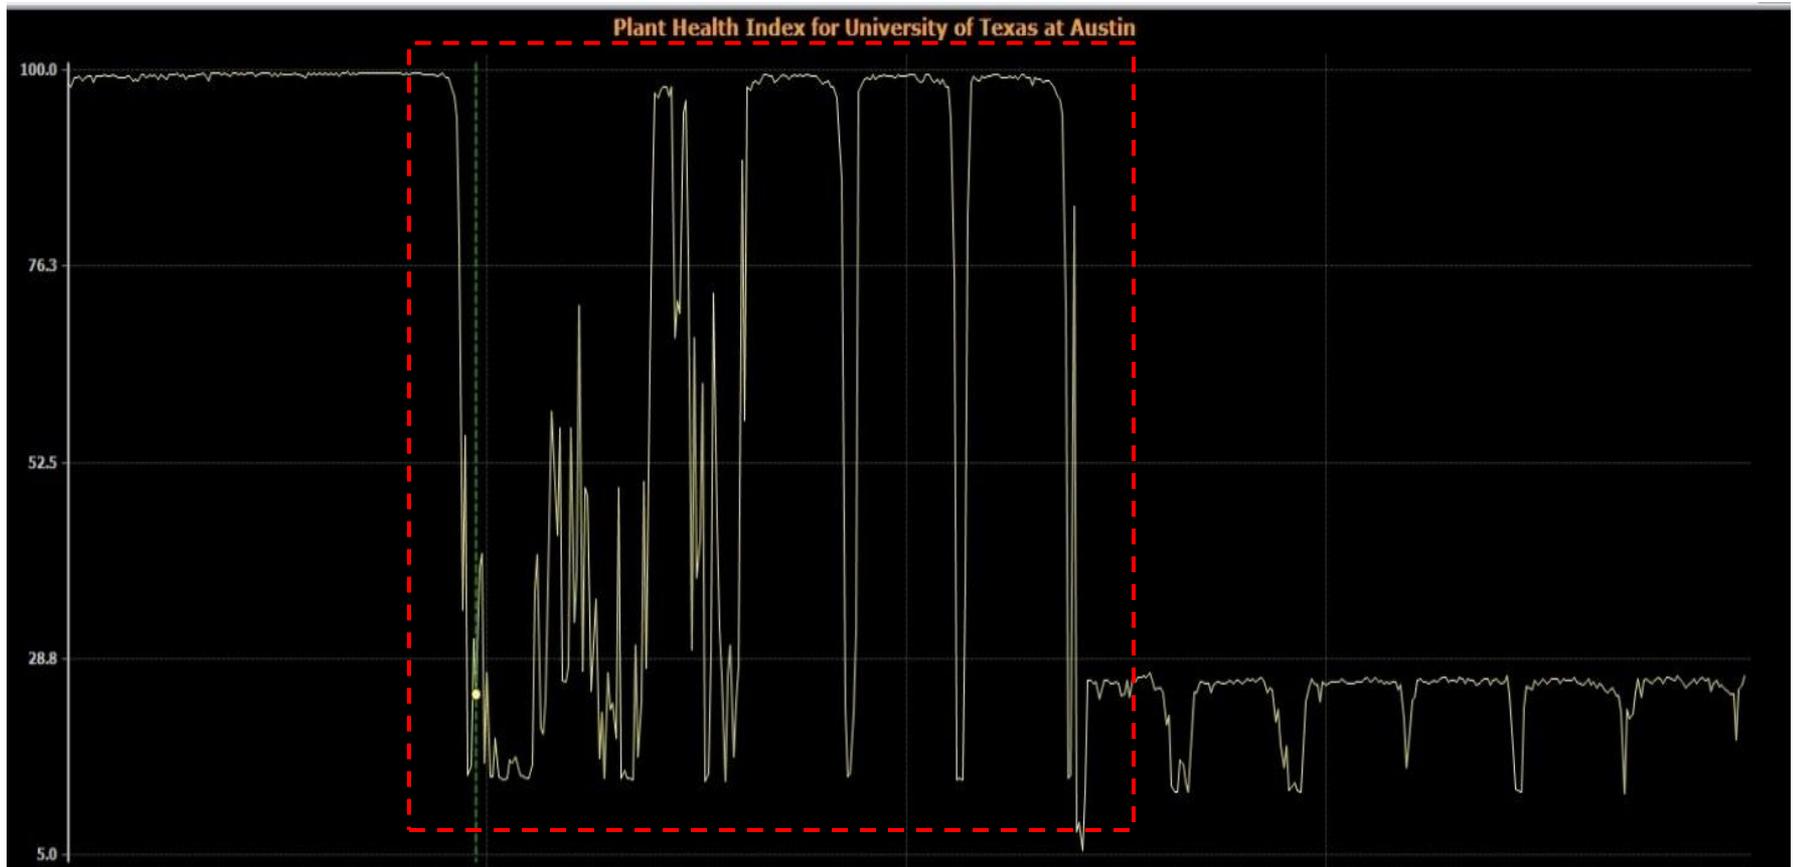
- System: Boiler 3 , FD Fan –Main Index Trend

- System: Boiler 3 , FD Fan
- It was observed that the quality of the main trend was dropped down to 25% on November 22, 2015 again about the same time after four days. This occurrence is observed on October 12, 2015 and December 14, 2015 after the fans were swapped.

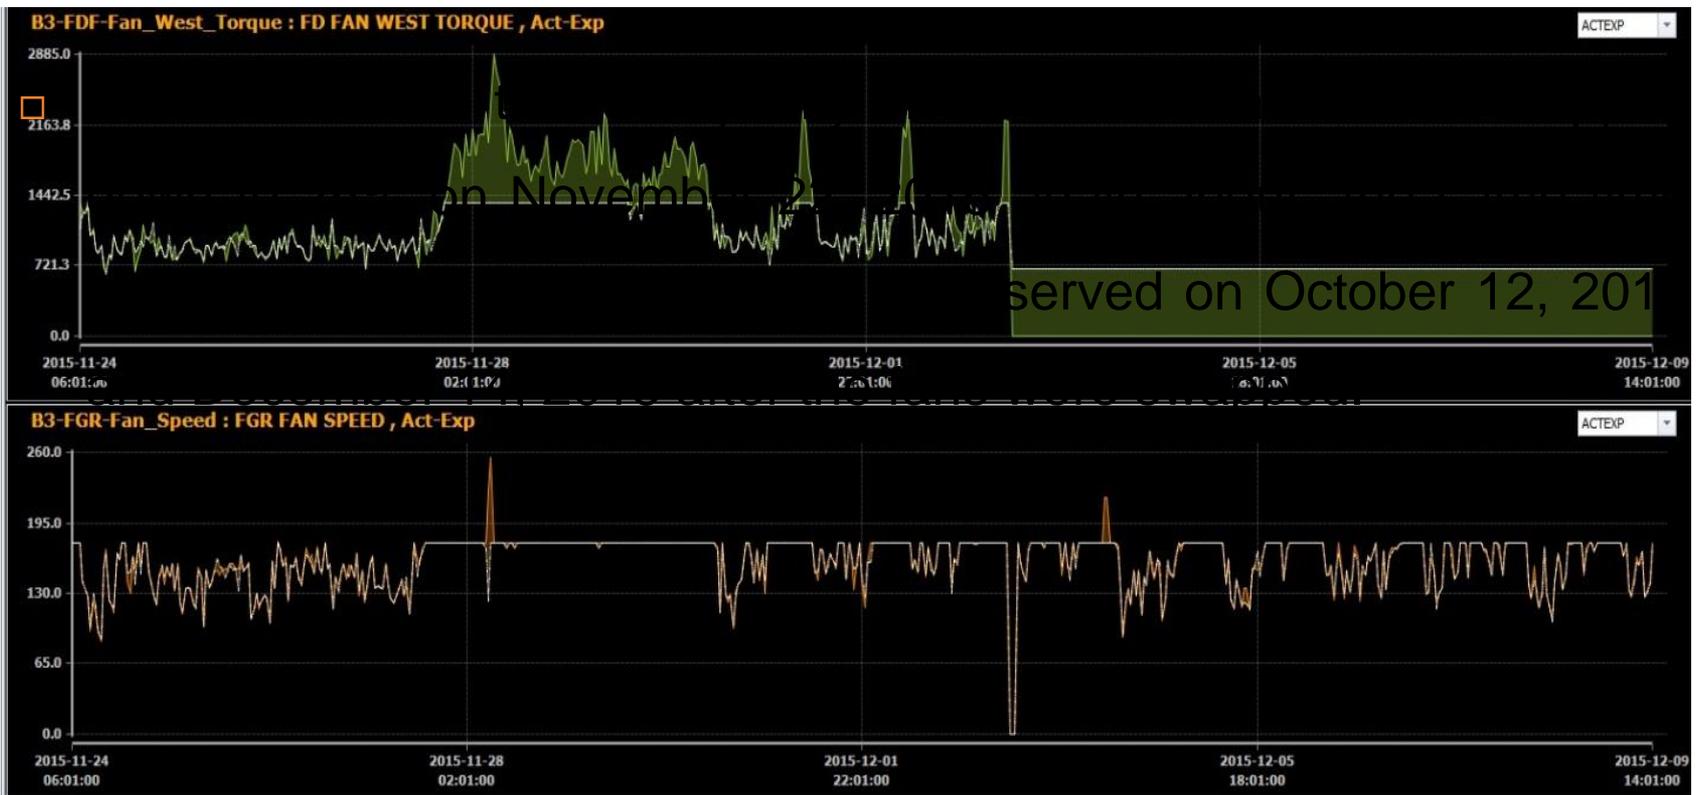
- FD-FAN speed and torque Actual-Expected Trend

- A low health index was observed on boiler 3 and after analysis it was discovered that there were variation in west fan torque and the current as shown on actual-expected trend.
- This kind of behavior did alarm the system and was not observed in the plant historian database. According to the instrumentation team, there were two differential pressure transmitters were not in the same position hence the difference in readings.

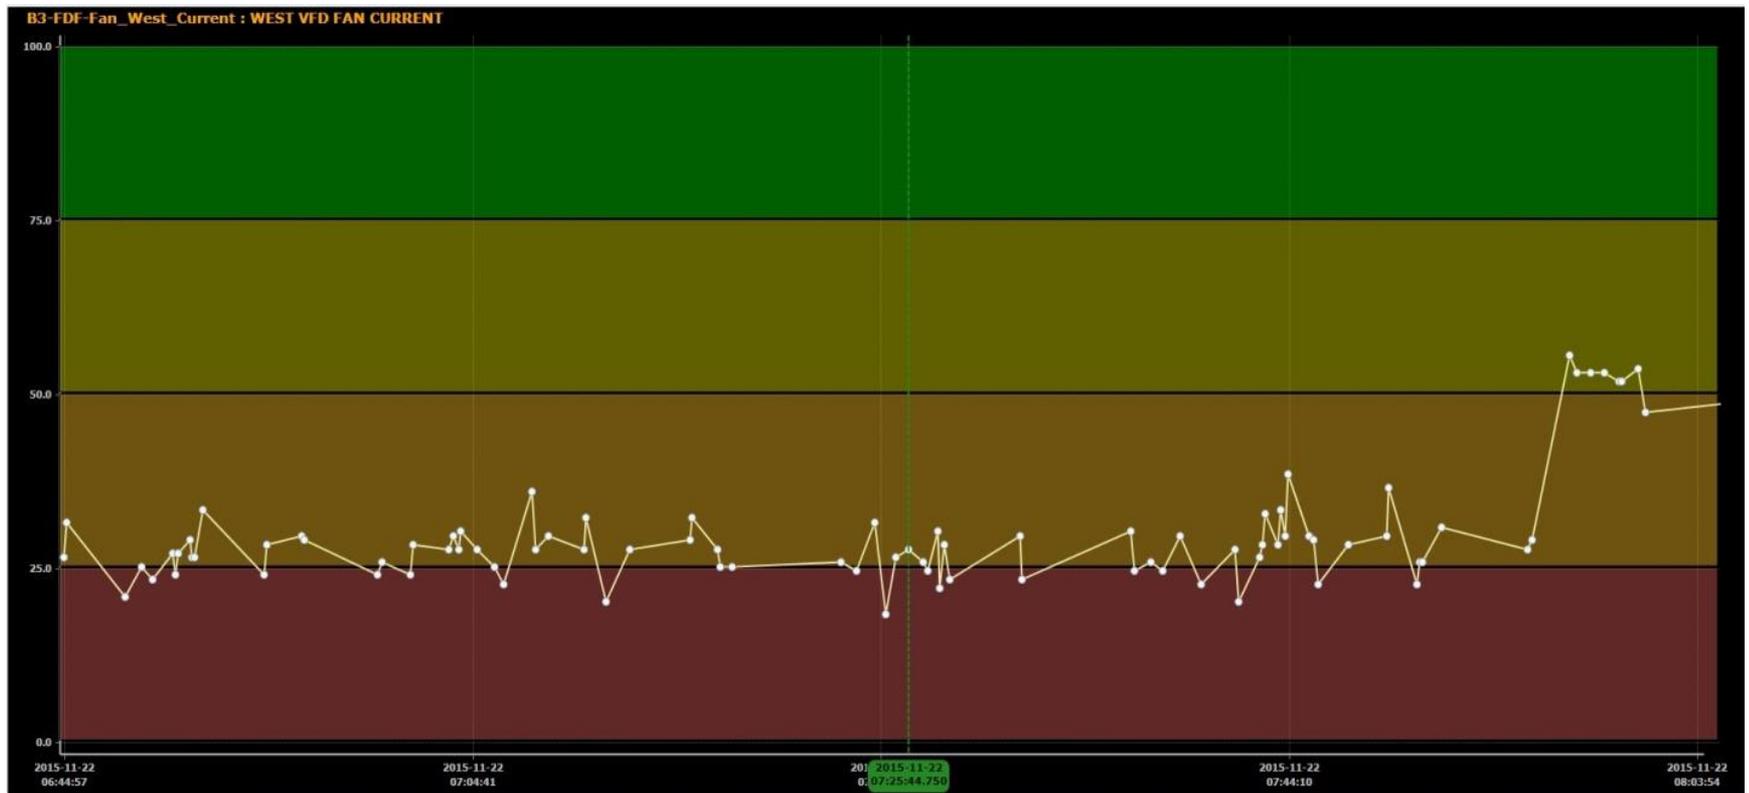
Alarm Trend

- There is a disparity between the instrument readings, ideally the readings from both instruments should be exactly the same. It was about 180 % more than the other one. The boiler was shut down and the meters were calibrated.
- After the calibration the difference in reading has improved remarkably, although the difference in reading is not equal, the improvement is tremendous. There is a need to calibrate instruments for further accurate reading.
