# Improved Management of Water Infrastructure Assets Using Non-Invasive Acoustics to Help Determine Rehabilitation Strategy

**Graeme Brandt**  
Senior Project Specialist, Echologics LLC

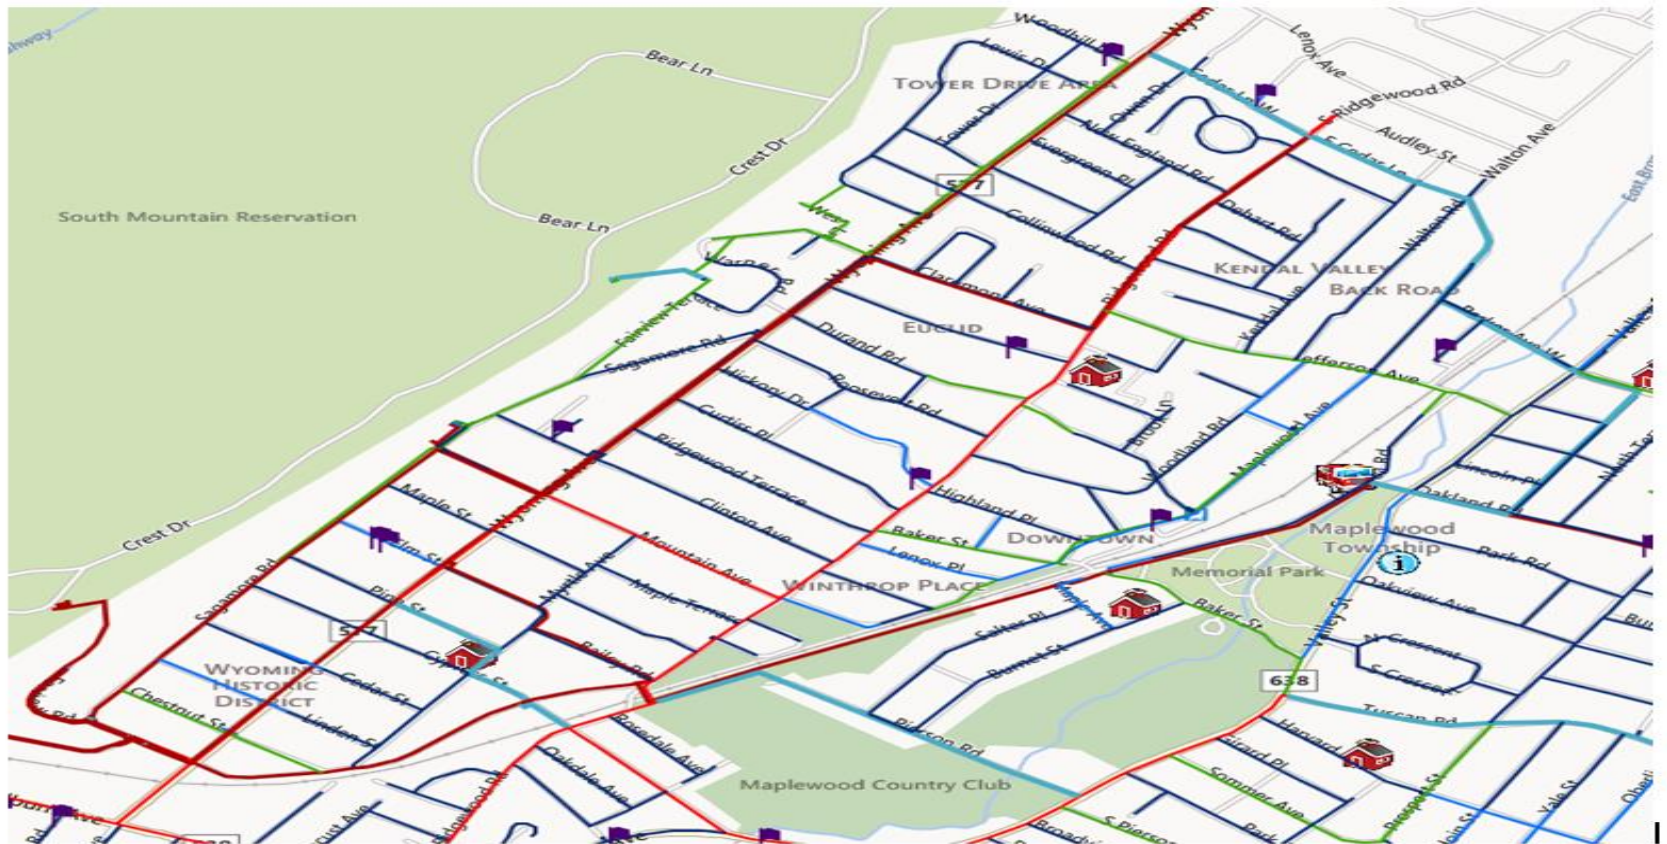
Figure 6 - 2012 Main Breaks

The two municipalities have had a total of 106 main breaks over the last four years, see Table 1. This study is not inclusive of either municipality in its entirety. Figure 6 below identifies main breaks reported in Mapcall for the year 2012. There does not appear to be any major structural issues with the water mains but a condition assessment to measure remaining wall thickness is recommended prior to implementing the project(s) and selection of rehabilitation methods.

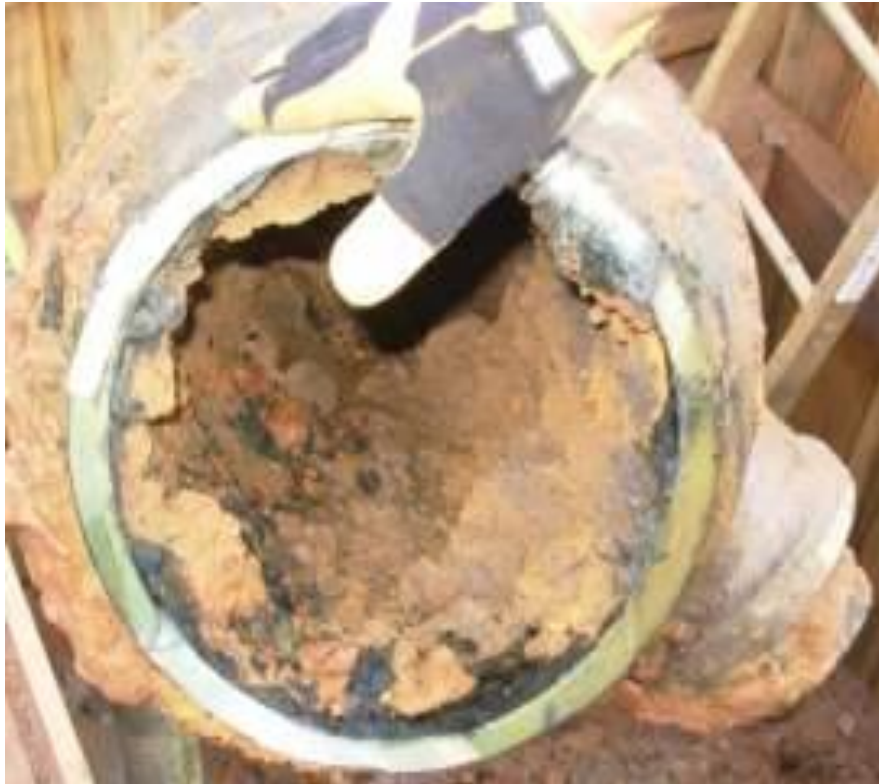
## Pre-1960 Cast Iron Main

- Mineral deposits decrease water volume and cause discoloration especially during higher flow conditions
- Graphitization in cast iron causes main breaks

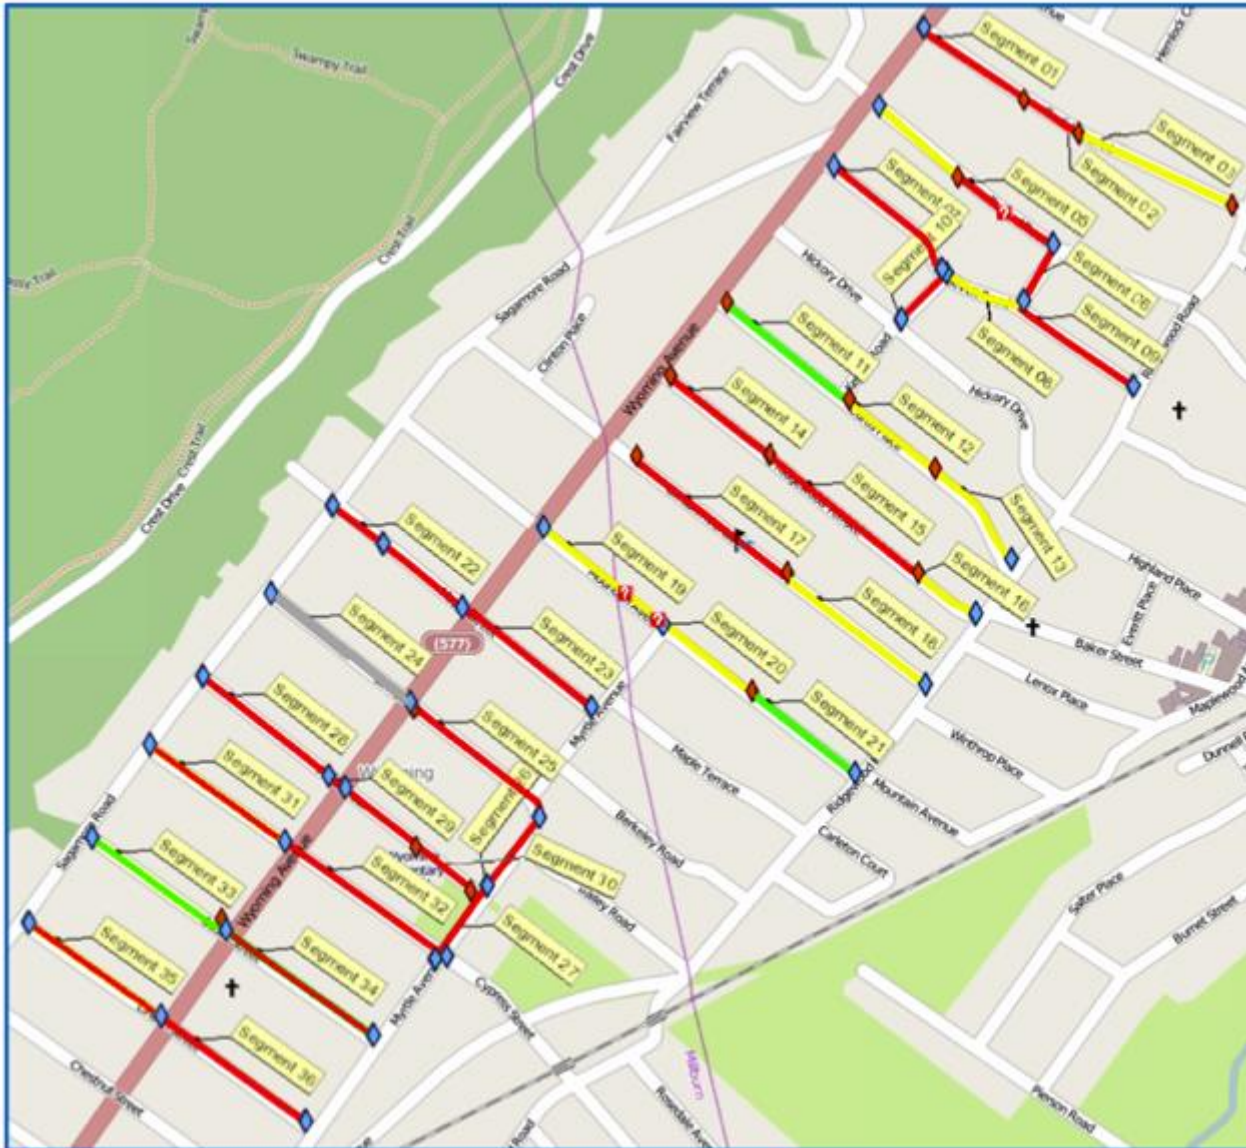
# Millburn-Maplewood Condition Map

- Most pipes experienced greater than 30% pipe wall loss
- 1 pipe segment has 50 years or more of service life remaining
- 9 segments have between 15 to 50 years of service life remaining
- 23 segments have less than 15 years of service life remaining or have exceeded their estimated service life

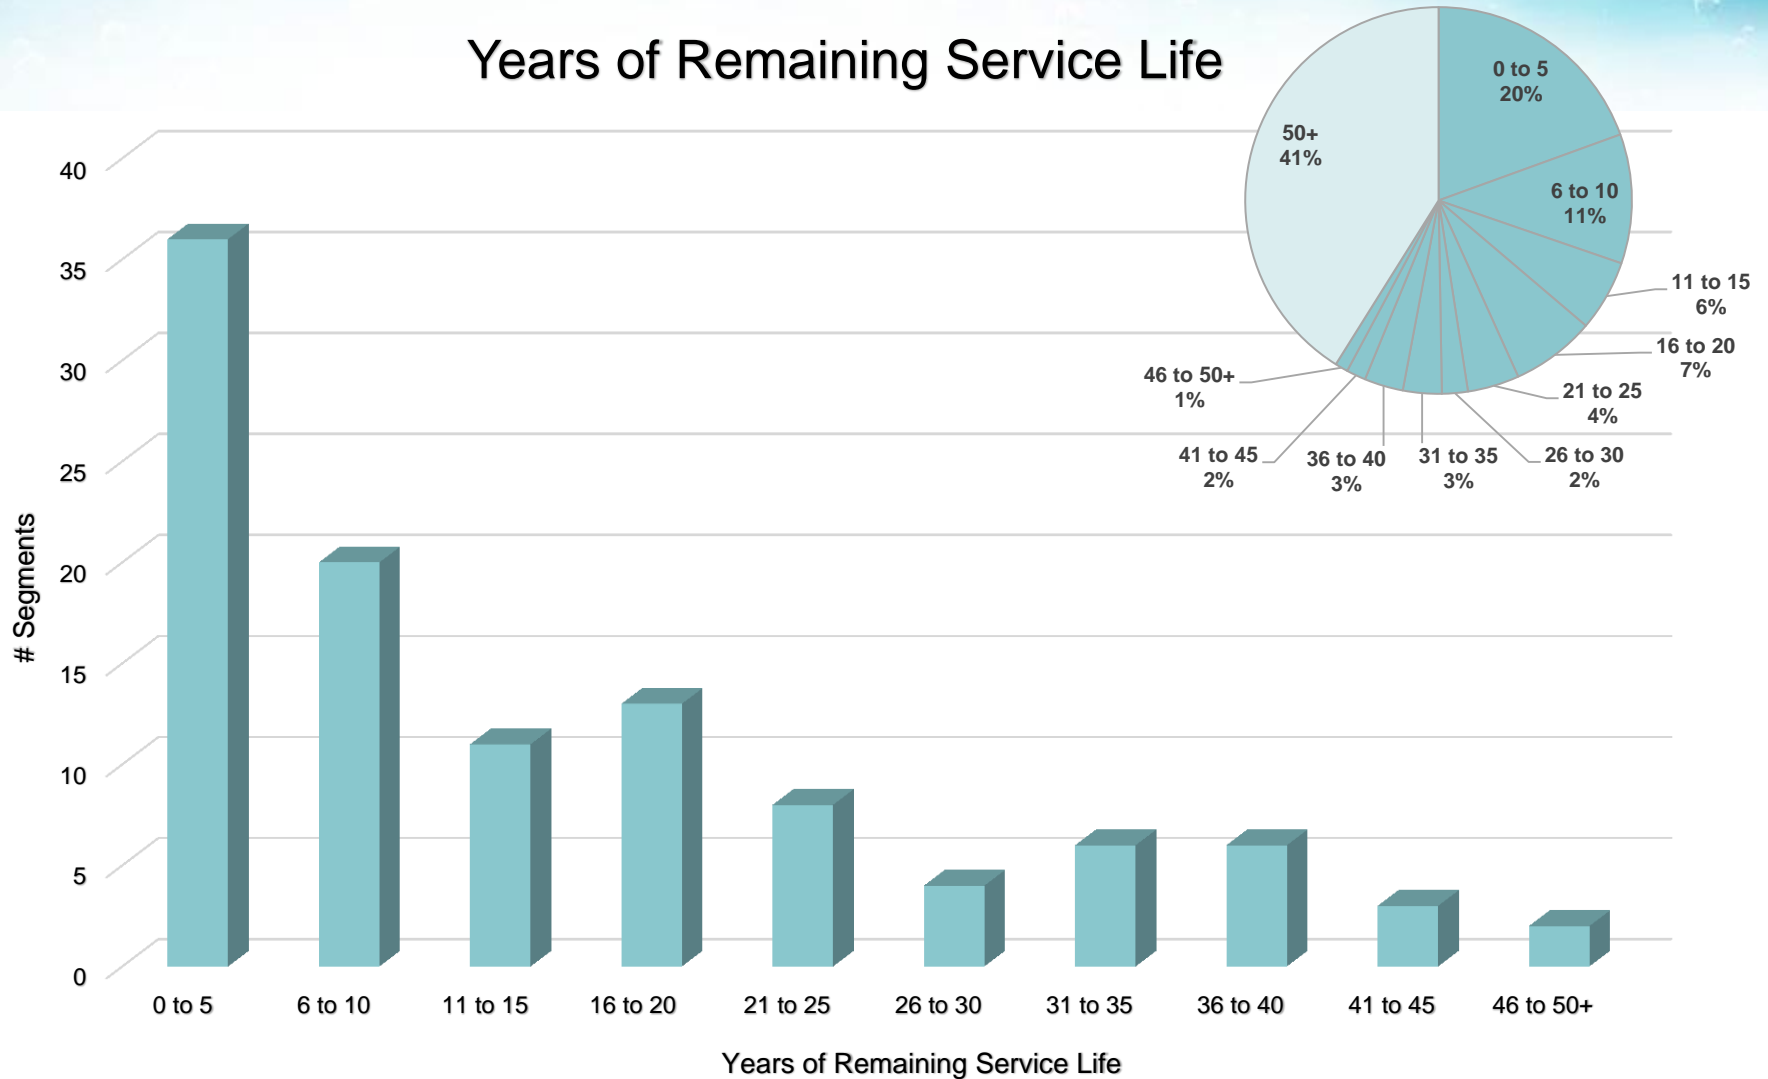
## Years of Remaining Service Life

- Most pipes experienced greater than 10% wall loss
- 11 segments have 50 years or more of service life remaining
- 2 segments have less than 20 years of service life remaining

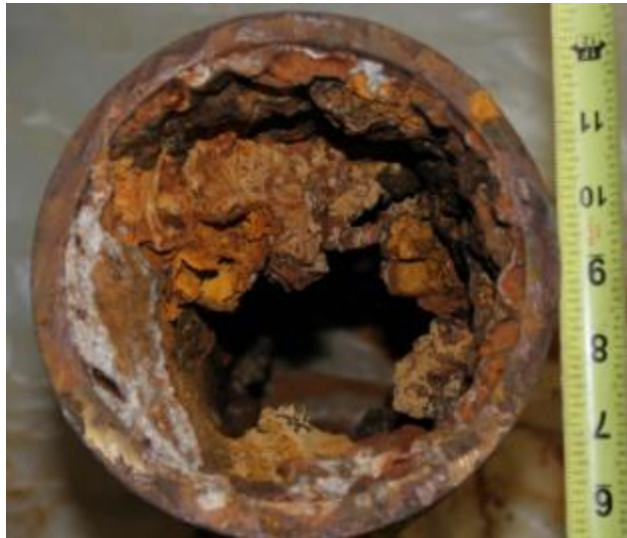
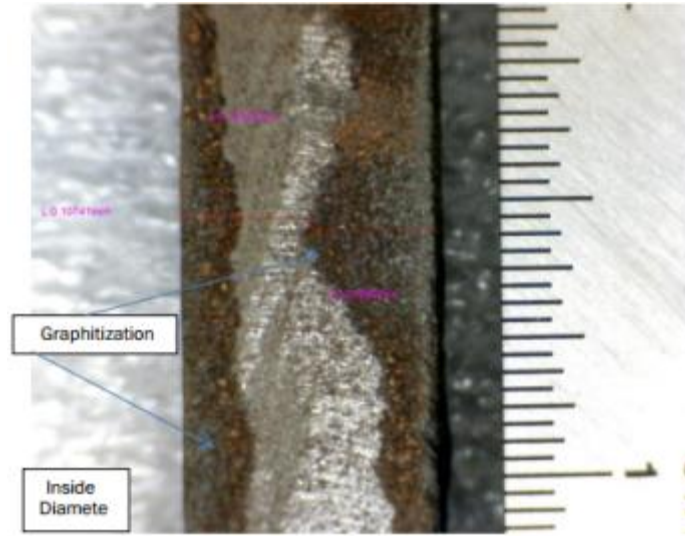
Samples from Kermit St.

- Coupon validations for four (4) sites that were tested
- Matched up well with acoustic results

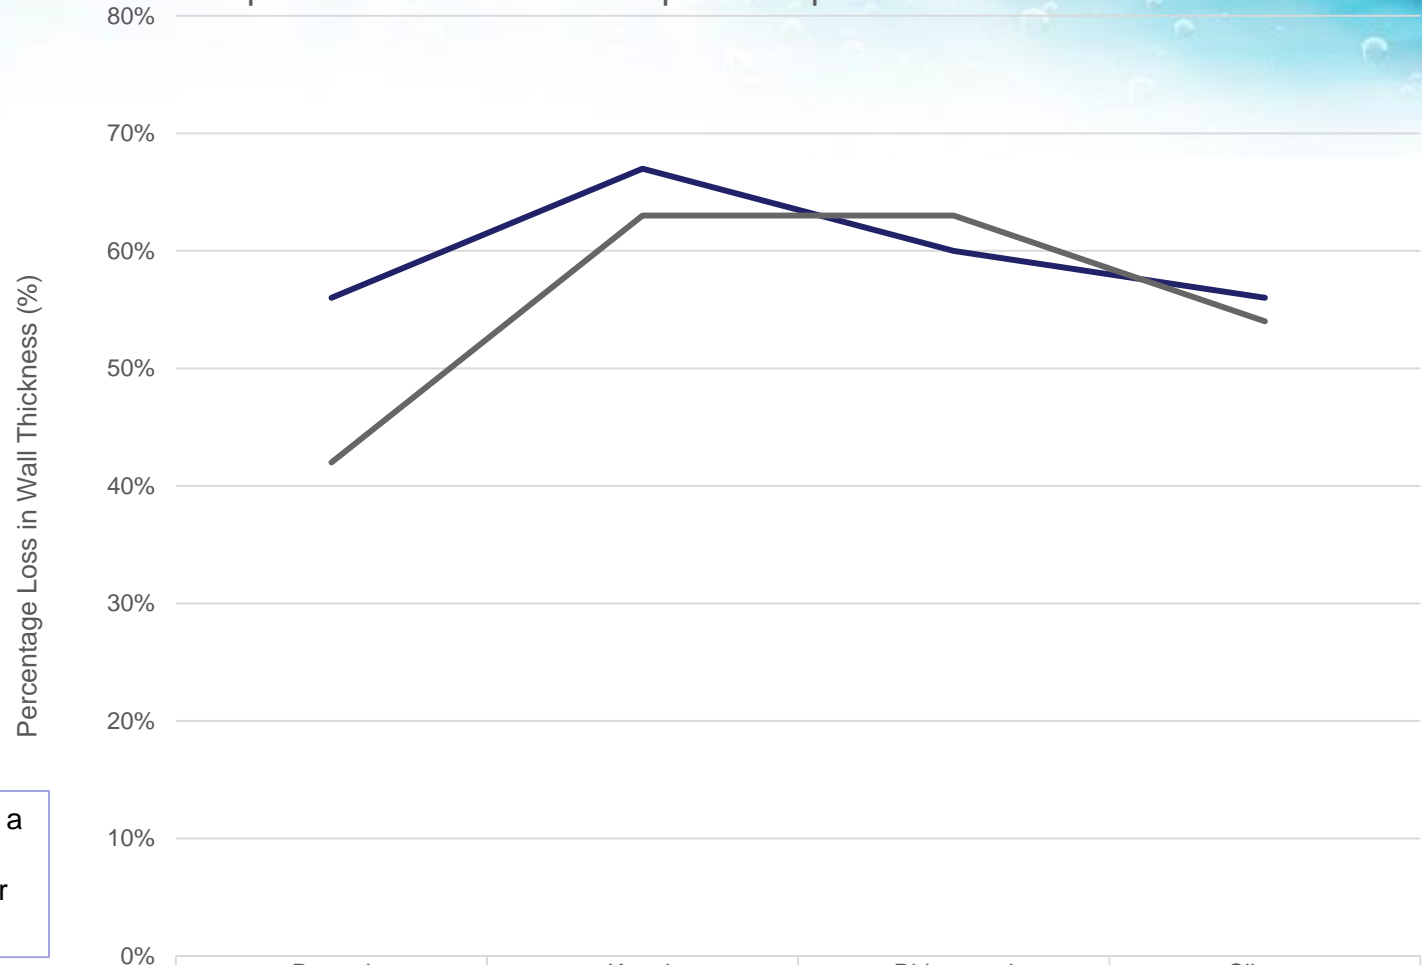
Comparison of ePulse vs Coupon Sample Results

\* Note: There was a discrepancy in the forensics report for Durand.
