CREATING A RELIABLE CAMPUS POWER DISTRIBUTION NETWORK, WITH FOCUS ON POWER QUALITY

Sathish Anabathula, PE
William G. Evans, EIT

University of Virginia Overview

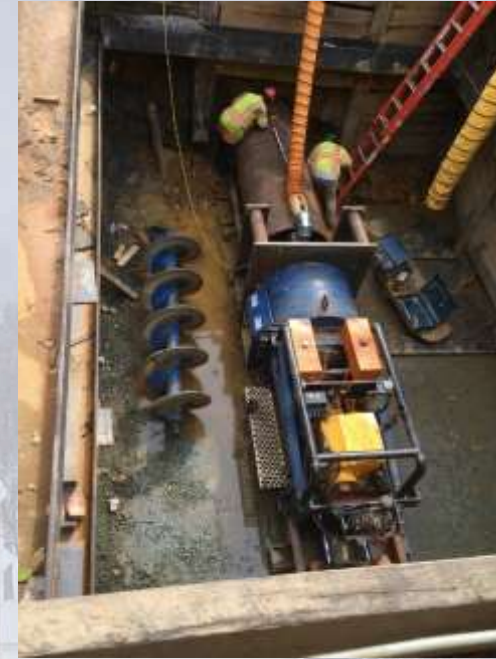
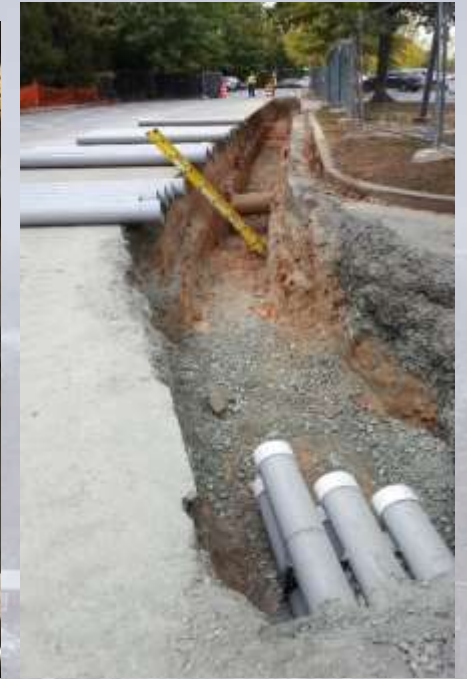
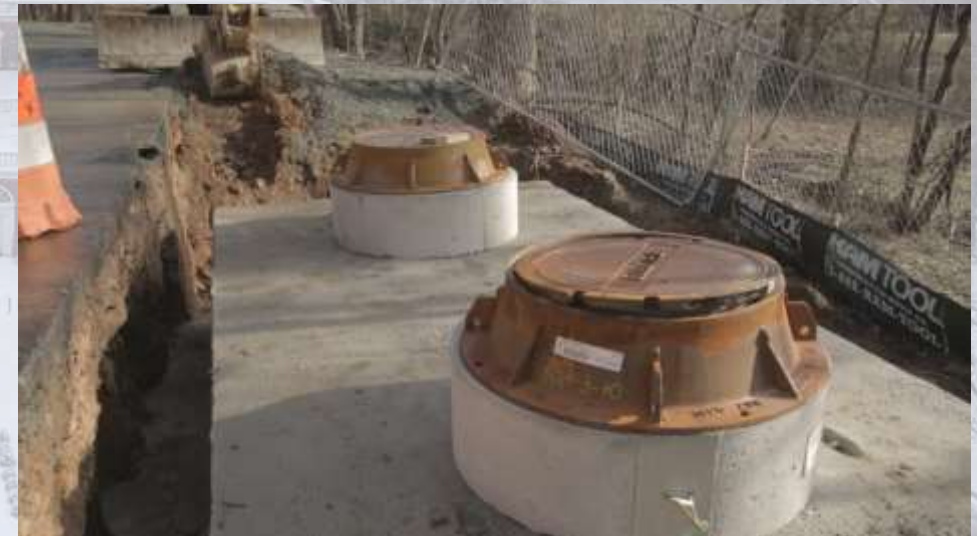
- 12 months of Construction
- Completed December 2017
- Reclosing in underground distribution system for automatic restoral
- Main(NC)-Tie(NO)-Main(NC) arrangement to Main(NC)-Tie(NC)-Main(NO) to maximize benefits of underground circuit

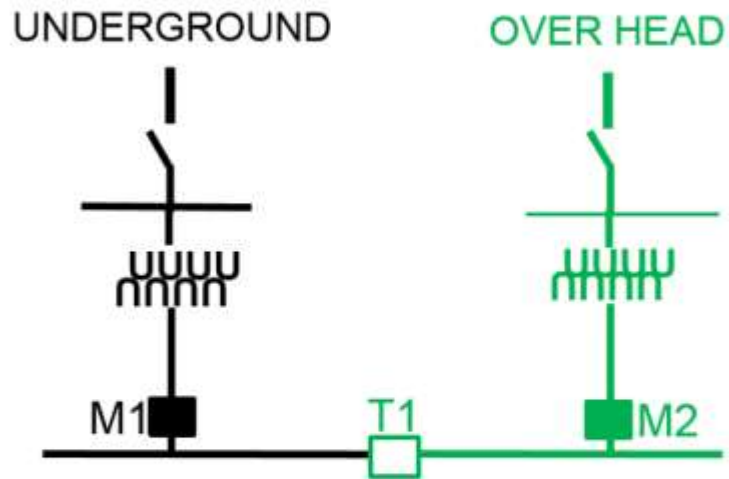
Old Configuration
(T1 N.O., M2 N.C.)

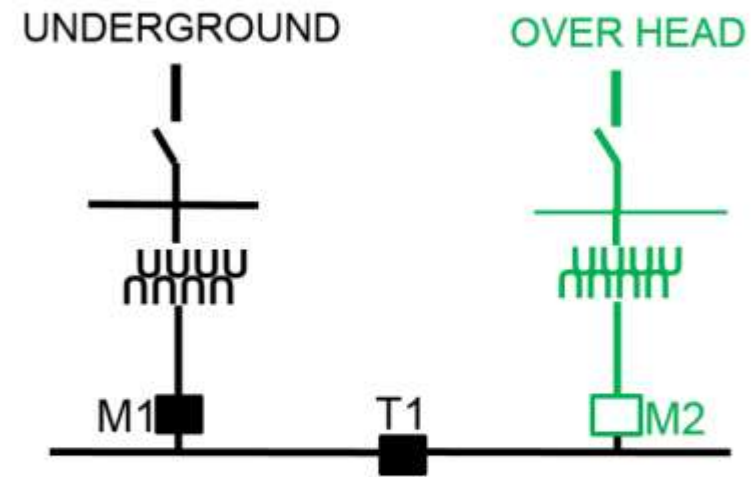
New Configuration
(T1 N.C., M2 N.O.)

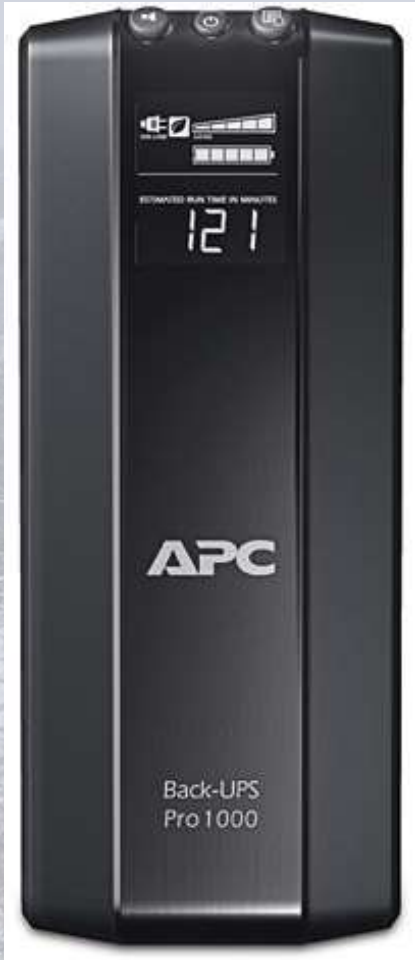
- Powers patient data monitors
- 750VA – 1000VA

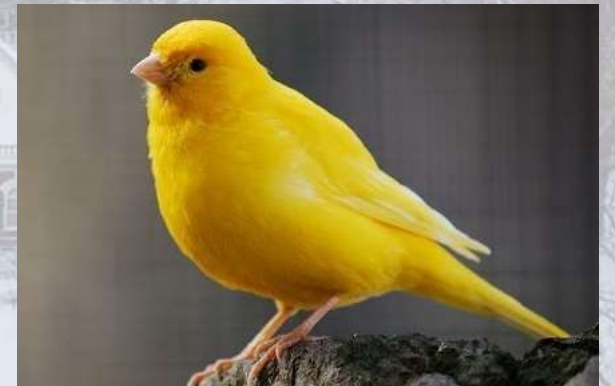
Proprietary Algorithm looking at:

- dV/dt
- Frequency (57Hz-63Hz)
- THD

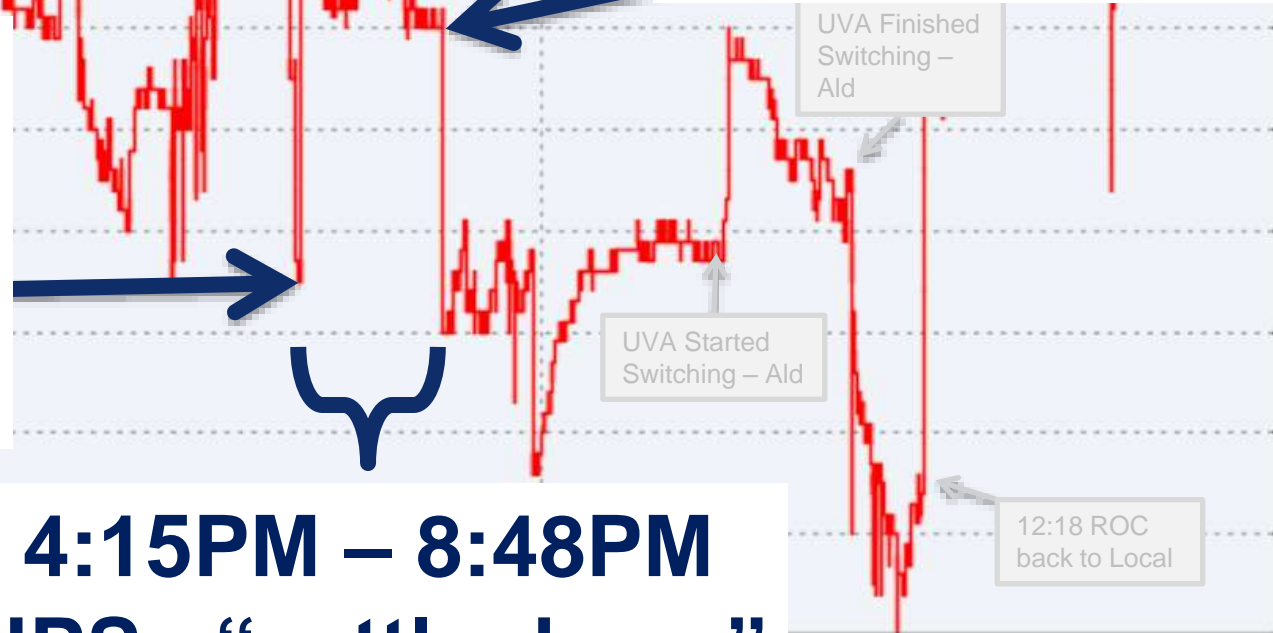
8:48PM
35kV Cap Bank
Opens at Utility
Substation

4:15PM
35kV Cap Bank
Closes at Utility
Substation

4:15PM – 8:48PM
UPSs “settle down”

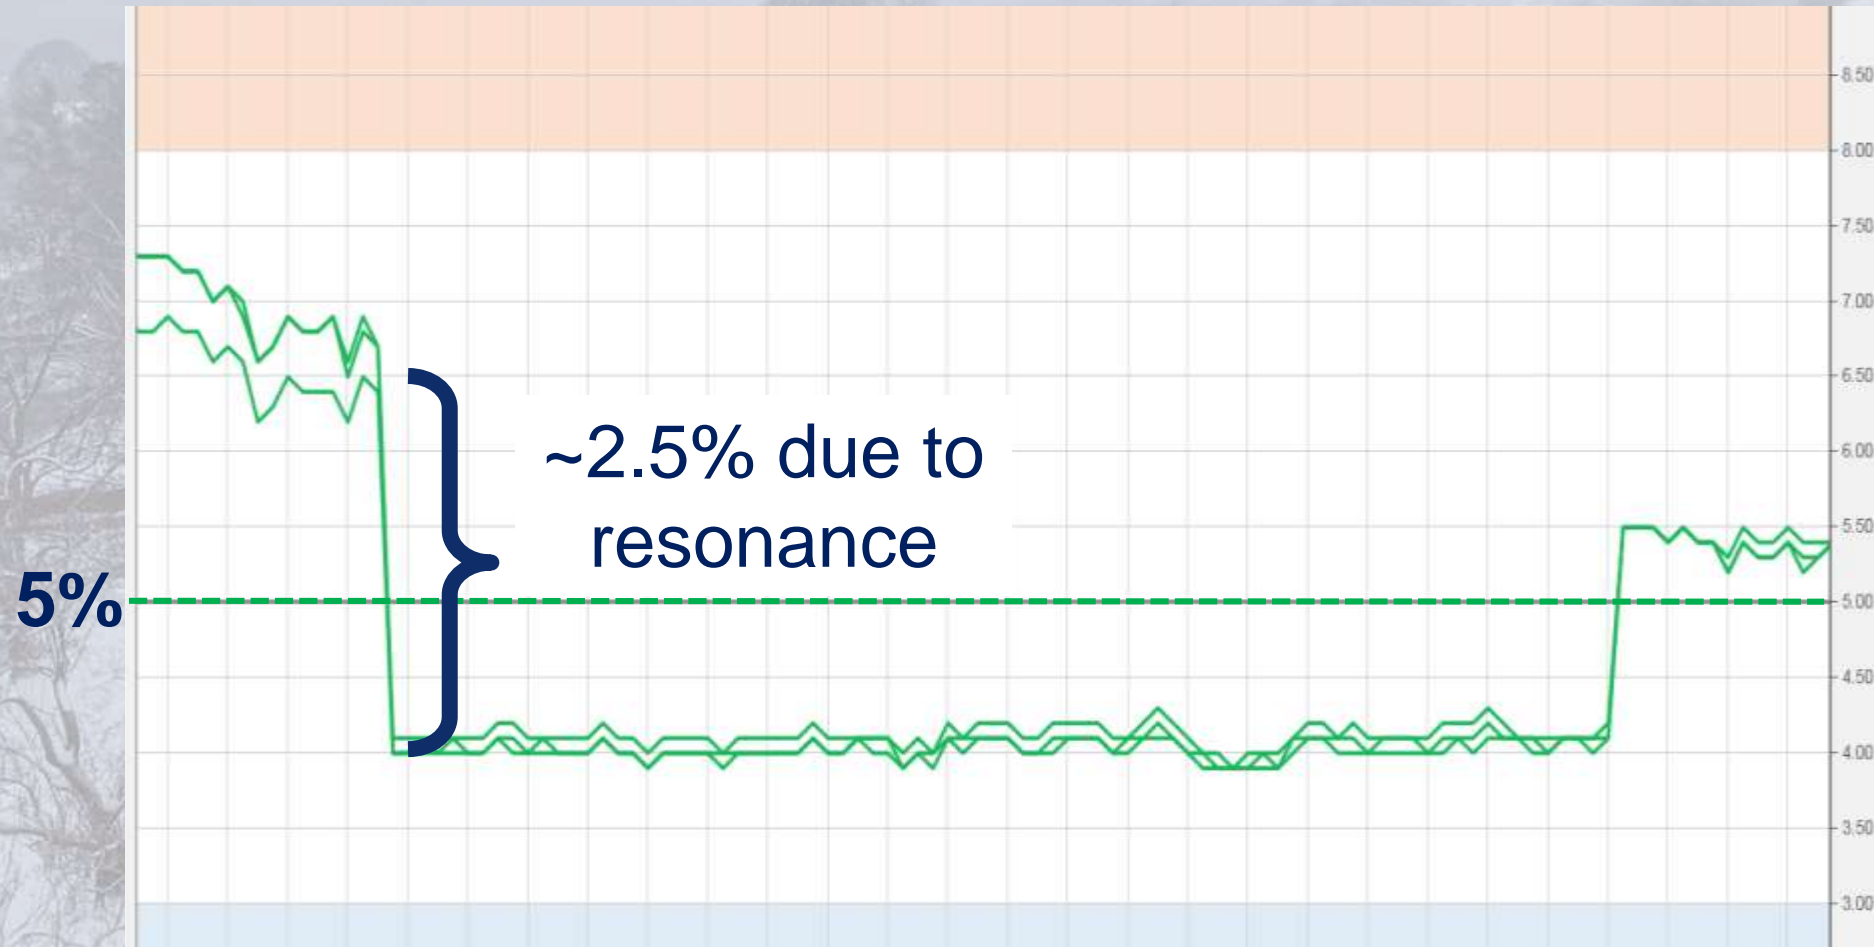
Utility opens cap bank at UVa Substation

- Cap Bank at Utility's 115kV/35kV substation out of automatic operation, manually closed
- Cap Bank at UVa's 35kV/13.2kV substation opened
- 35kV Line Reactors modeled and sized by Utility to be installed to allow Cap banks to go back into operation (Spring 2019)

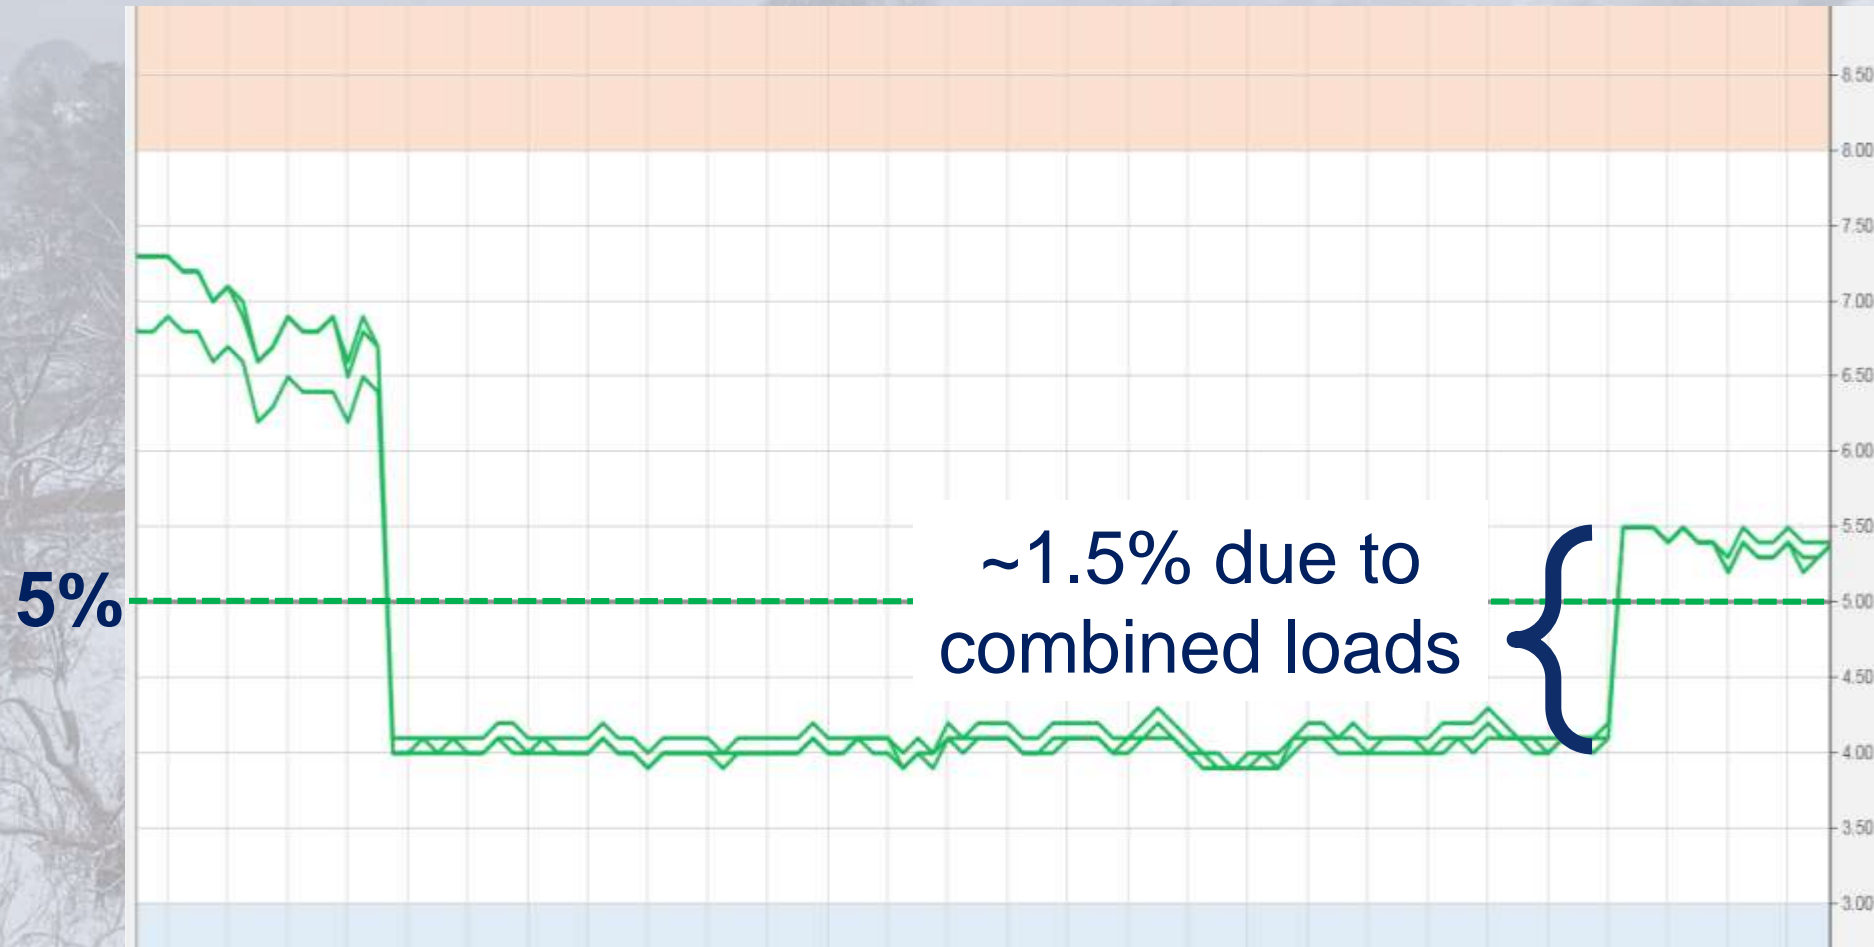
UVa closes Tie T1, Returns system to auto

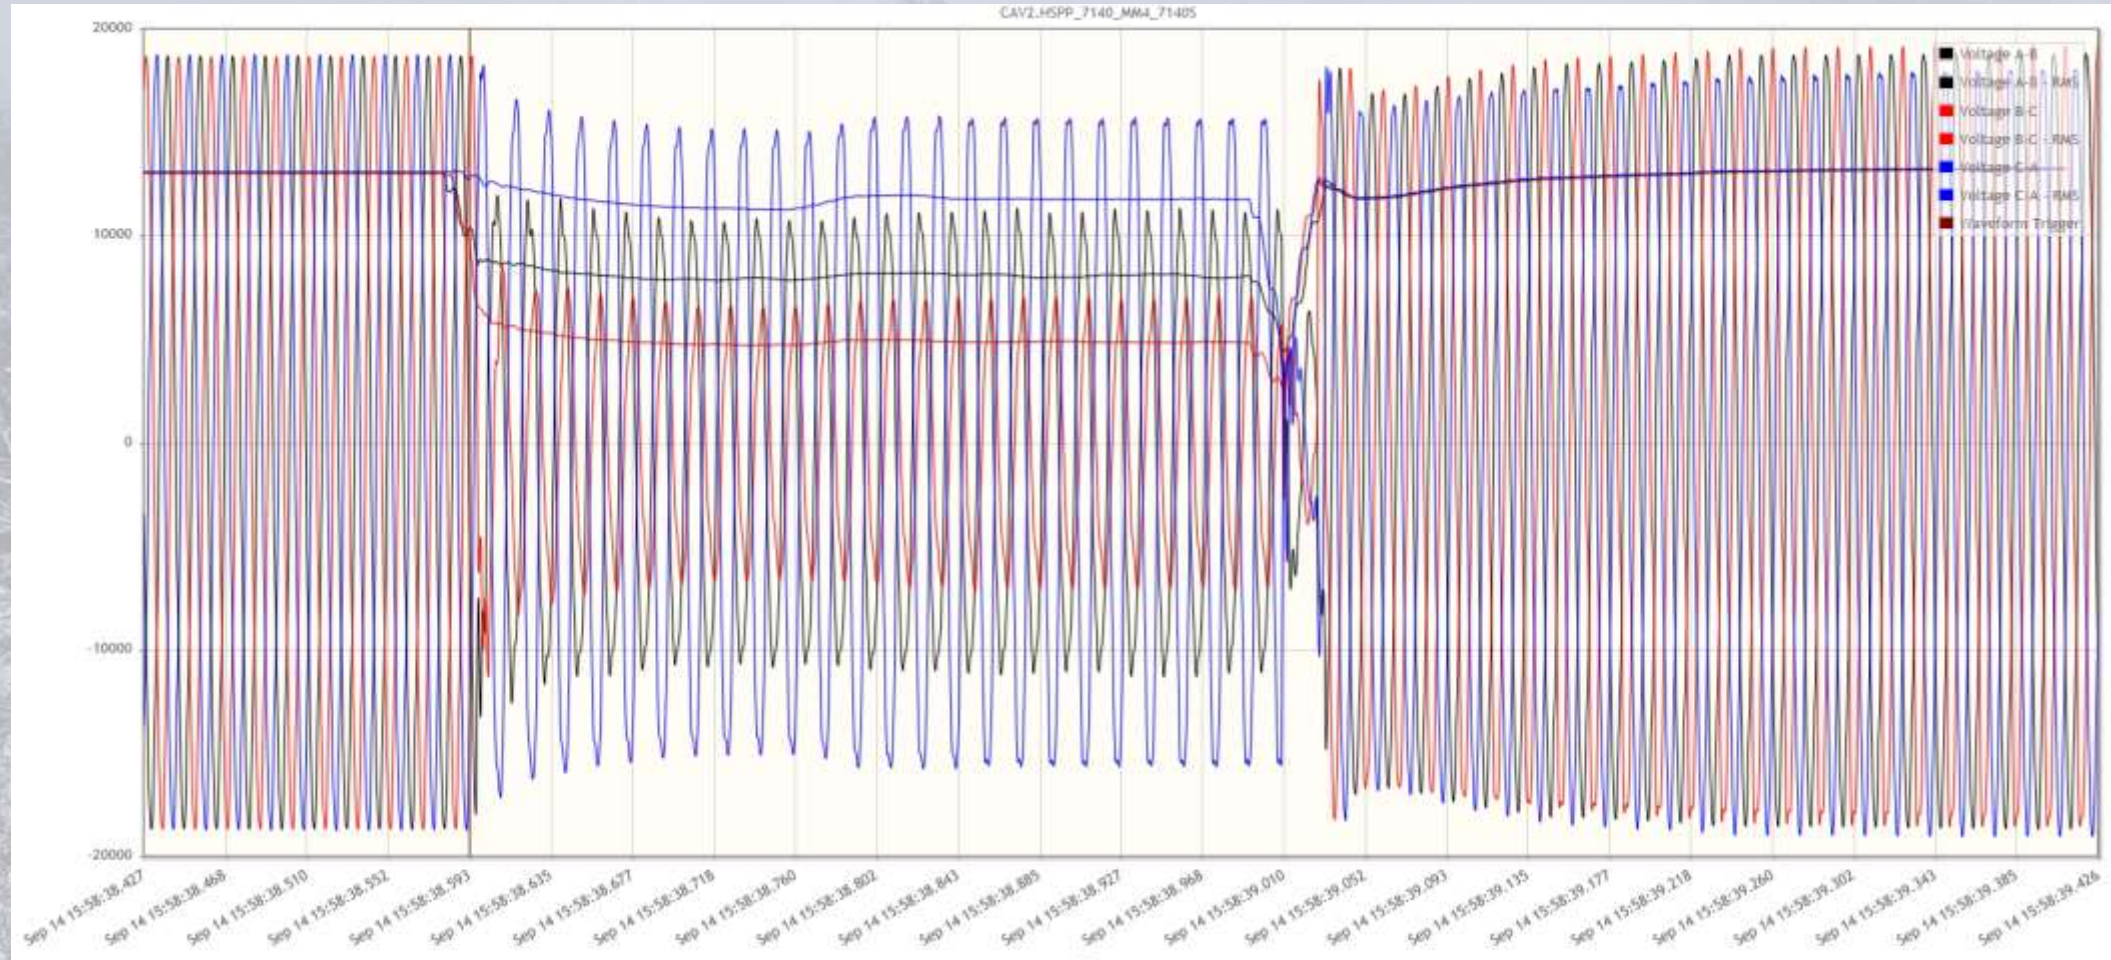
Pre 35kV Duct Bank:

An event on 9/14/2017

- >1 hour of voltage loss avoided
- Avoided events due to weather—trees, vehicle accidents, animals, fog, etc.
- Dedicated bus helps to isolate UVa from non-UVa circuits in heavily wooded areas
- Greatly reduced impact of sags

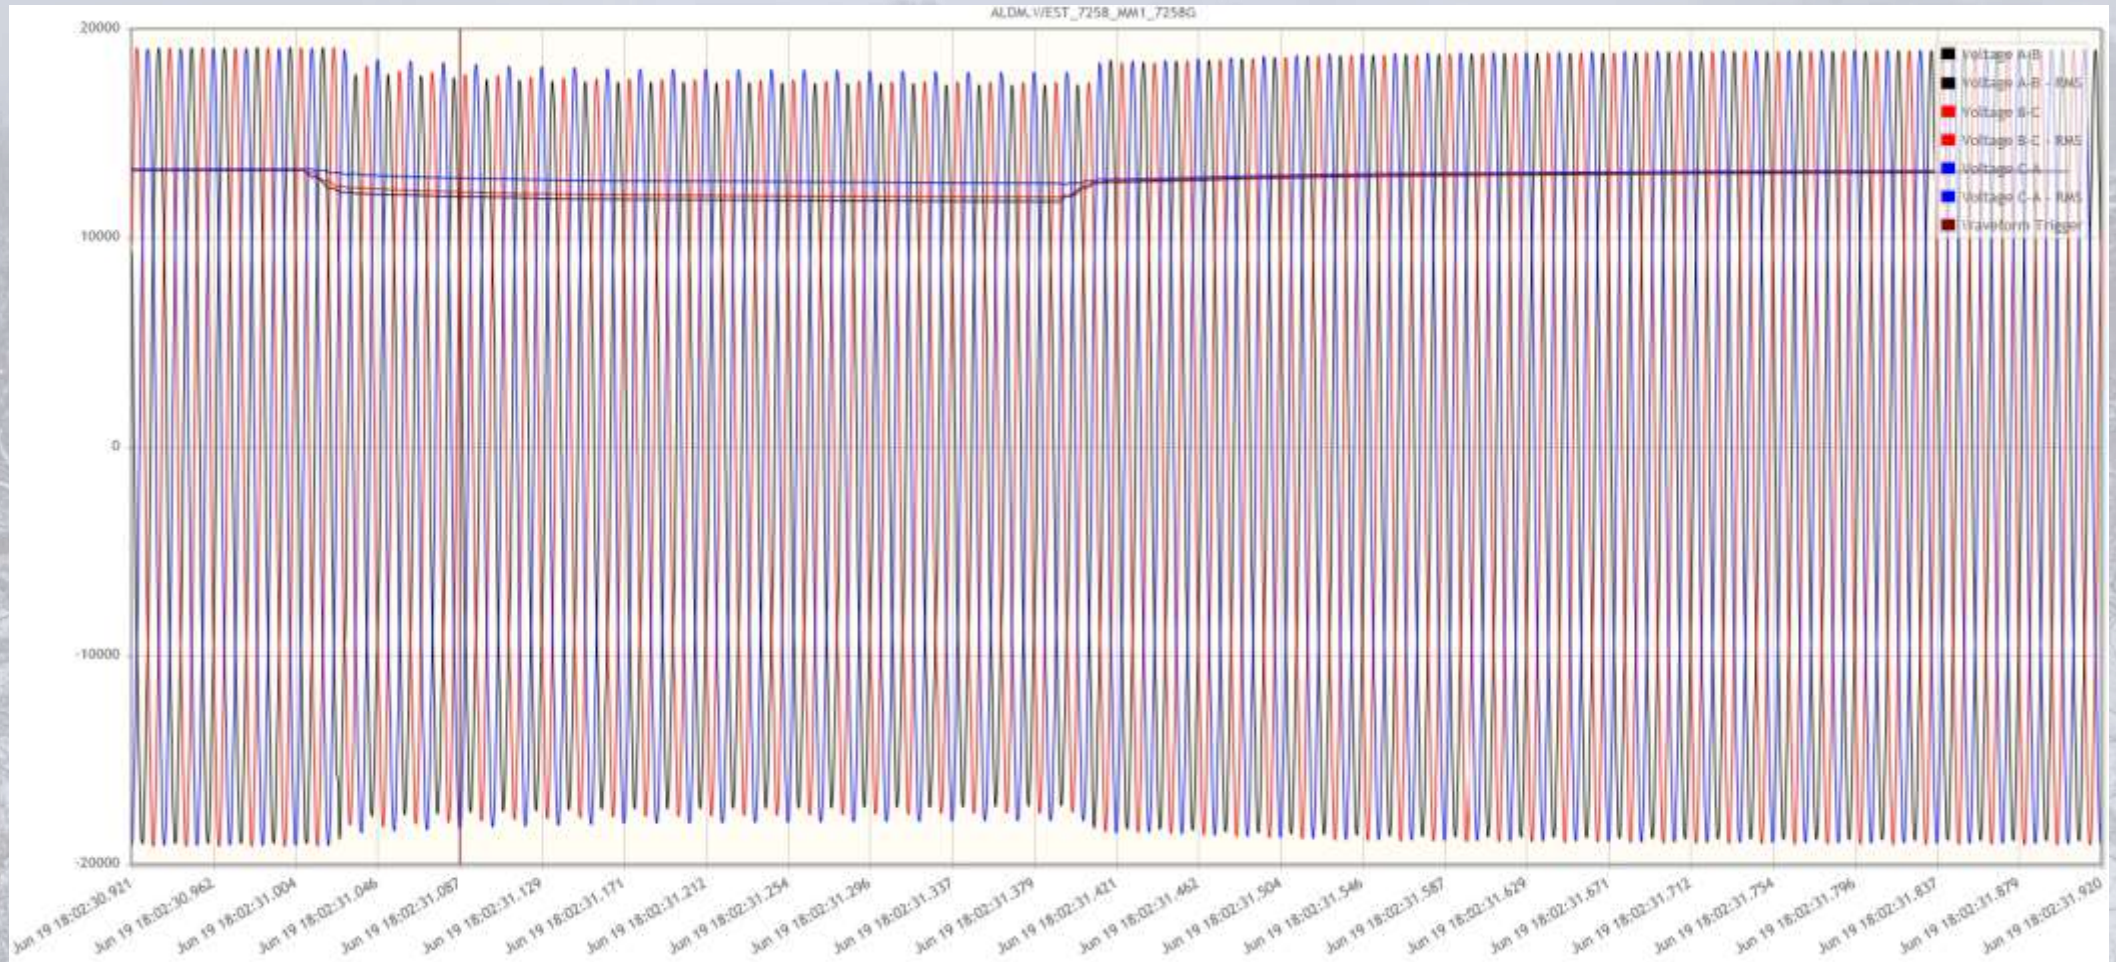
Post 35kV Duct Bank:

An event on 6/19/2018
