Poster submission: CampusEnergy 2018

Company: Aeroseal LLC

Title: Innovations In Duct Sealing: Universities Discover New Opportunity
For Significant Energy Savings

INNOVATIONS IN DUCT SEALING:

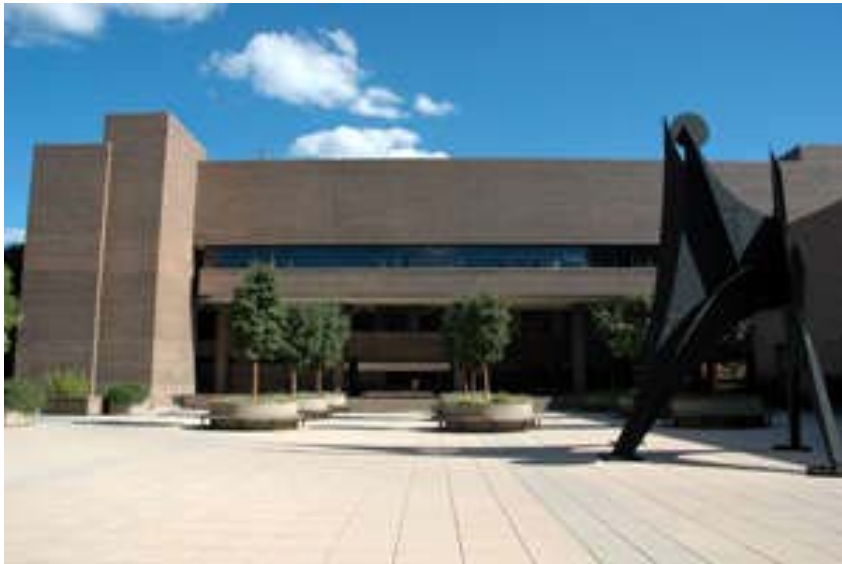
PRINCETON UNIVERSITY – Jadwin Hall

- 98% reduction in duct leakage
- Allowed balancing
- Reduced fan usage / speed

6-story physics building
HVAC renovation project
Had to use existing exhaust shafts

Leaks in existing exhaust shafts
Unable to balance
Increased fan speed / energy use

No demolition needed to access duct
Completed in 2 ½ days

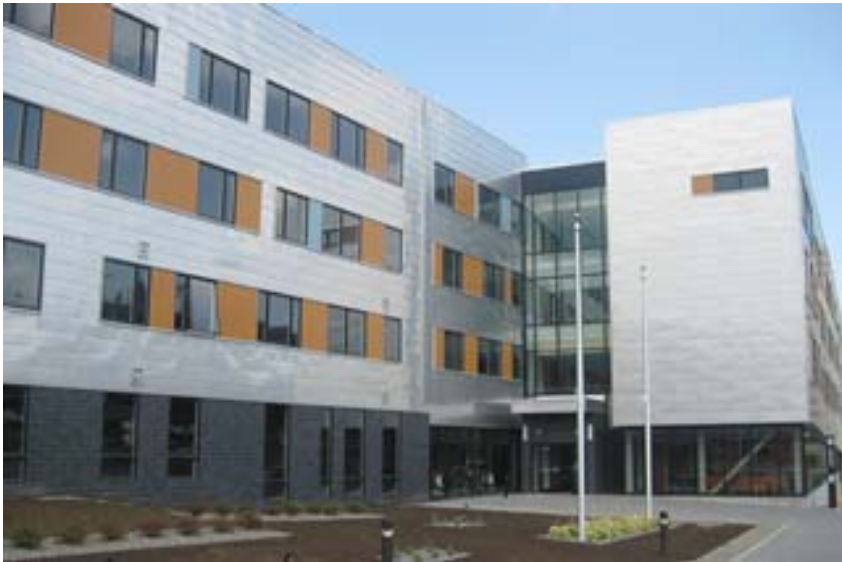
Syracuse University – Campus West

- New 4-story dormitory
- Need to meet < 10 CFM per floor NYSERDA specs

- Average 120 CFM of leakage post install
- New construction barred access for re-sealing

- No demolition needed to access duct
- Completed in 3 days

- All ducts tested below 10 CFM of leakage
- Met stringent NYSERDA requirements

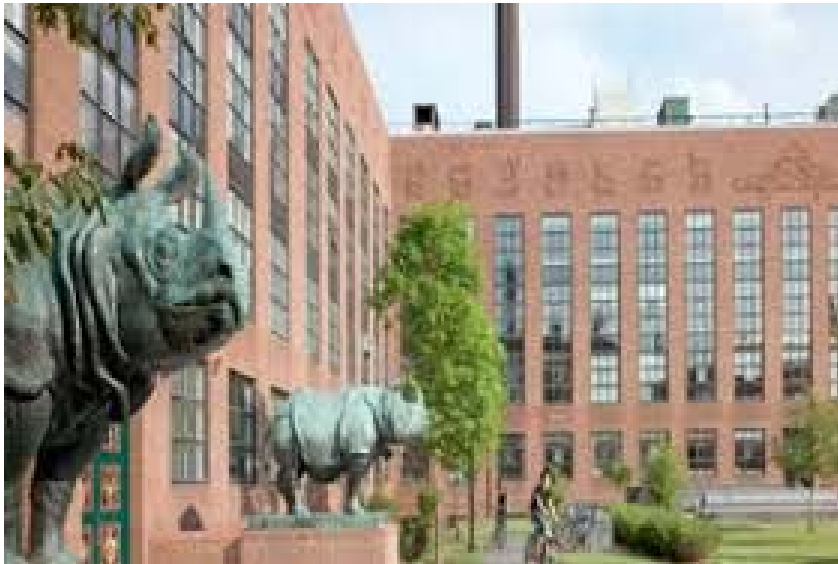
Harvard University – Girguis Labs

- Reduced leakage by 98%
- Lowered fan speed by 60%
- Complete HVAC coverage throughout

Installed new 8,500 CFM air handler
using
existing ductwork

Fan was running at 97% capacity yet treated air was not reaching all target areas. With ducts under insulation and behind layers of pipes, traditional sealing was deemed unviable.

Aerosol sealing completed in 3 days

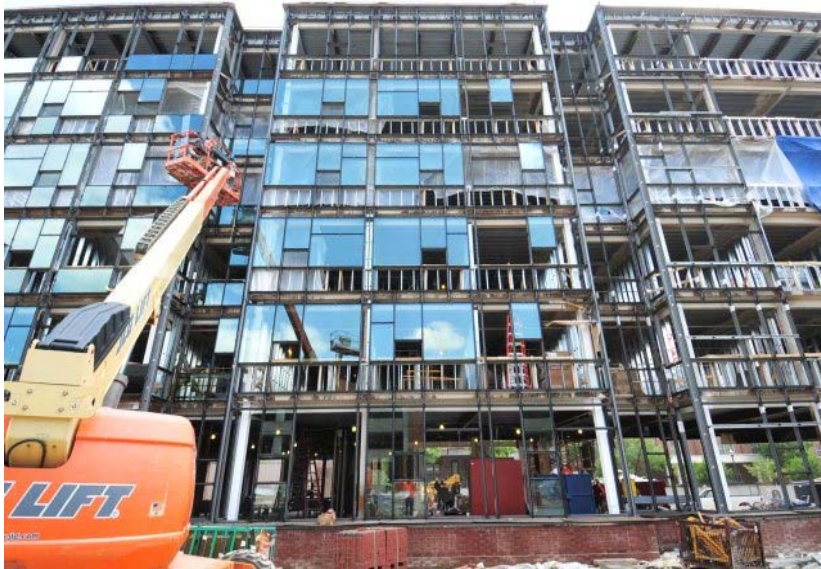
Ohio State University – William Hall

- Sealed 98% of leaks
- Passed fire code. Earned LEED silver
- Saved estimated \$100,000 annually

New 6 story dormitory
existing ductwork

All 19 ventilation shafts failed pressure tests
Couldn't pass fire code or receive LEED silver
Estimated +\$95k annually in additional energy costs

Aerosol sealing completed in 2 weeks

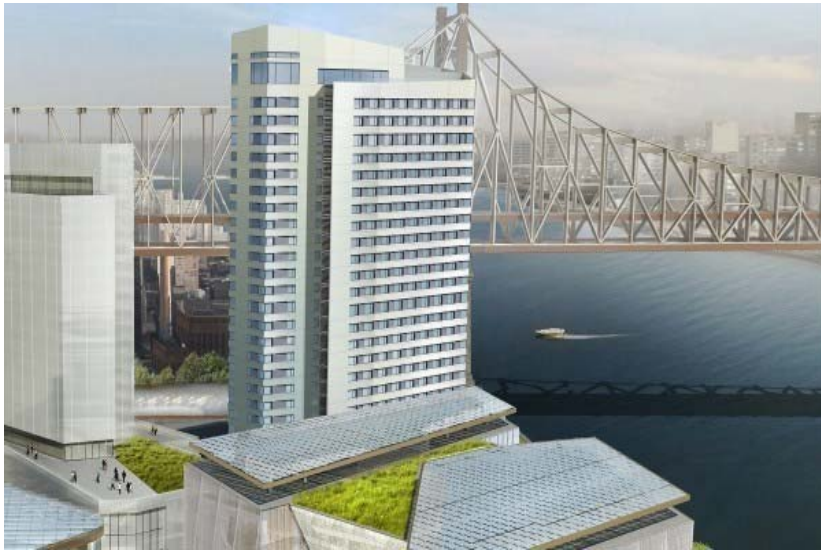
Cornell University – William Hall

- Average leakage after aroeseal .7% CFM
- Helped make world's largest passive house possible.

New 26-story residential building
World's largest passive house

Needed to achieve < 1% CFM overall leakage

Completed aroesealing 55 risers and
more than 1,600 individual trunk lines in
just 8 days.

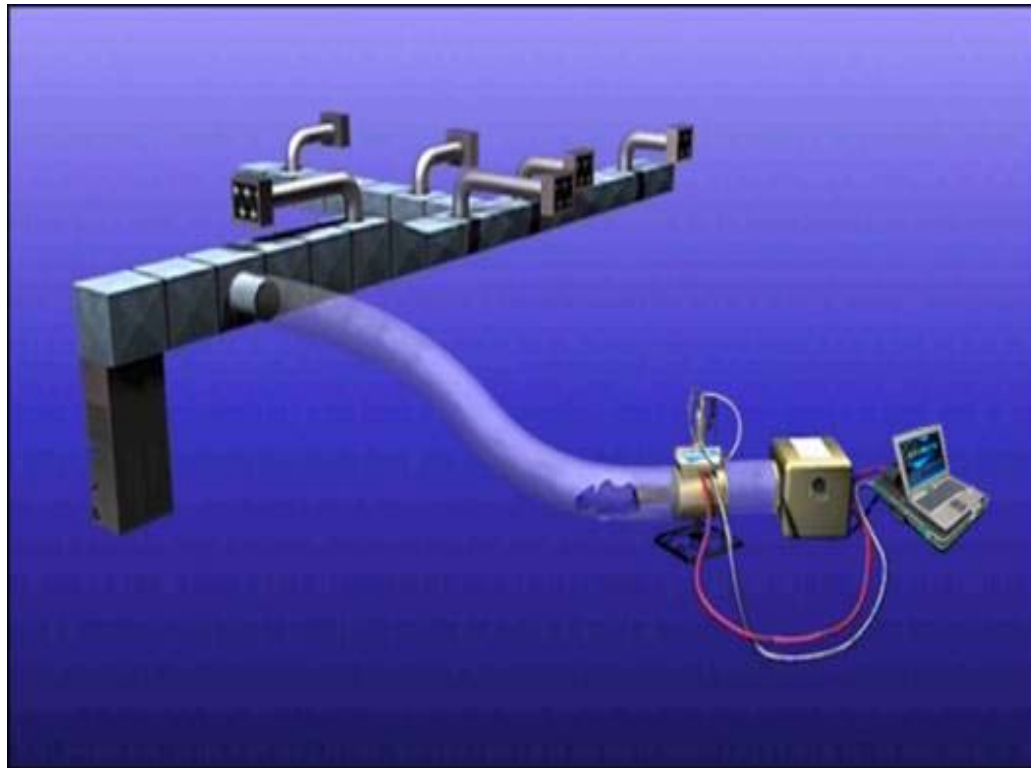
Aerosol-based Duct Sealing

- Developed by U.S. Department of Energy
- Sealing from the inside
- 98% effective at sealing all leaks
- No demolition required

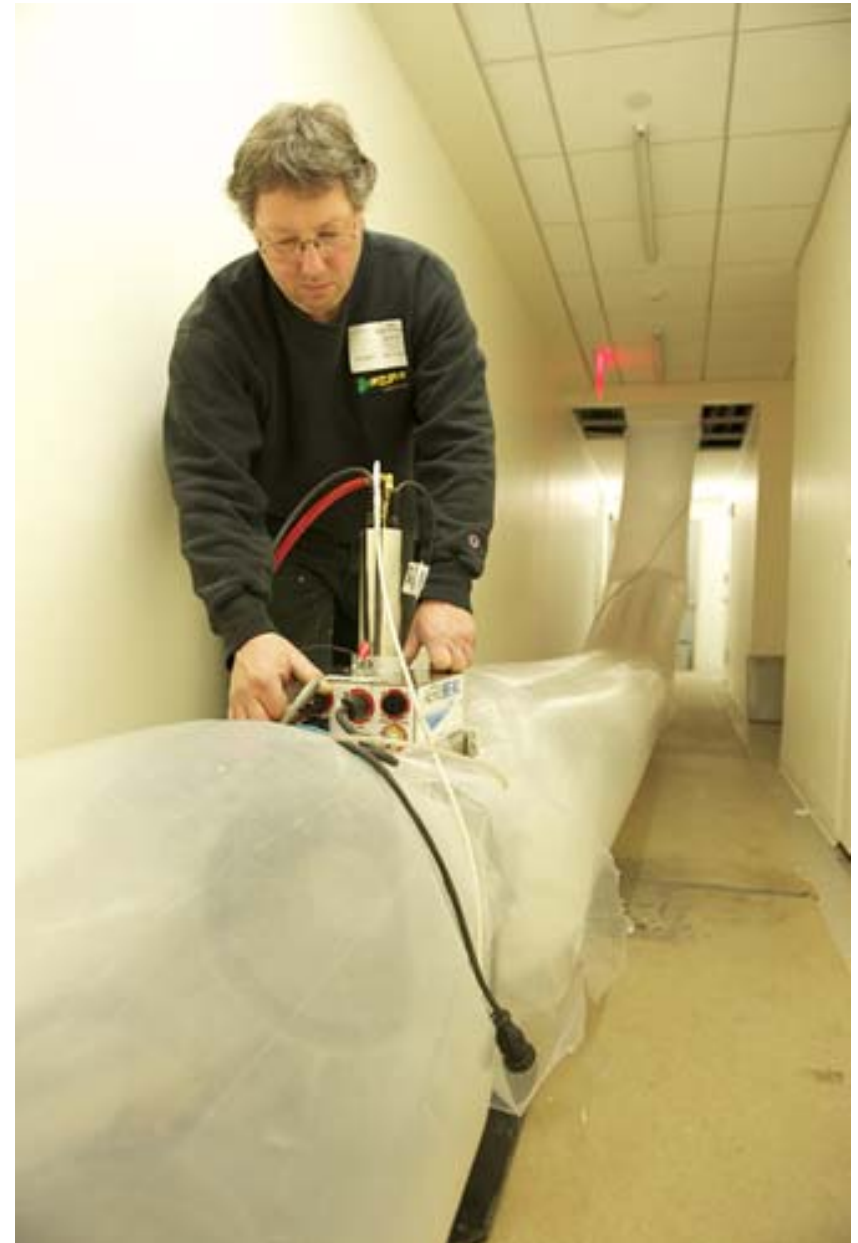
Sealing from the inside

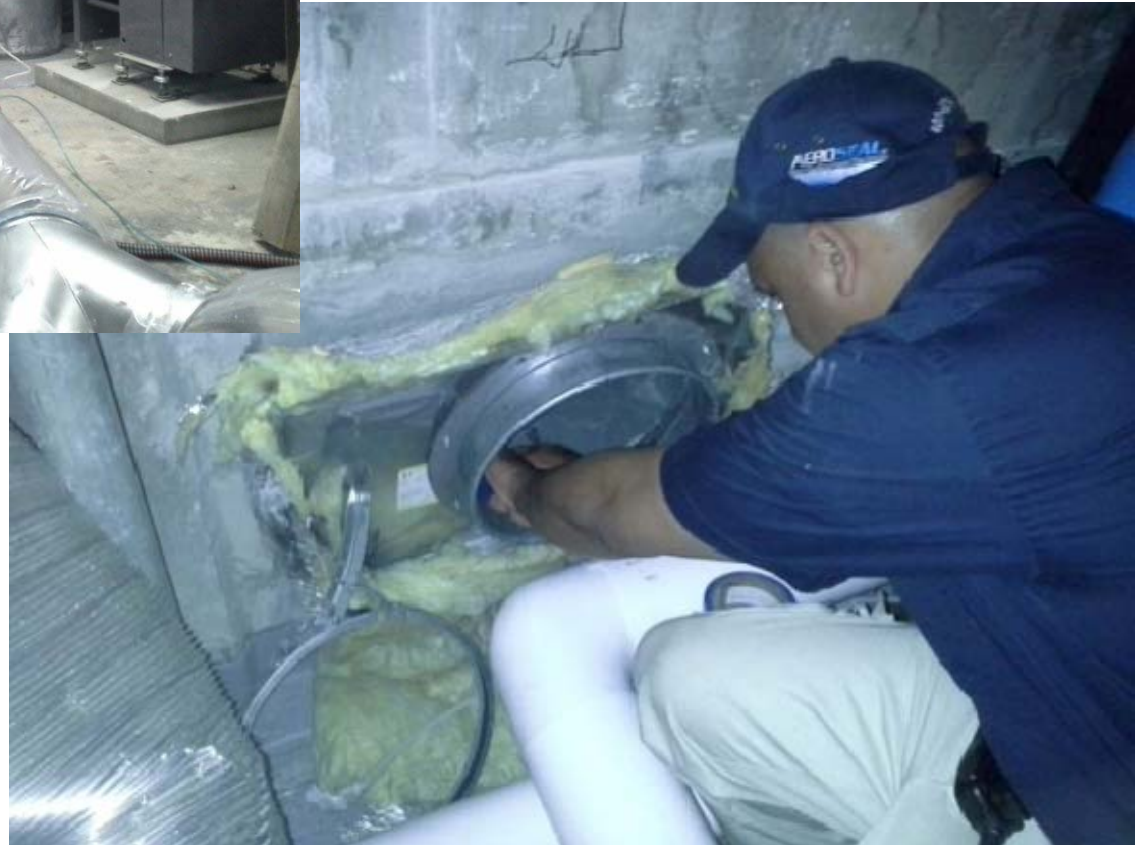
Harvard University reducing fan requirements...and energy usage.

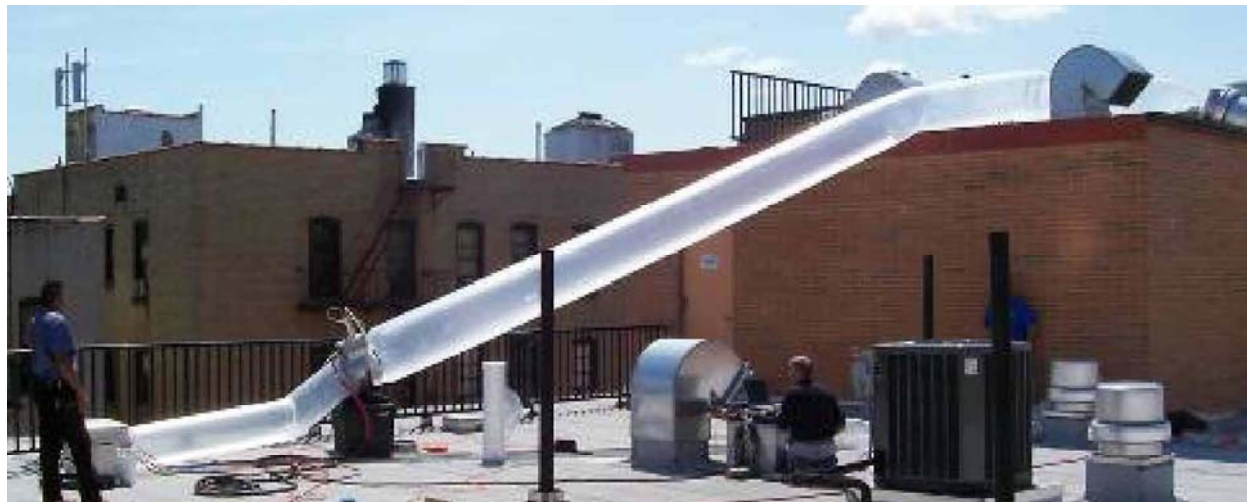
Alternative access via rooftop fan outlet

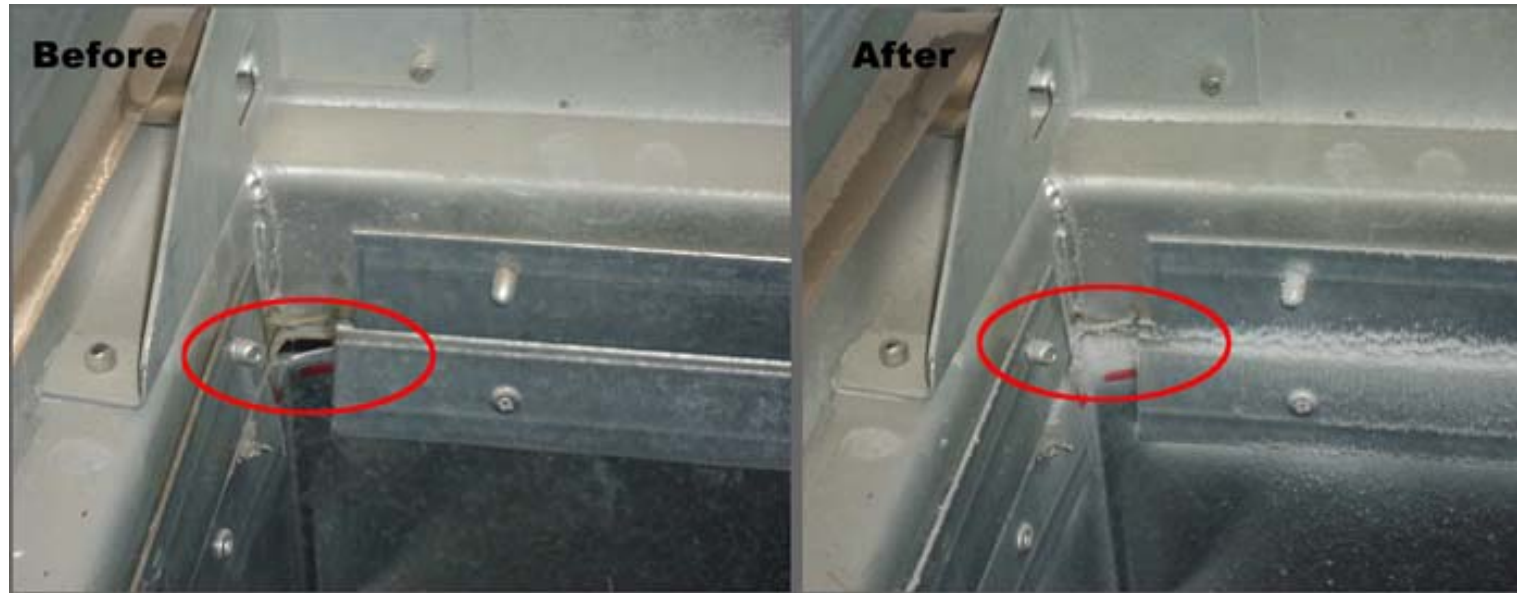
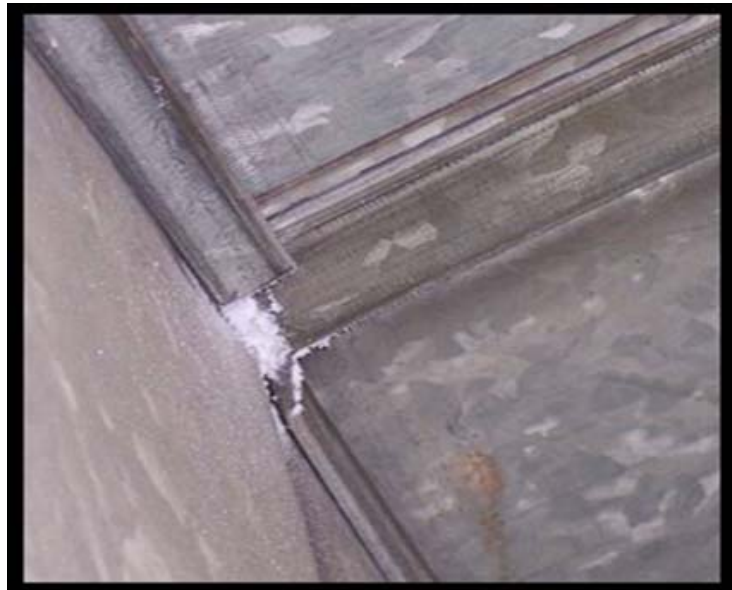
Doesn't coat the duct interior.
Accumulates solely around the
leaks.

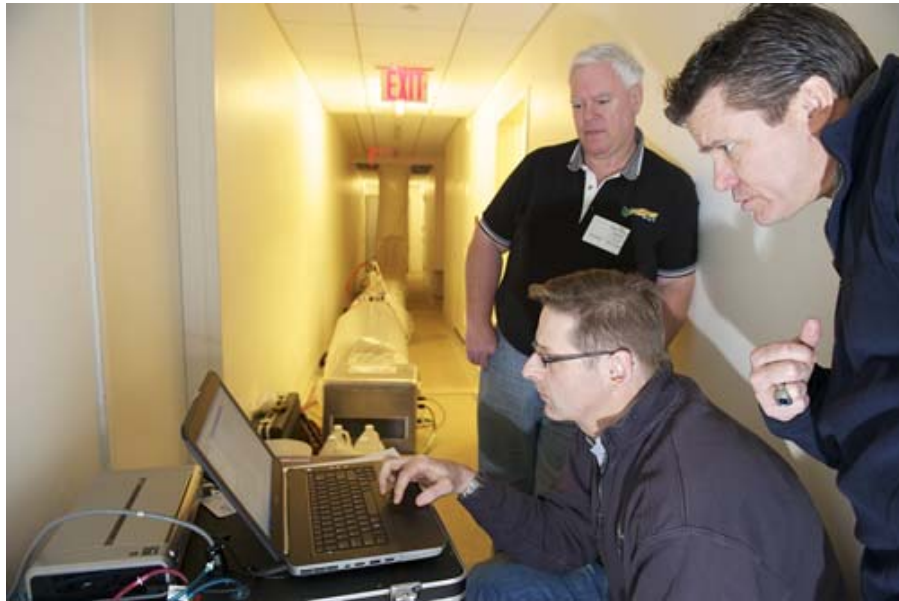
Computer-controlled process

Final printout report generated upon completion.

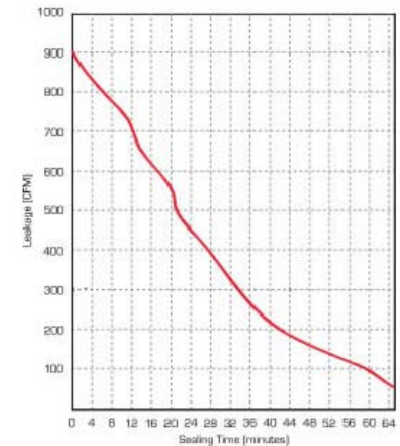
AEROSOL SEALING PROFILE

899.83 CFM of Leakage, equivalent to
124 Square Inch Hole

83.73 CFM of Leakage, equivalent to
3.5 Square Inch Hole

This corresponds to a **91%**
Reduction in Duct Leakage

Note: Duct leakage results are calculated
in cubic feet per minute (CFM) measured
at a standard OPERATING PRESSURE of
25 Pa (0.10 in. water).

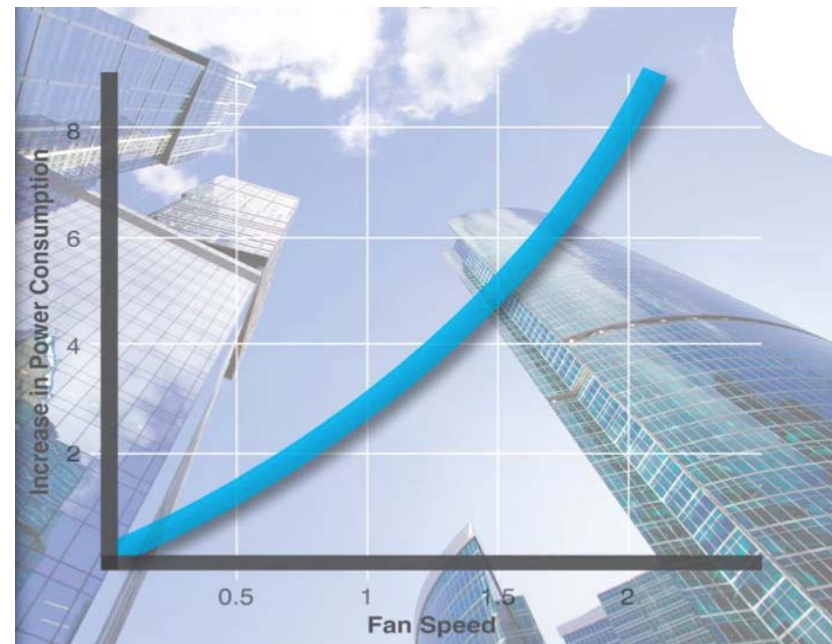
Increased fan use:

**20% increase in fan speed =
a 73% jump in energy use.**
