Consolidated Edison Company of New York

Steam Remote Monitoring System: Successes and Challenges

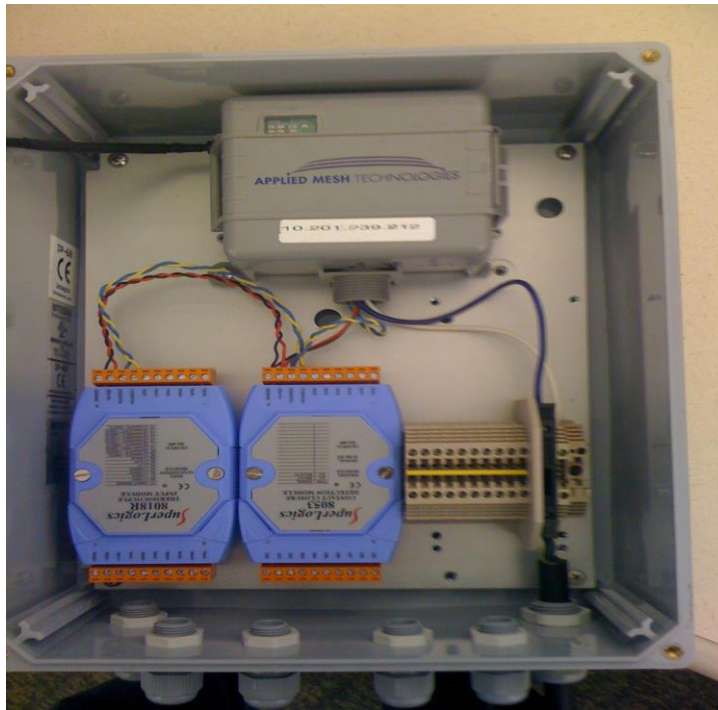
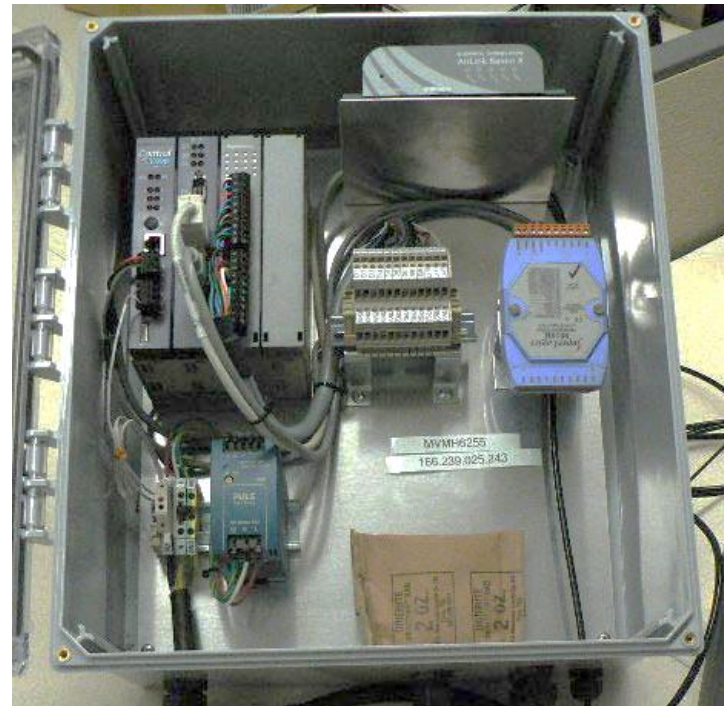
Remote Monitoring System: Remote Telemetric Unit (RTU)

- Two design iterations
 - Smart Sync (2008-2011)
 - Bristol (2011-current)

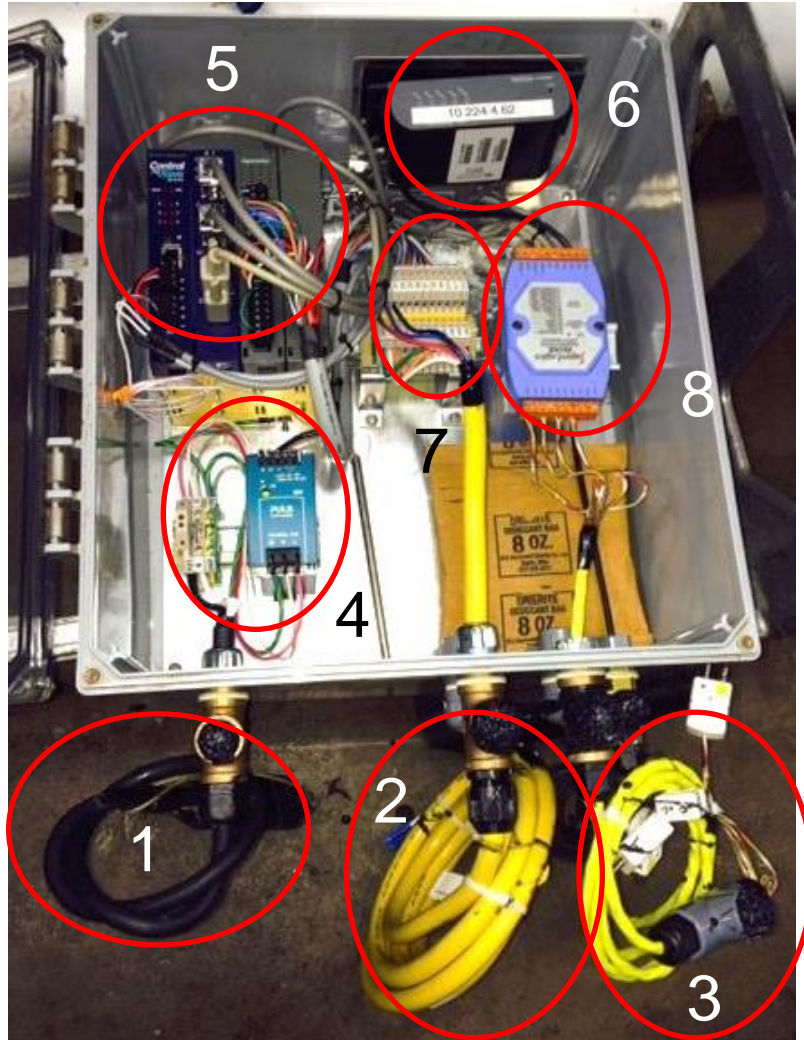
Remote Monitoring System: Remote Telemetric Unit (RTU)

External

- 1. Power cable
- 2. Float connections
- 3. Trap connections

Internal

- 4. Fuse and Rectifier
- 5. Programmable Cards
- 6. Wireless modem
- 7. Digital input float block
- 8. Trap thermocouple reader

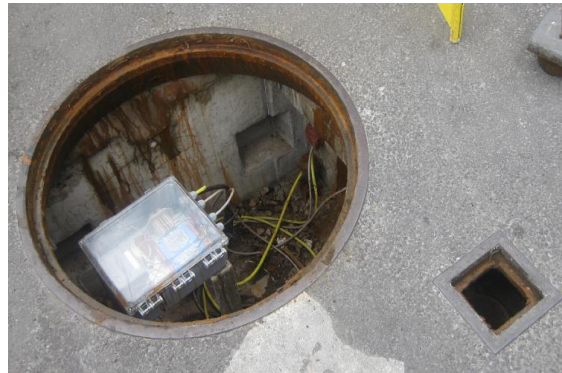
Secondary
Network

Remote Monitoring System: Infrastructure

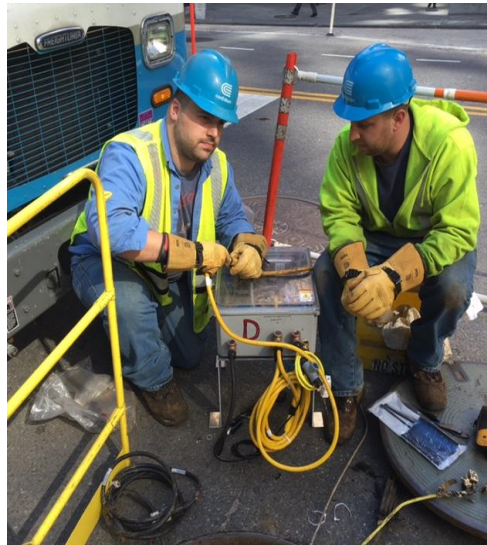
Remote Monitoring System: Progress as of 12/31/15

- System Expansion:
 - Total Locations: 871
 - Water Level: 757
 - Trap Monitors: 747
 - Planned Locations: 900

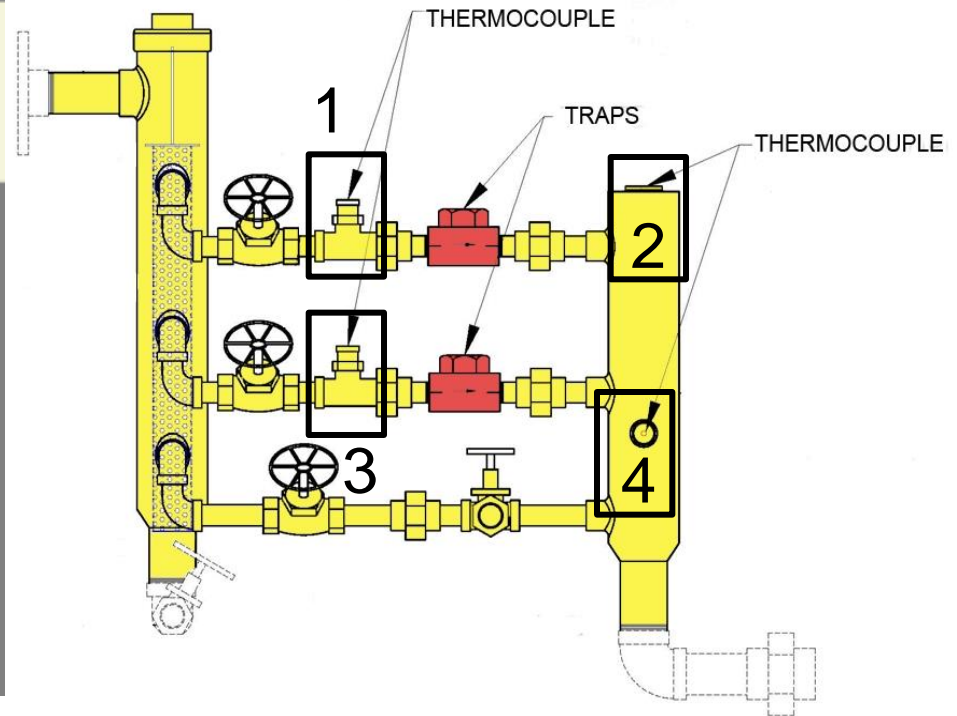
Remote Monitoring System: Trap Alarm

Manhole Number: TMH15178
Address: Fifth Ave s/o 65th St

Trap Temperature	
Upper Inlet	Upper Outlet
369.14	213.08
Lower Inlet	Lower Outlet
18031.82	213.44

Condition: **Values out of range**

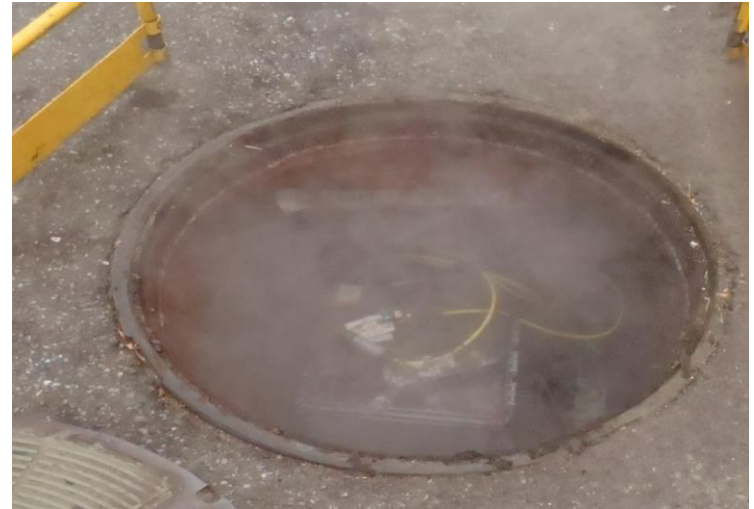
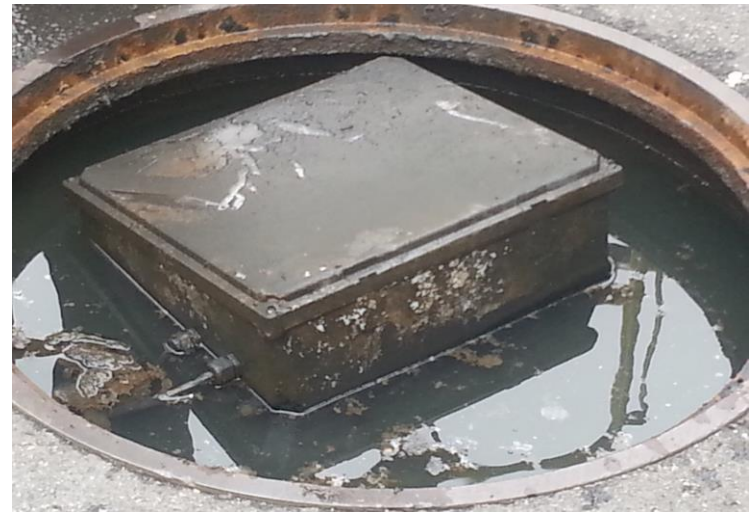
Remote Monitoring System: Maintenance

- Equipment Failure
 - Steam Leaks
 - High Ambient Temperature
 - Water Infiltration
 - Debris Collection

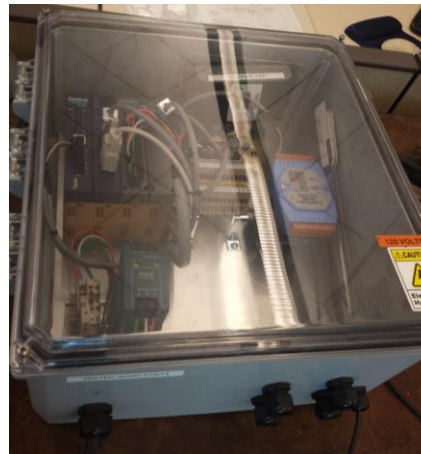
Instrument Manhole

Antenna conduit to street surface

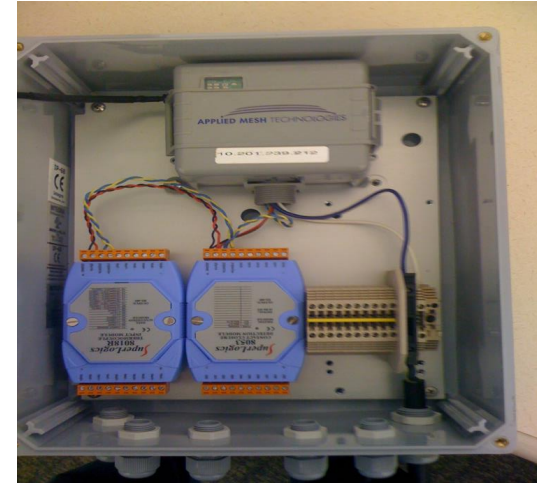
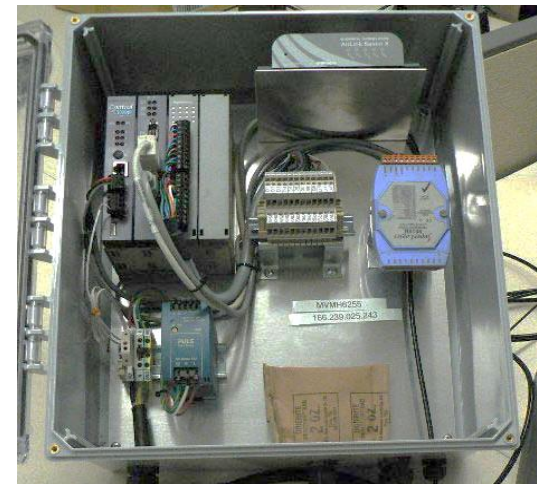
Remote Monitoring System: Lessons Learned

- Water Infiltration
 - Wire penetration sealing
 - Rubberex Epoxy
 - Electric Junction Boxes w/ Foam

- Water Infiltration
 - Successful wire penetration sealing design
 - Piping Tee with RTV Foam

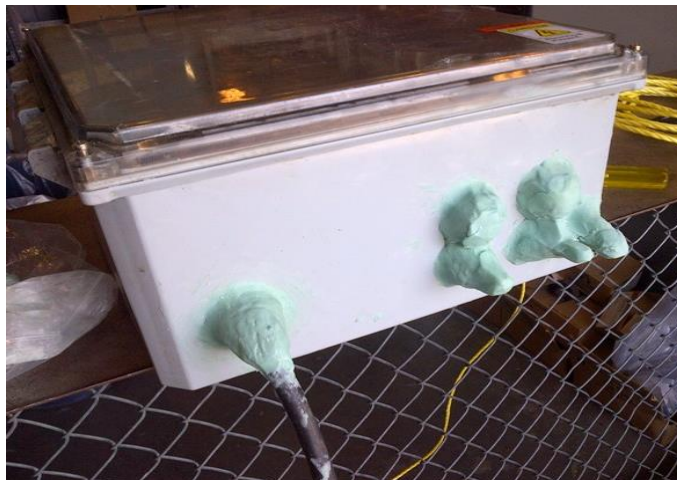
Rubberex Epoxy

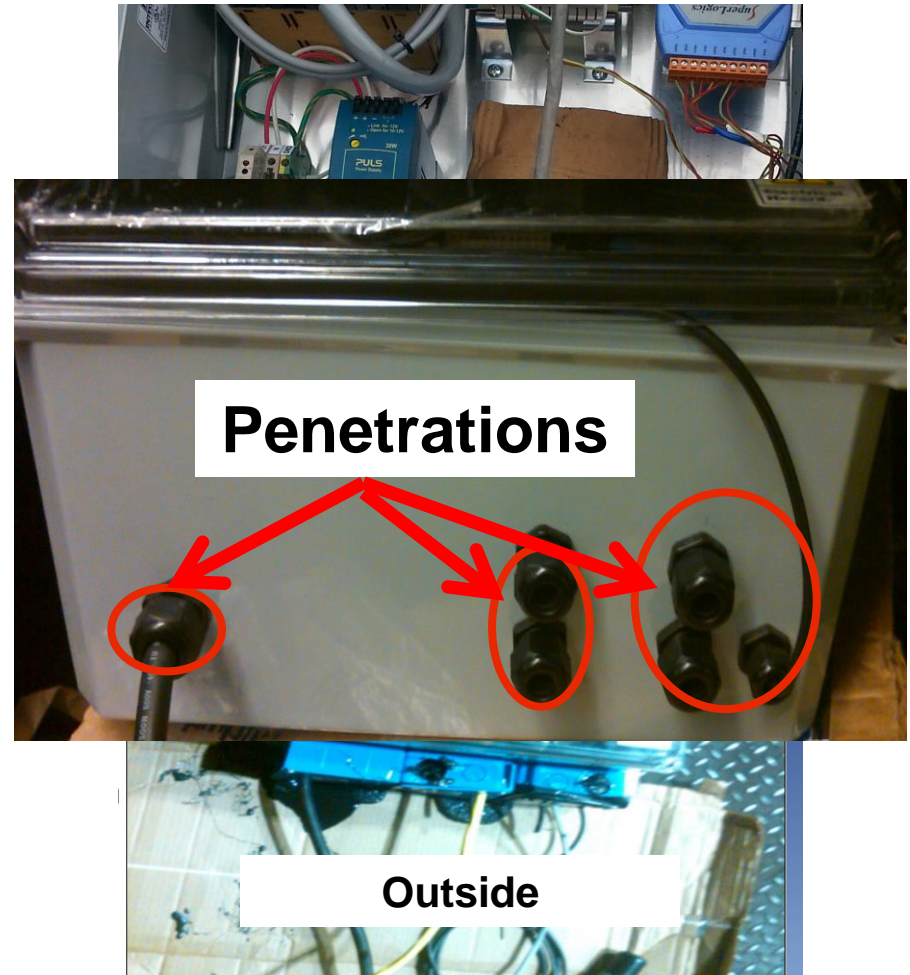
Electric Junction Boxes

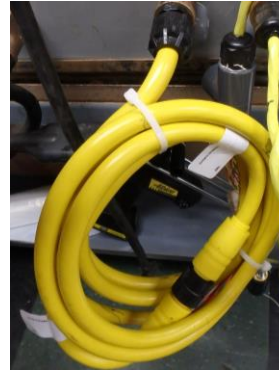
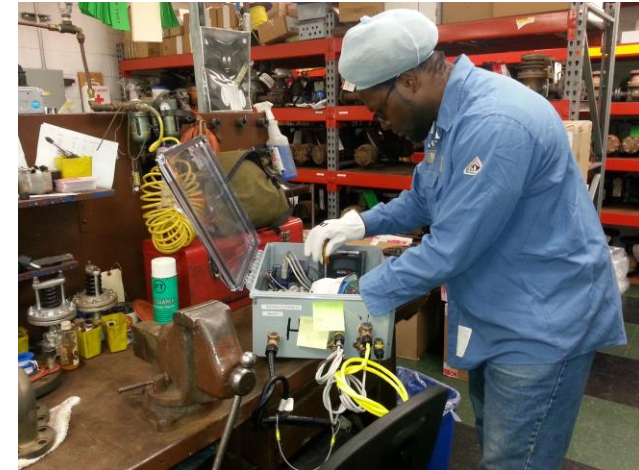
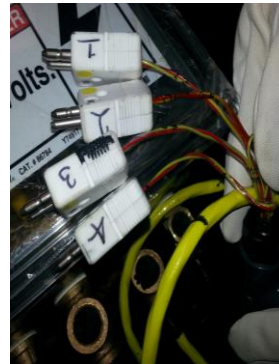
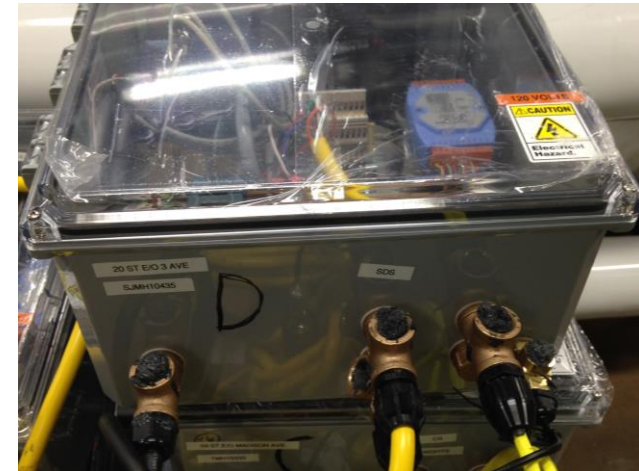
- Improved Work Practices
 - Pre-configured all equipment
 - Limited field work
 - Quick disconnects
 - Floats
 - Traps
 - Antenna (pending)
 - Quality controls

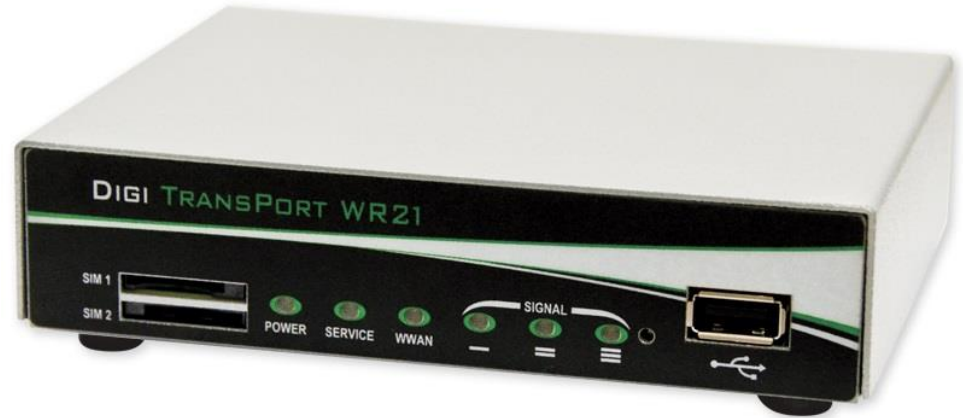
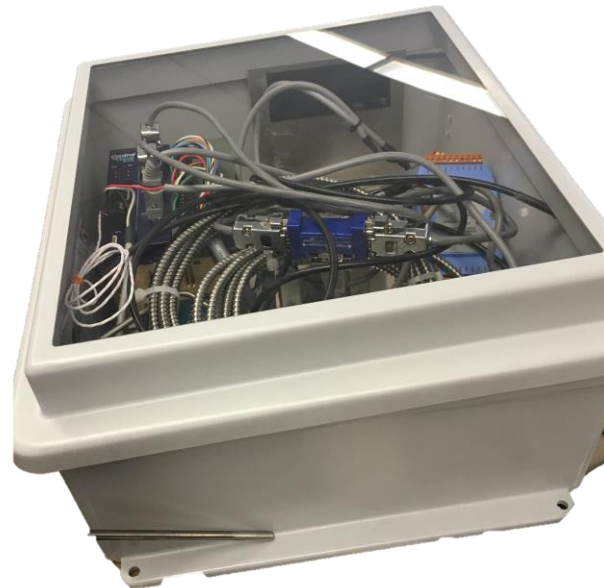
- Improved Equipment
 - Cellular modems
 - Industrial SIM Cards
 - Robust enclosures
 - Electronics coating

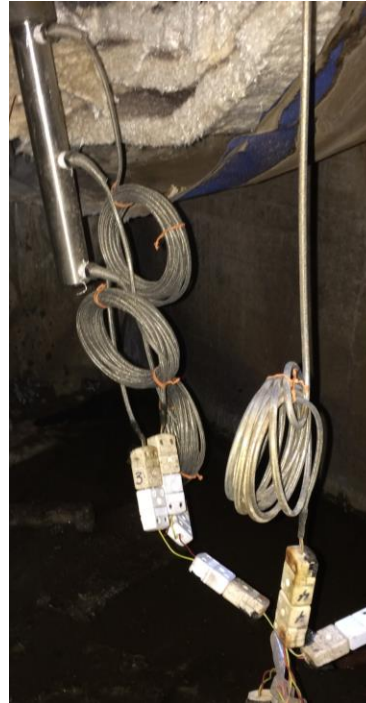
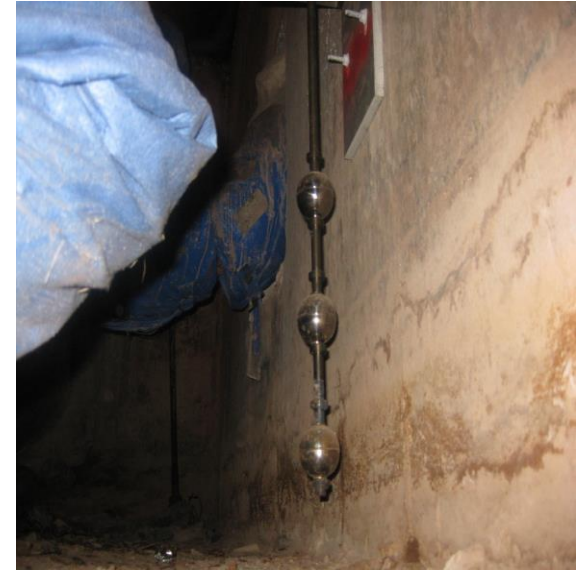
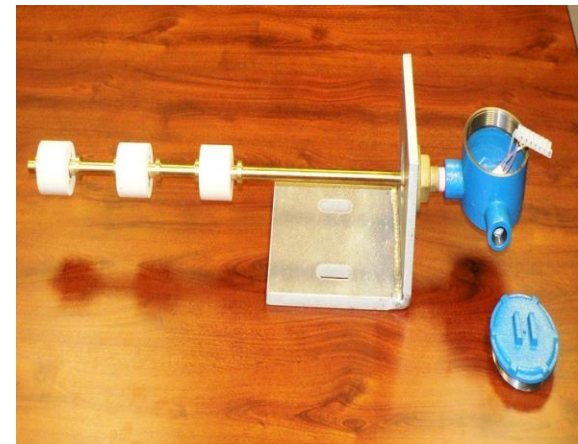
- Improved Water Level Equipment
 - Braided to solid wire
 - Stainless steel floats
 - Thermal conductivity
 - Capacitance
 - Resin floats with brass rod
 - Thermocouple temperature sensing – pending testing
