Manual valve actuators in steam in steam distribution applications

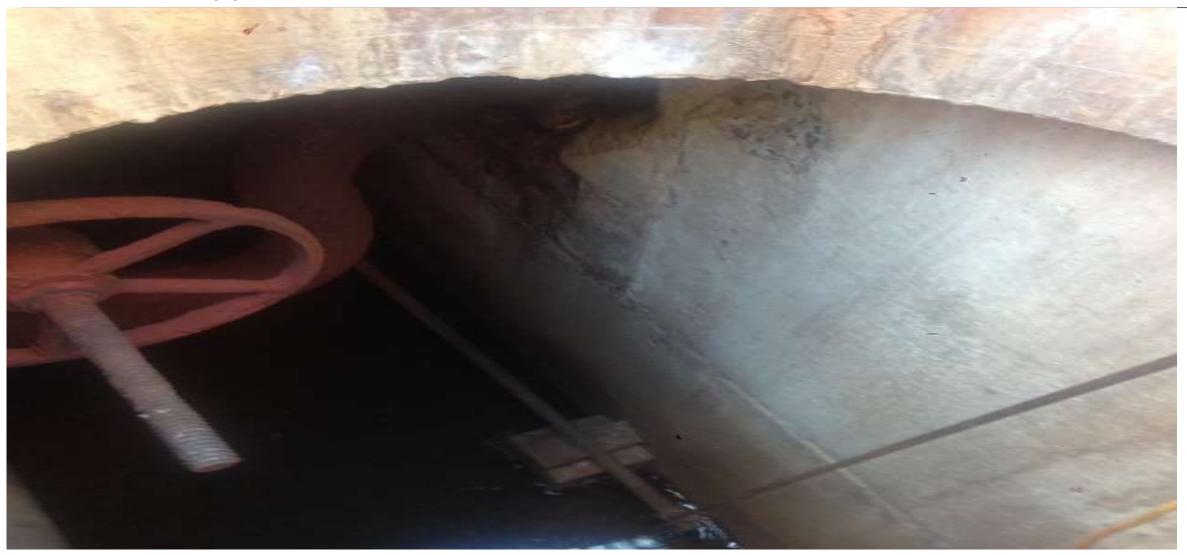
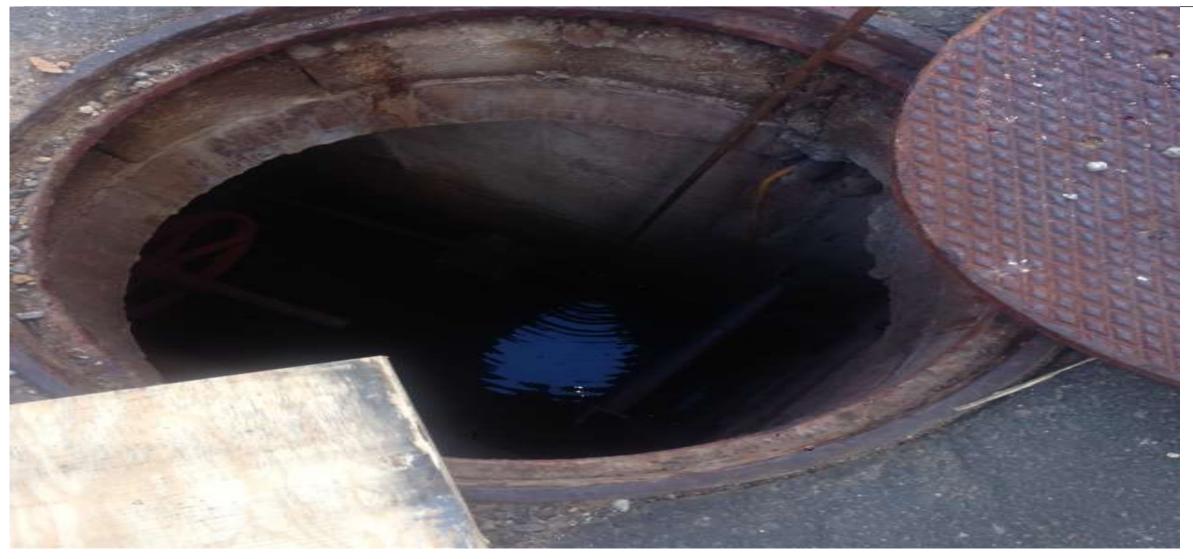
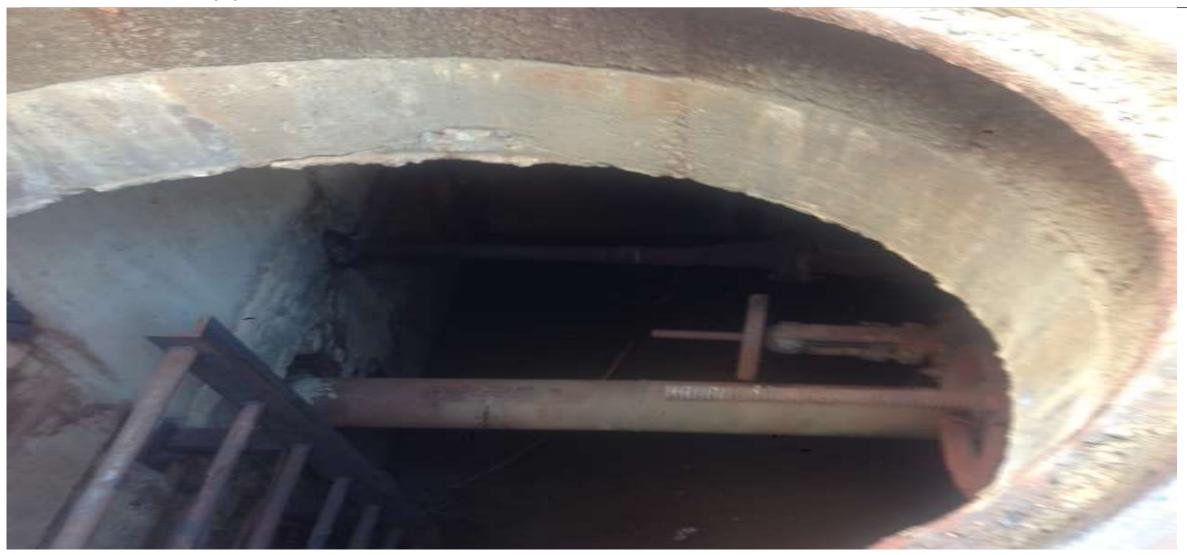
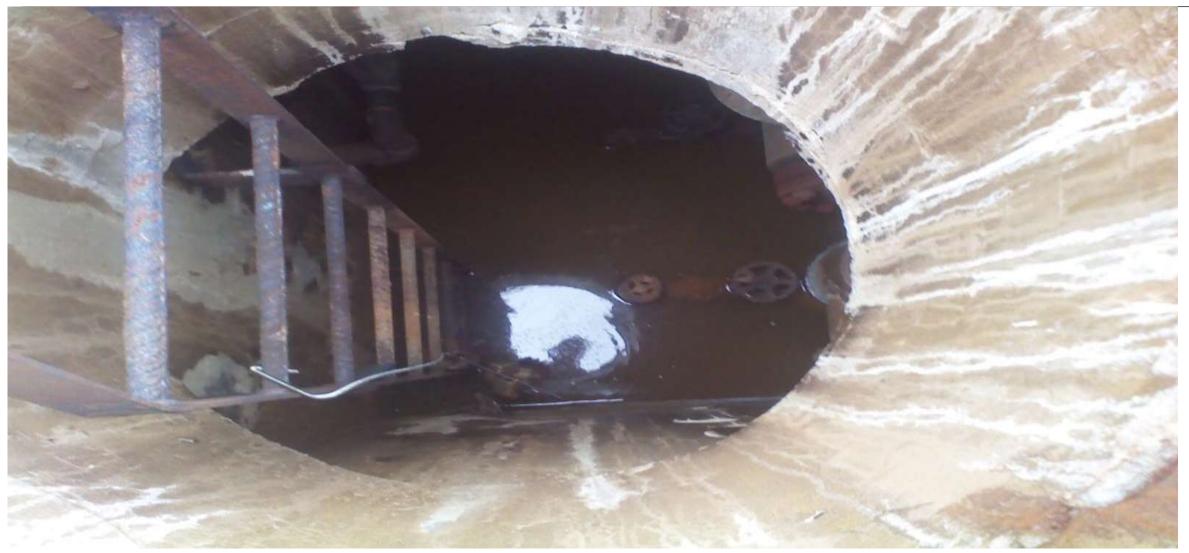
- Manholes and vaults can be aggressively corrosive environments because:
 - Road salt (magnesium chloride, sodium chloride, calcium chloride, potassium chloride) run off from snow melt sometimes drips directly onto the gearbox / bracket and accumulates in the vault.
 - Low pressure steam heats the water but does not boil it dry.
 - Valves and piping suffer little corrosion because the heat from the steam thru the piping evaporates road salts.

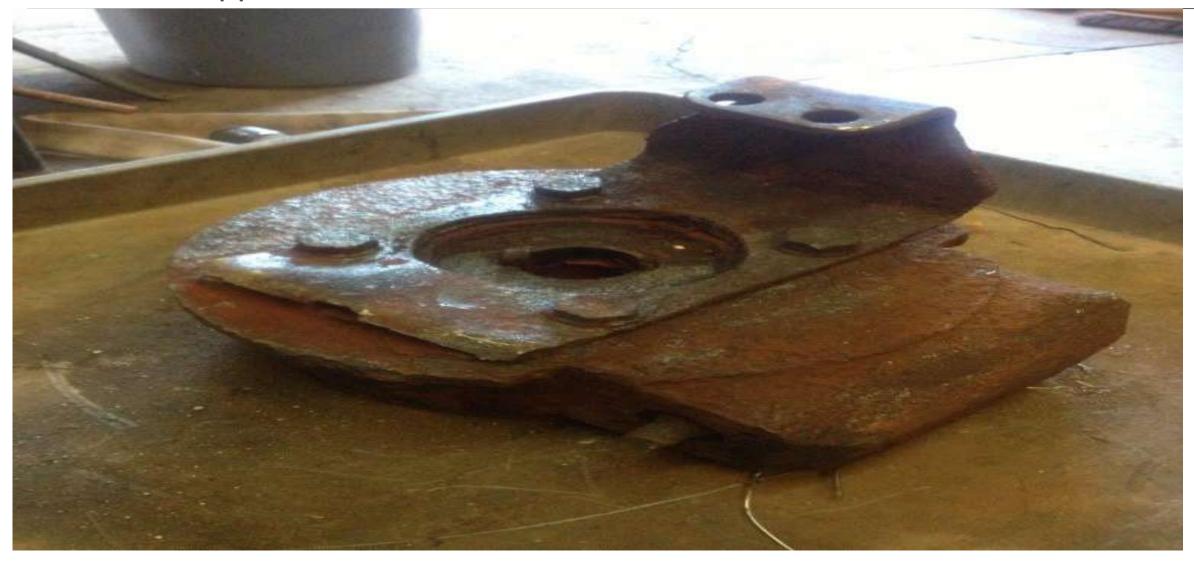
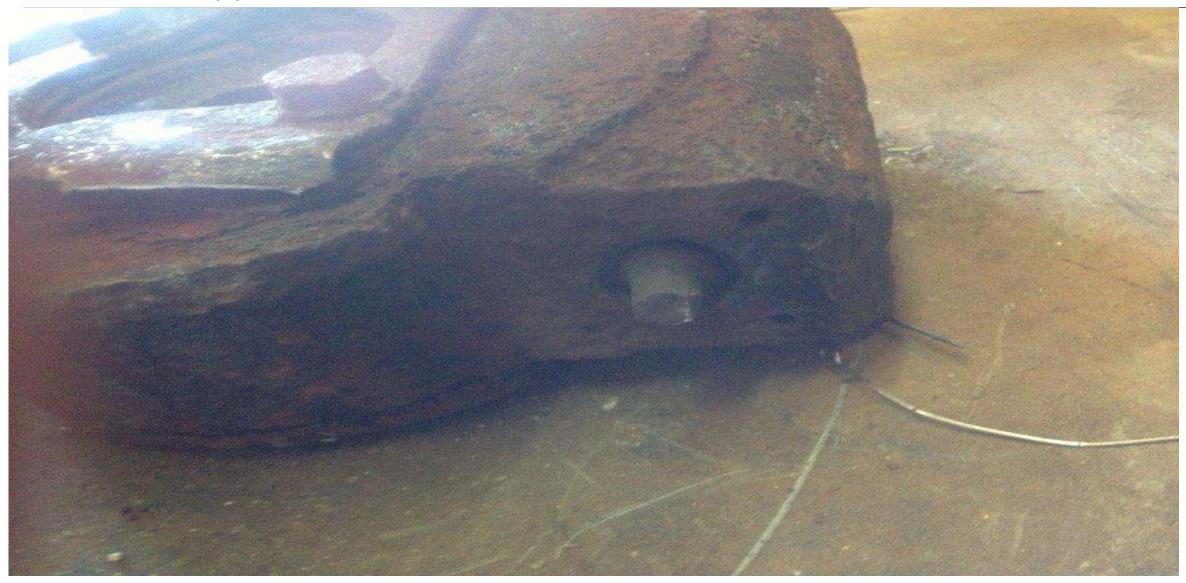
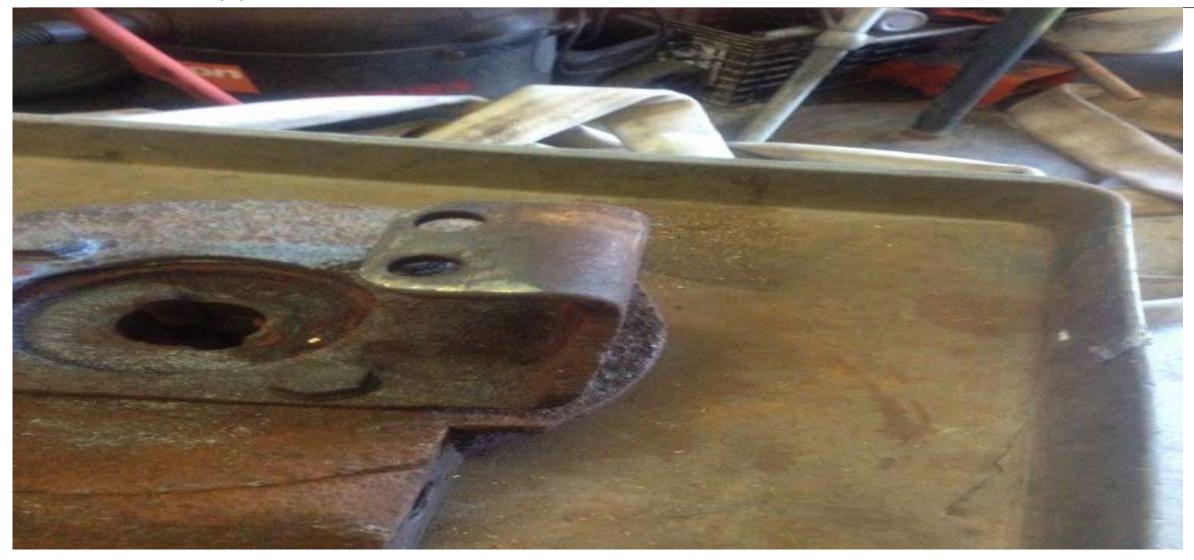
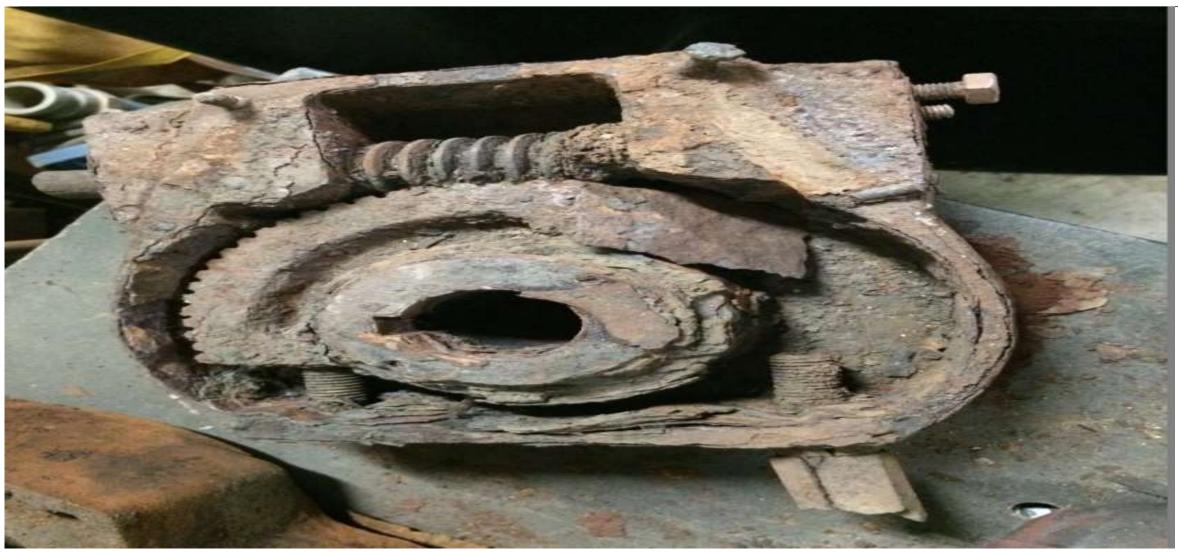
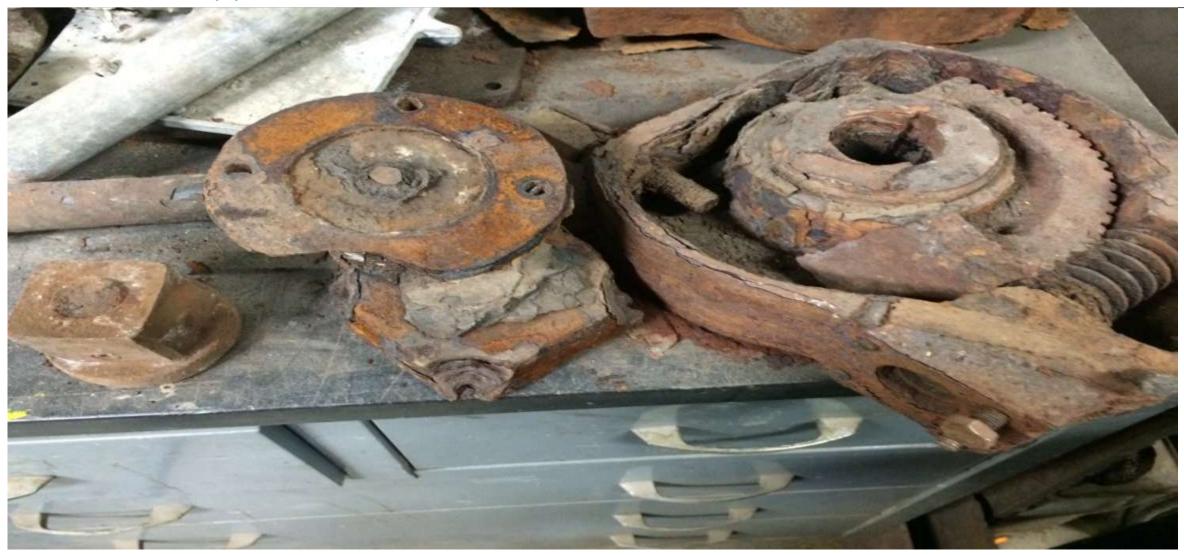
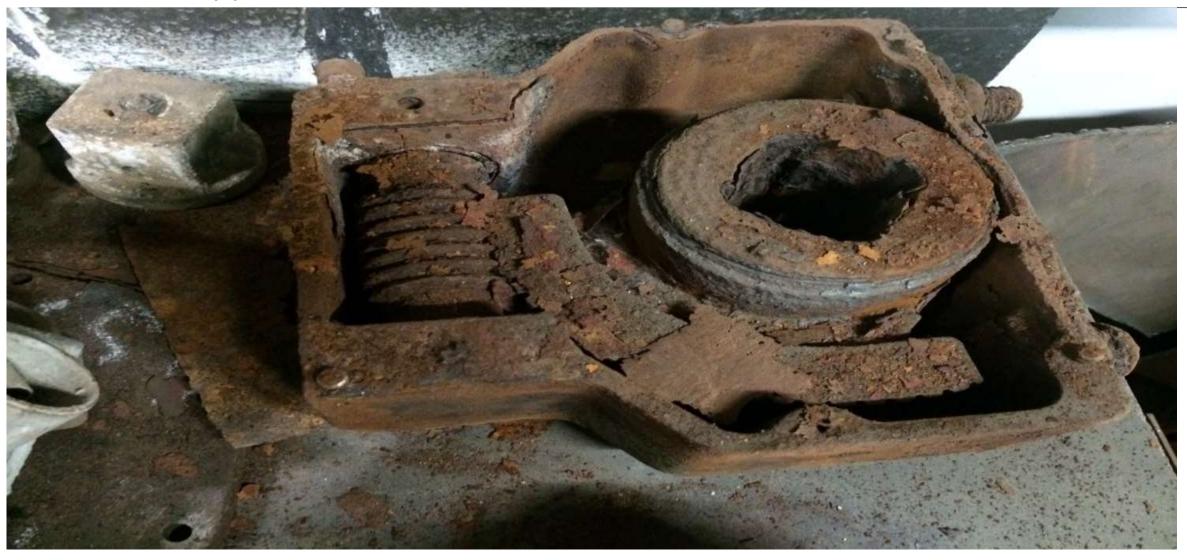
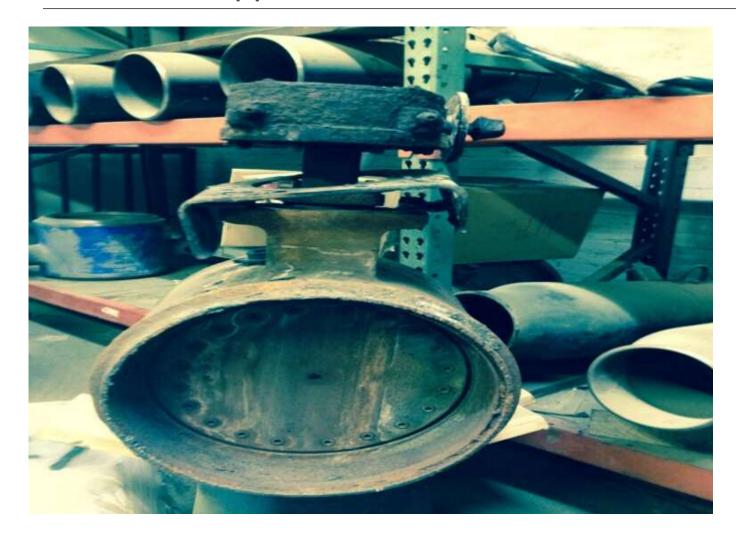
- Average industrial service gearbox / bracket will last 6 to 12 months.
 Typically these are bent metal which delaminates the steel crystal structure and decreases corrosion resistance.
- Gears and brackets can be coated to last longer but if coating is chipped, issues lie just beneath the coating.
- Once gear fails the valve is inoperable causing multiple valves to be closed for isolation.
- Replacement of the gear / bracket in field is a costly and major job estimated at \$5k to \$7k per hole entry.

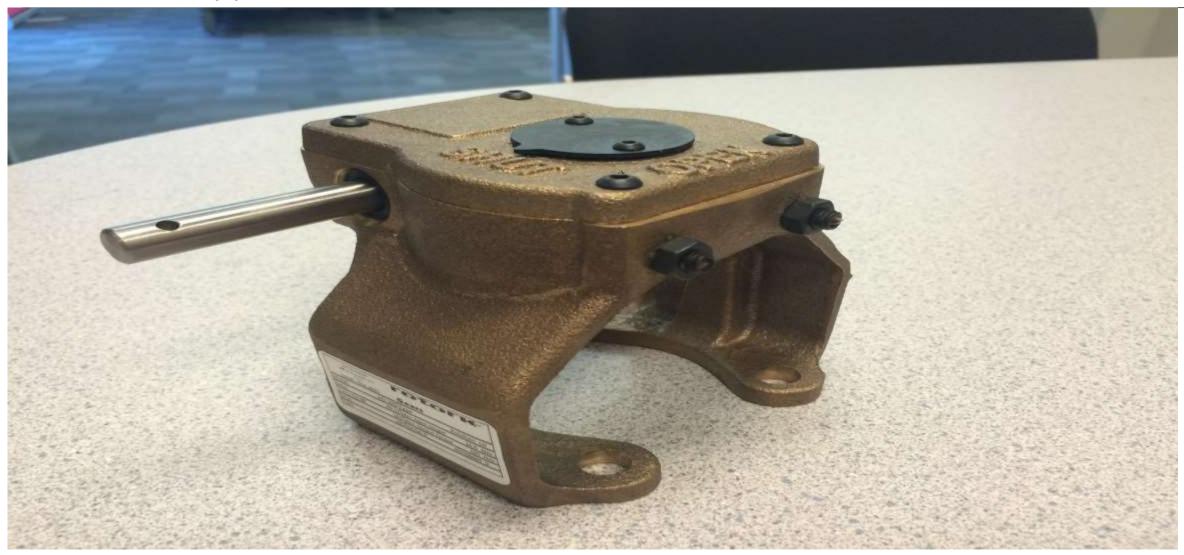
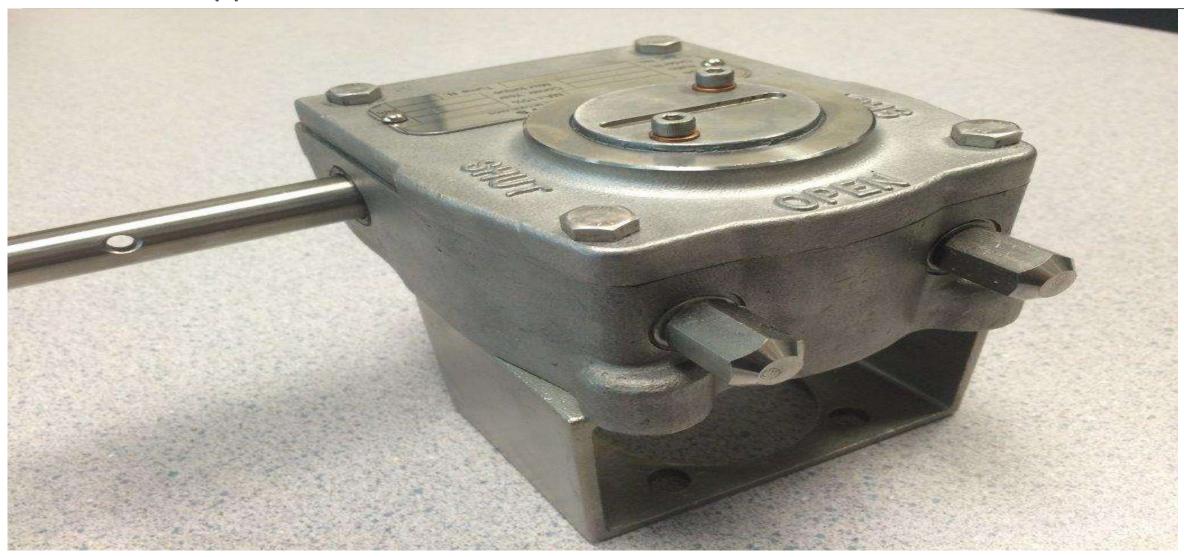
• Solution is to change the materials of the gearbox and bracket to cast aluminum bronze that will withstand this corrosive environment.

- Bronze gear boxes and brackets have not been available in the market before.
- Two designs are possible either a one piece gearbox with integral bracket or a separate gearbox / bracket as currently used.
- In field testing of one piece gears to prove materials of construction have gone well so far after two months of service.

COMPONENT	MATERIAL	SPECIFICATION
Gear case	Aluminum Bronze	ASTM B148 C83600
Cover plate	Aluminum Bronze	ASTM B148 C83600
Quadrant	Aluminum Bronze	ASTM B148 C95800
Input Shaft	316 SS	Arcor treated
Gasket	Liquid seal	
Oil Seal	Viton	
Worm	Carbon Steel	AISI 1045
Needle Bearing	AXK-AS	Hardened Steel
Position Indicator	316 SS	Arcor treated
Grease	Renolit CLX2 Hi temp
