# Constructing a New Utility Tunnel on an Active Medical Campus

Walter Reed National Military Medical Center  
Bethesda, Maryland

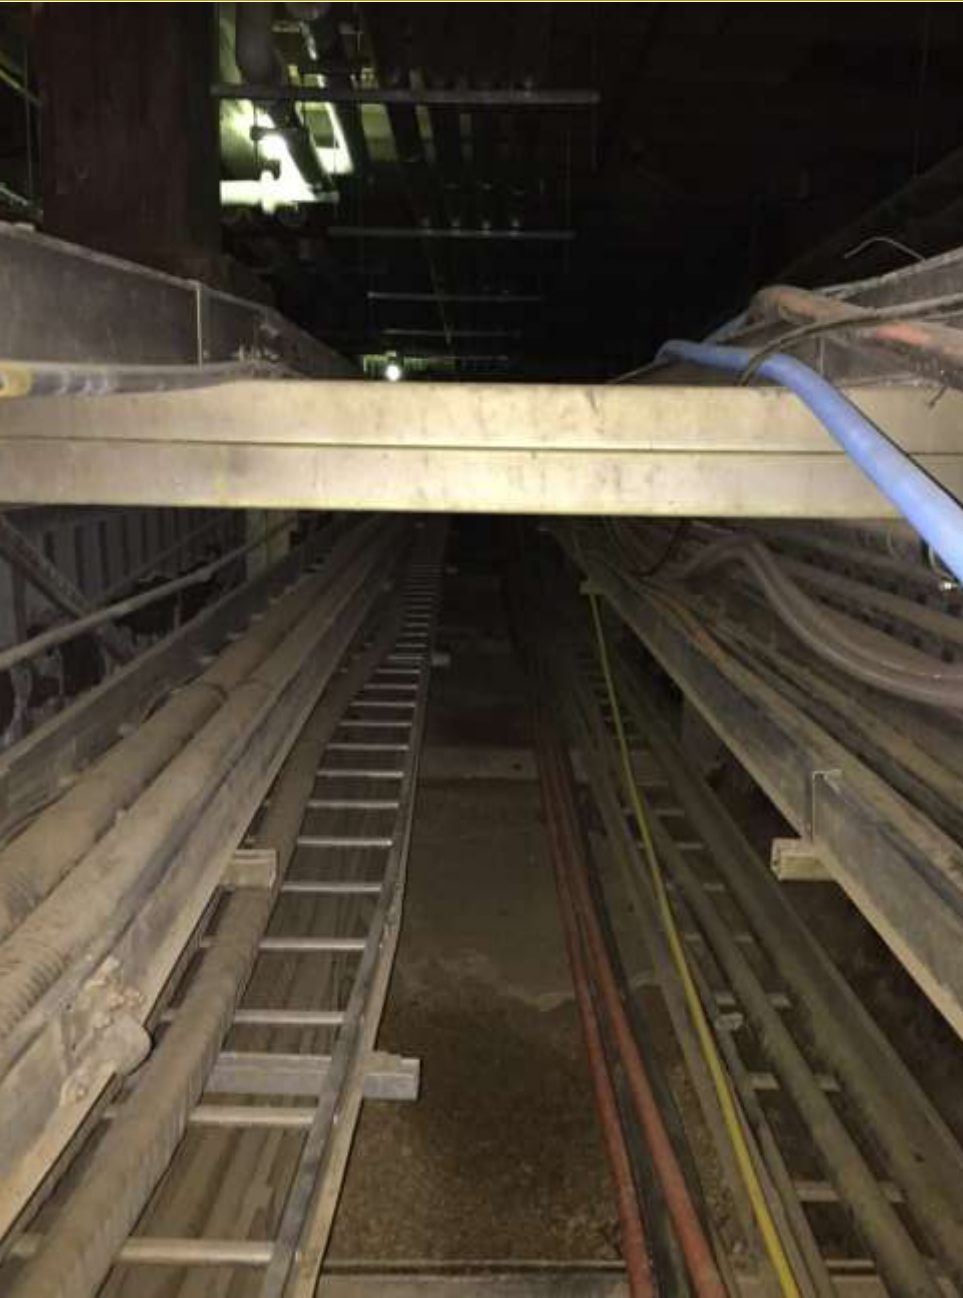
- **Trench in Crawl Space of STEM**
  - **Medium Voltage Feeders**
  - **Over 80 Communications Cables**
  - **New Tunnel Will Cut Trench in Half**

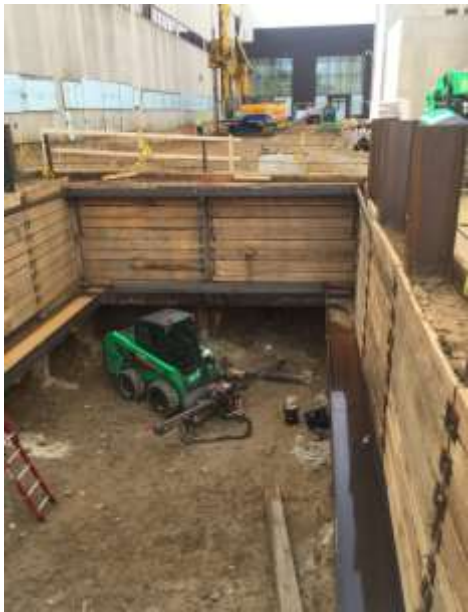
**Line Drill**  
**3-31-2016**

- Extremely Hard - >20,000 psi
- Extensive in Excavation Below 20'
- 5 Months to Complete 775 Cubic Yards of Excavation

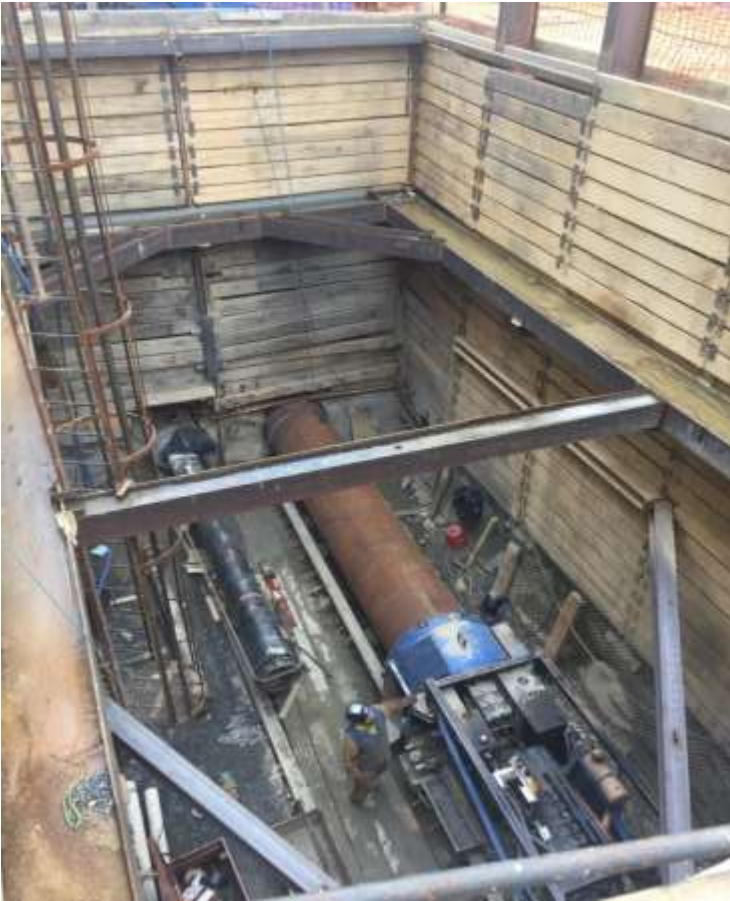
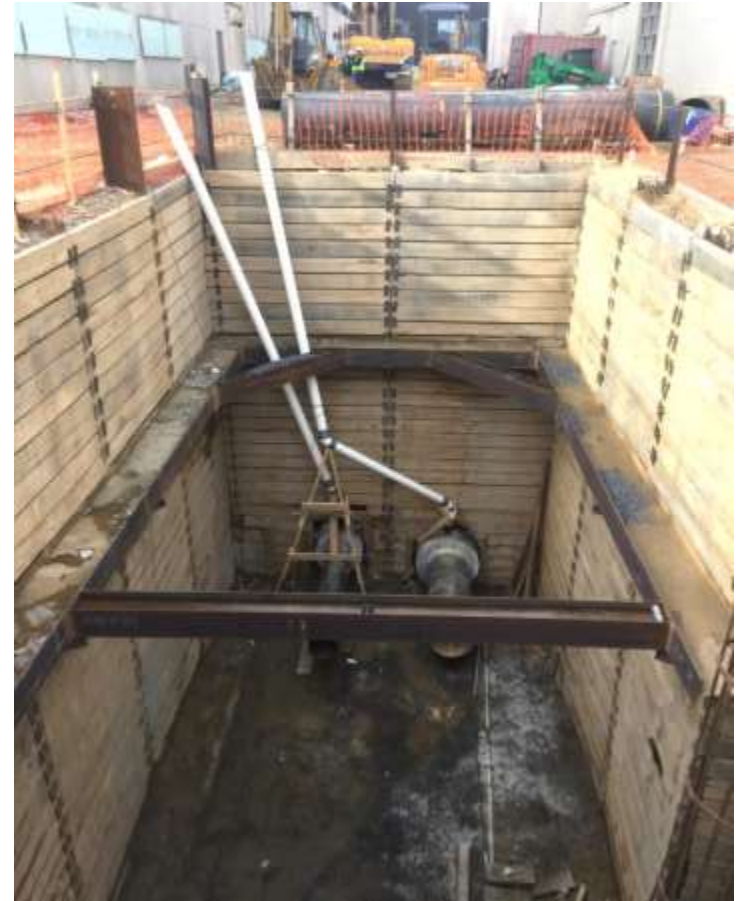
- Rock Boring – Multiple Breakdowns, 6 months to complete two (2) 270LF crossings
- Dewatering
- Shoring-of-Excavation (SOE) Conflicts

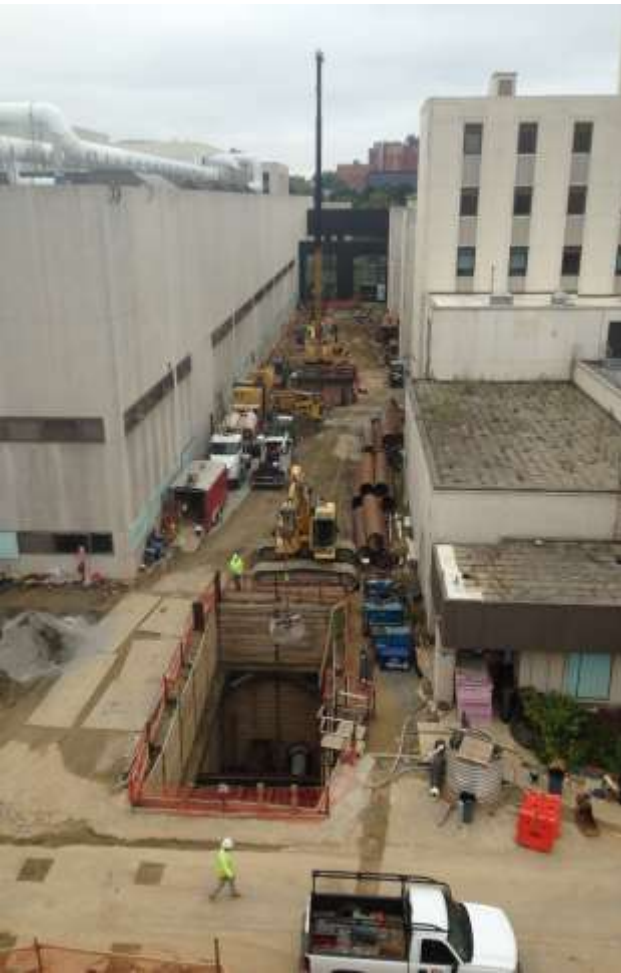
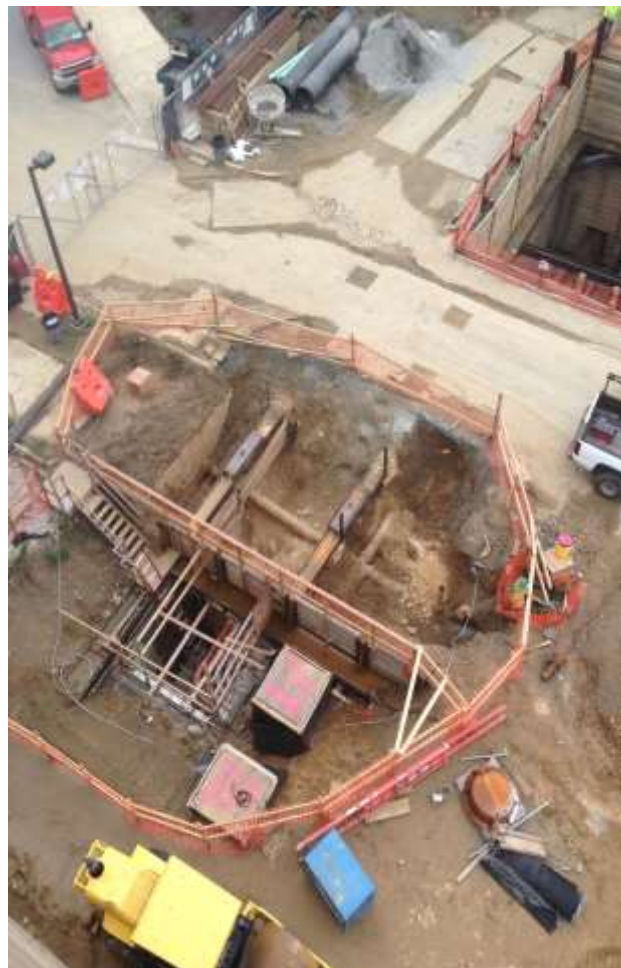
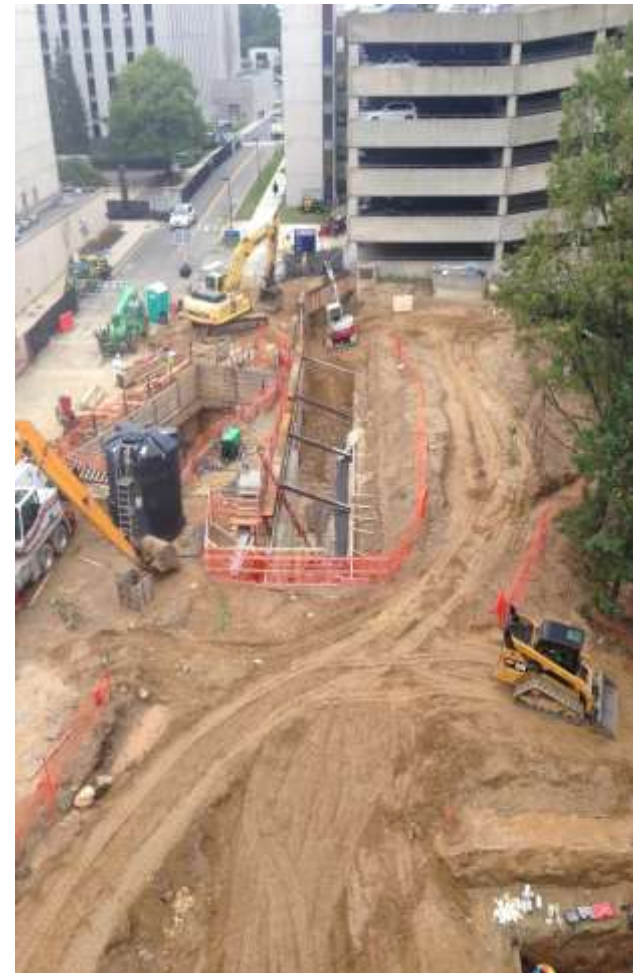
- Boring & Tunneling Took Place Between Occupied Buildings
- Pedestrians and Vehicular Traffic
- Laydown Yard ½ Mile from Site
- Site broken up between 6 main areas and miscellaneous interior work

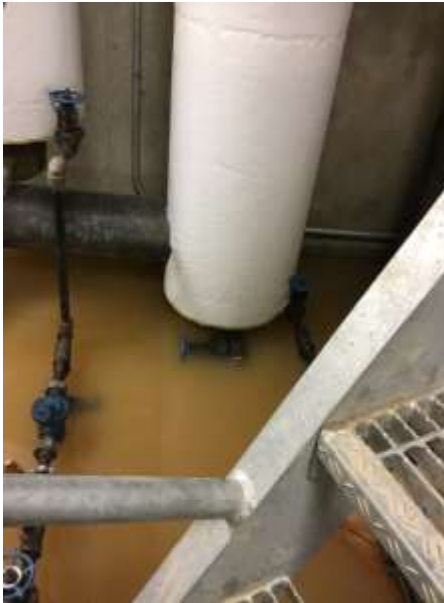
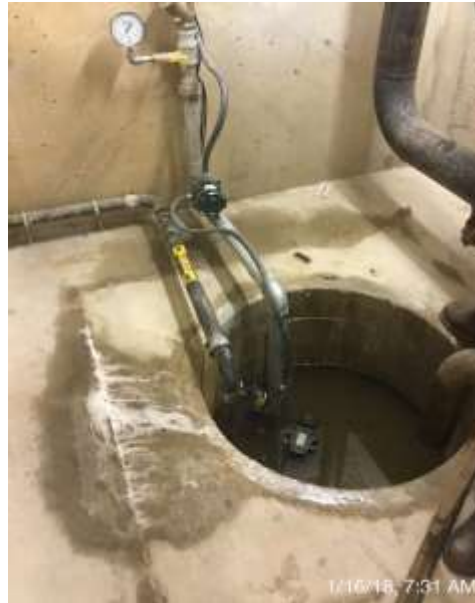
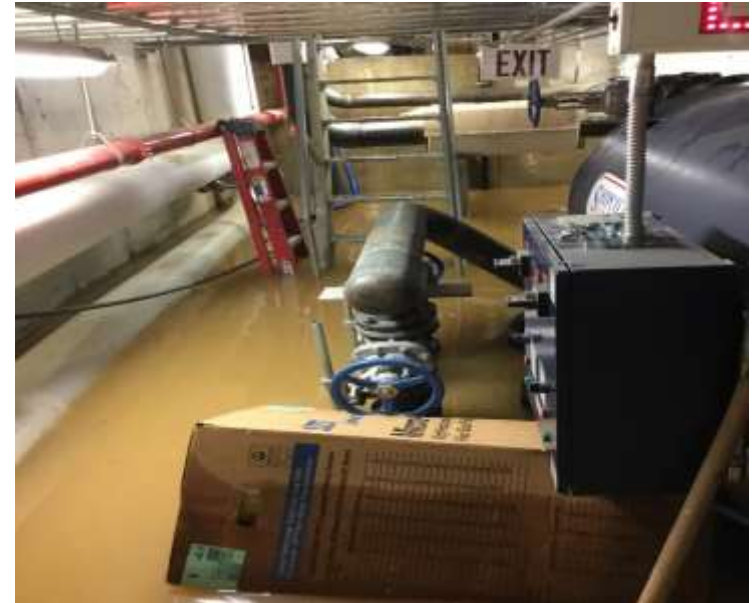
- **Utility Tunnel designed to be completely enclosed (no exterior sumps)**
- **Multiple areas not able to be immediately enclosed resulted in waterproofing replacement**
- **Ground spring (or broken water line?) required fiberglass sump insertion and chemical grout injection along with multiple concrete re-pours.**

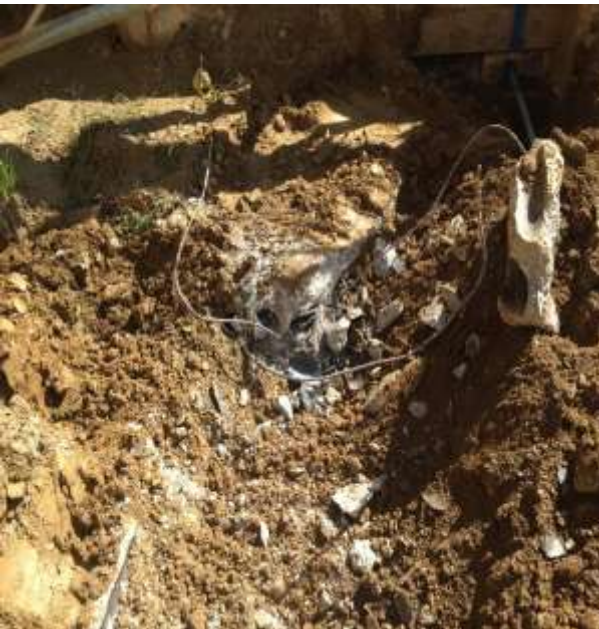
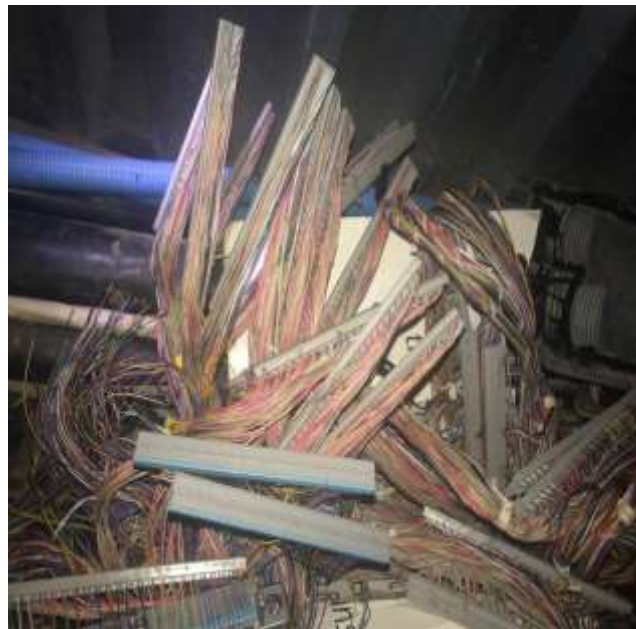
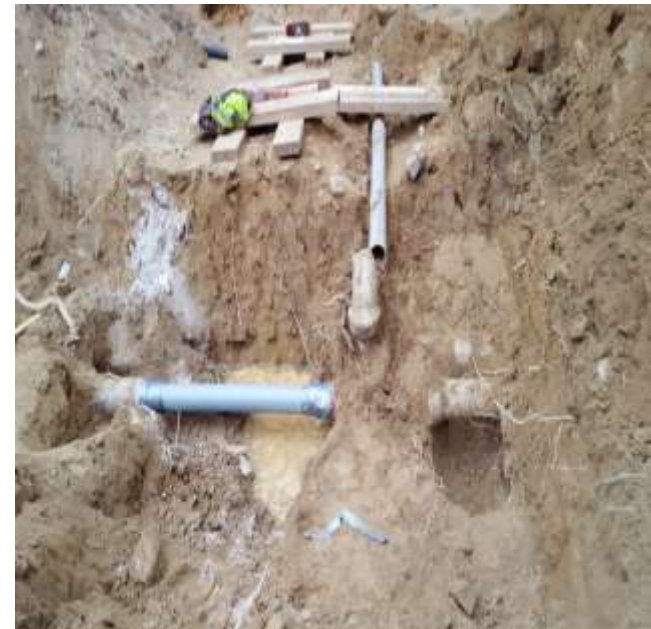
- Condition of existing utilities on a 80 year old installation was a major headache
- More utilities than not were missing from as-builts, and ended up being found the hard way!
- Tie-ins and shut-downs had to be carefully sequenced to allow operations to be maintained continuously

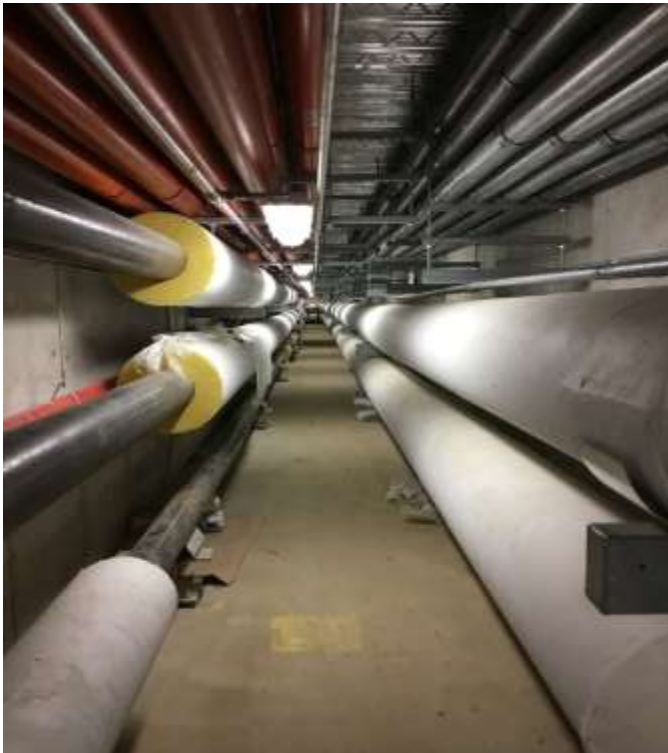
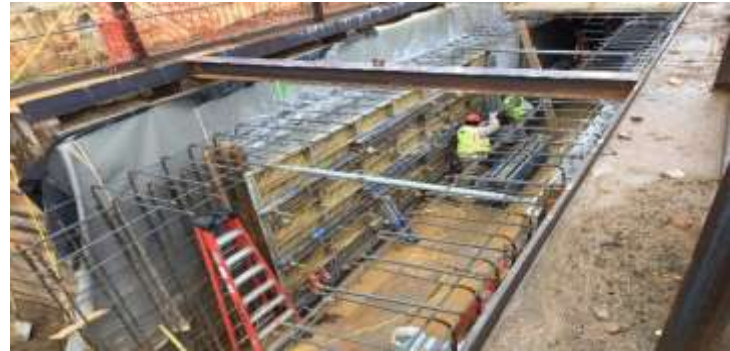
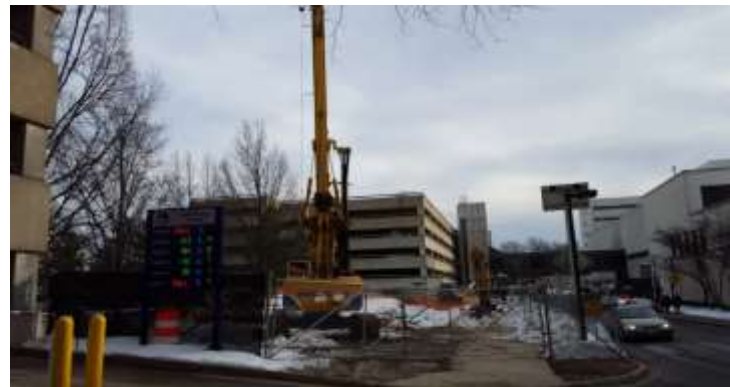
- Sequencing had to be well defined during preconstruction to identify the correct critical path
- “Domino” effect plagued the job for the duration of the project
- Quality control, labor management and safety inspections became challenging with so much going on

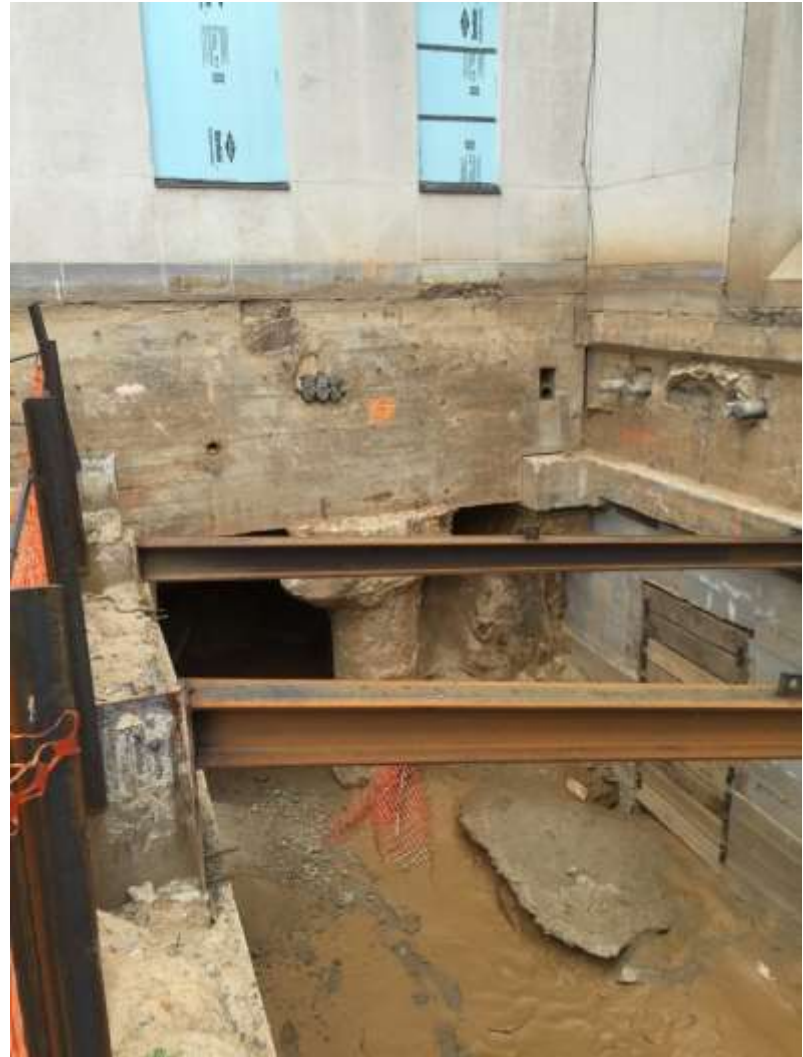
- Building structural as-builts were not accurate, and required quick redesign of shoring system to allow the tunnel to continue on schedule
- Underpinning pits were required where tunnel traveled underneath existing buildings
- Innovative shoring solution required underneath connectors with turn-down slabs and caissons
