### IN REHAB: REBUILDING UNIVERSITY OF FLORIDA'S UNDERGROUND INFRASTRUCTURE

Jennifer Meisenhelder, PE Assistant Director, Facilities Operations UNIVERSITY OF FLORIDA

Vince Basilio, PE, CEM Steam Systems Engineer RMF ENGINEERING, Inc.

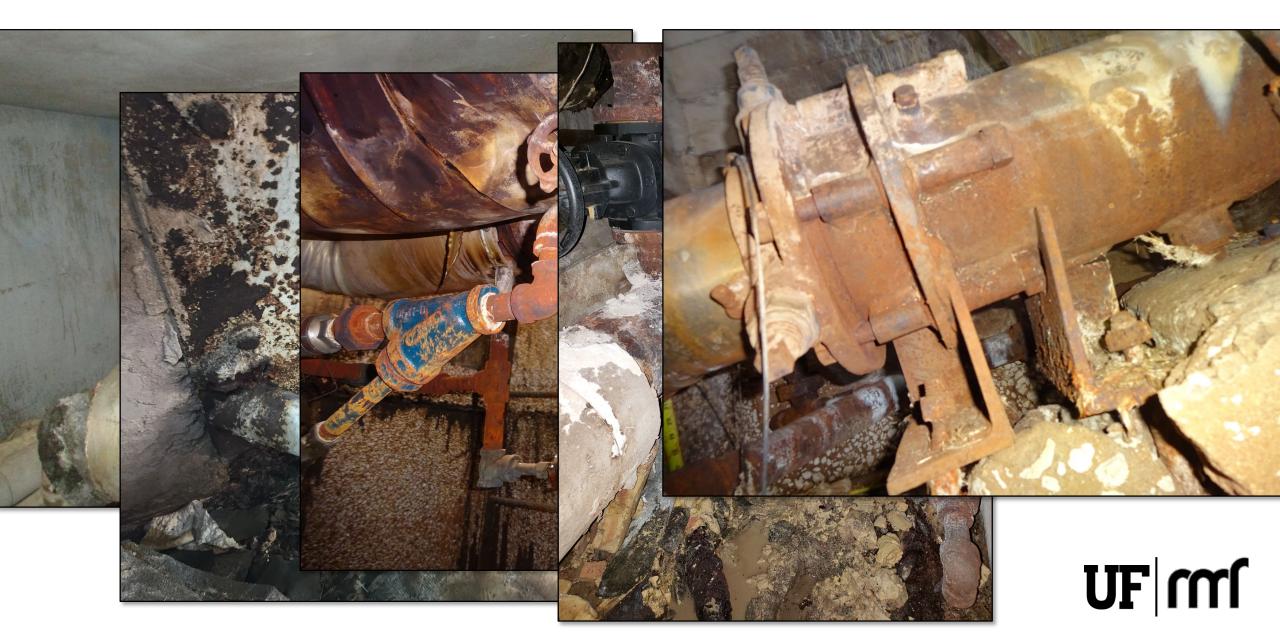
MECHANICAL MANHOLE: MH-3D3-9 SYSTEM CONDITION								CONDITION PHOTOS																
Manhole Co Neck Condi	er Condition: ondition: ition: Surface Tempera ent?	Obsv./ Perm Source:	Access Cove Spa Ladder Com Notes: 140 Depth: 0"/	alling: 🗹 dition: D deg F 18" and MH-3D3-	N/A Exposed Rebar Good 13	r: 🗆		Ru	sted and			or Plate	on		Loc	king South			Lookir	and North				
Pipe Hange Pipe Ancho	ors Condition:	Good Poor	Pipe Hange Pipe Anchor	rs Urgency:	N/A Immedi					6'	' 70S													
Service	Pipe Size (NPS		Pipe	Valve	Insulat		ller		Sacket	Ura		nsion Jo		Turre	Trap Size (in) (					1				
t Type 1 70S 2 PC	10 4				e A	Cond. Poor Poor	1 1	Type AL AL	Cond. Poor Poor	1 1	None	hannanananan	NA NA	None None	N/A N/A						2 2	- /		
3 70S 4 PC 5 70S	8 4 6			9	e ía	Poor Poor Poor	1 1 1	AL AL AL	Poor Poor Poor	1 1 1	SJ SJ SJ	Good Good Poor	NA 1	BiM None BiM	3/4				AL		2			
70S PC 70S	8 6 6			12		Poor Poor Poor	1 1 1	AL AL None	Poor Poor None	1 1 1	None	None None None	-	None None None	N/A						NA NA

70C	3/4		The	11	à	Poor	1	N/A	None	1	None	None	NA	None	N/A				-	4	NA			
																				Jest -				
General:	3D3-8. This man	hole also serves ern portion of a	h isolation poin s as a low point	t with normal s for traps and a	MENTS / CON ervice from MH-3D ccommodates then . This manhole is v	3-12 to th rmal expa	ne south Insion f	rom the	north in t	he ste	am and o	ondensa	te syst	ems.	71	UTILI			TURE AS		IT			
Piping: Exp. Joints	6" 70S XJ is leak	packed, slip joir	ts with no base	anchors. The	6" 70S XJ is leaking nsion. Anchor failu	g no north Ire in adia	h side. J	Anchor   anhole.	plate on 6	" 70S	XJ has h	eaved off	concr	ete				Reliab ue Date: 2/2018	ility. Effici	ency. Integrit echanical Ma <u>MH-3D3-9</u>	anhole:	:		
																			I			<u> </u>	UF

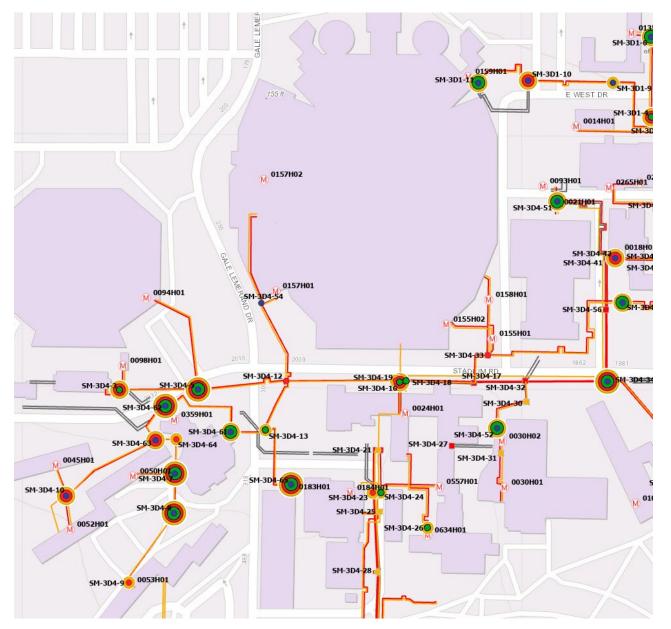
Steam MH Capital Planning Map Manhole (Water Intrusion) • 0.5 Manhole (Excess Heat) • Manhole (Mechanical Issues) 2 Manhole (Structural Issues) 2 Steam Meter M **Condensate** Piping Steam Piping Abandoned Piping Underground Enclosure Manhole temp

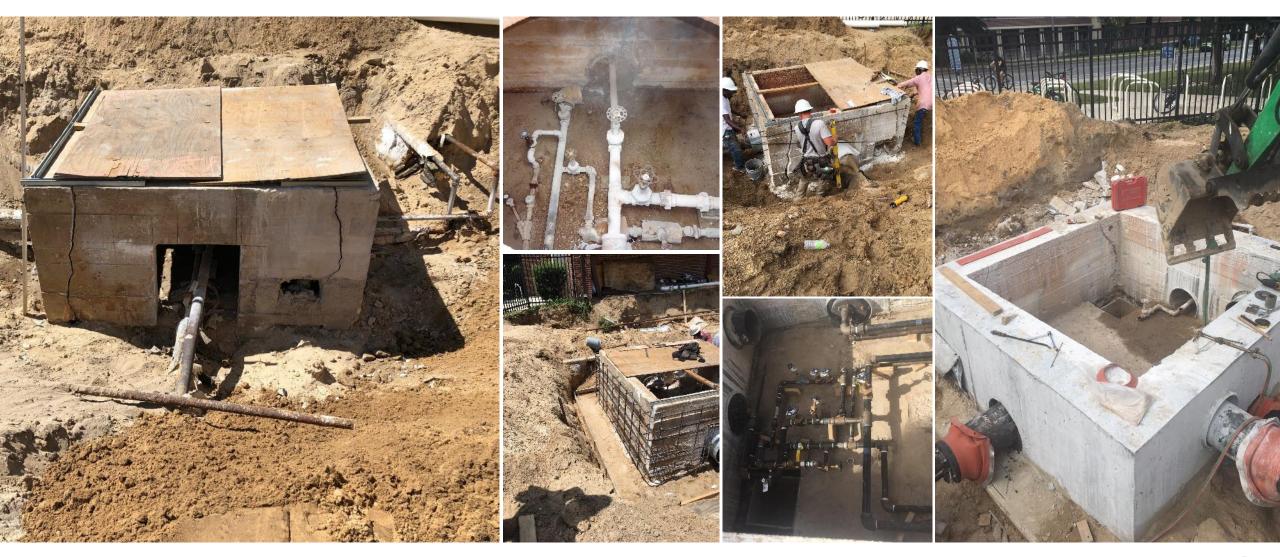
### **UNIVERSITY OF FLORIDA** COMPLETED VAULT REPAIRS
