RESPOND, REBUILD, & REDIRECT

Ashley Energy Plant

Emergency Event

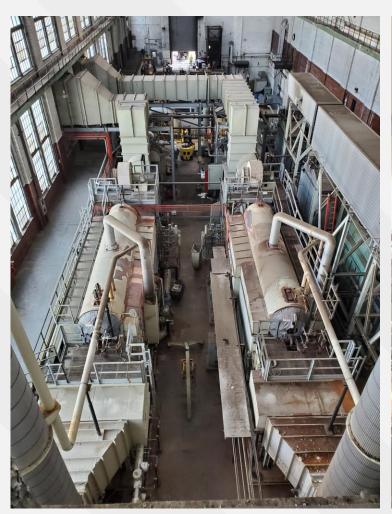
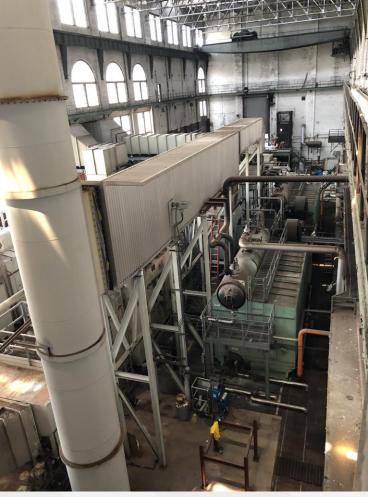
- June 1, 2019 Sanitary and Stormwater Pumping Station failed
- > > 5 million gallons of sanitary/stormwater entered the plant
- ► 11+ hour event, 25" of water per hour, filled plant to Elevation 29 (23+ feet)

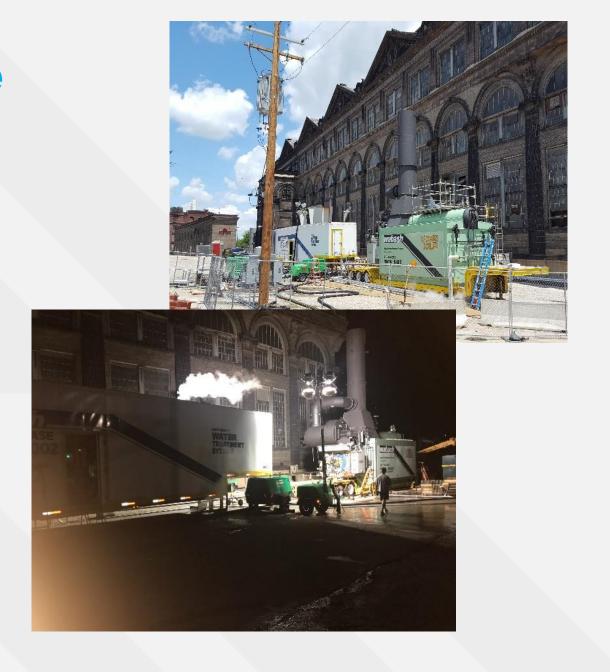
- Restore Steam Service
- ▶ Temp Elec Service to Plant
- Condition Assessment
- Equipment OEM's
- ► Hazardous Material Team
- **Contractors**
- ► Insurance Team
