Steam Piping Condition Assessments at Princeton University Using Ultrasonic Guided Wave Testing

Roger L. Royer Jr. and Fred DeGroot
Structural Integrity Associates, Inc.

Princeton District Steam System Background and Objectives

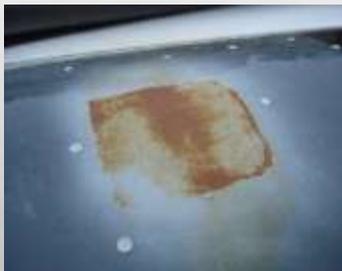
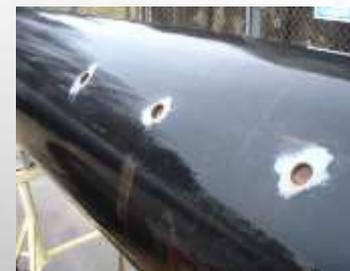
Defect 1 - 0°

~3"x3" Blend Out
50% Max Wall Loss

Defect 2 - 270°

~4"x4" Blend Out
50% Max Wall Loss

Defect 3 - 315°

Three Flat Bottom Holes
1" Diameter, Depth=60%
Spacing between holes = 1 ft.

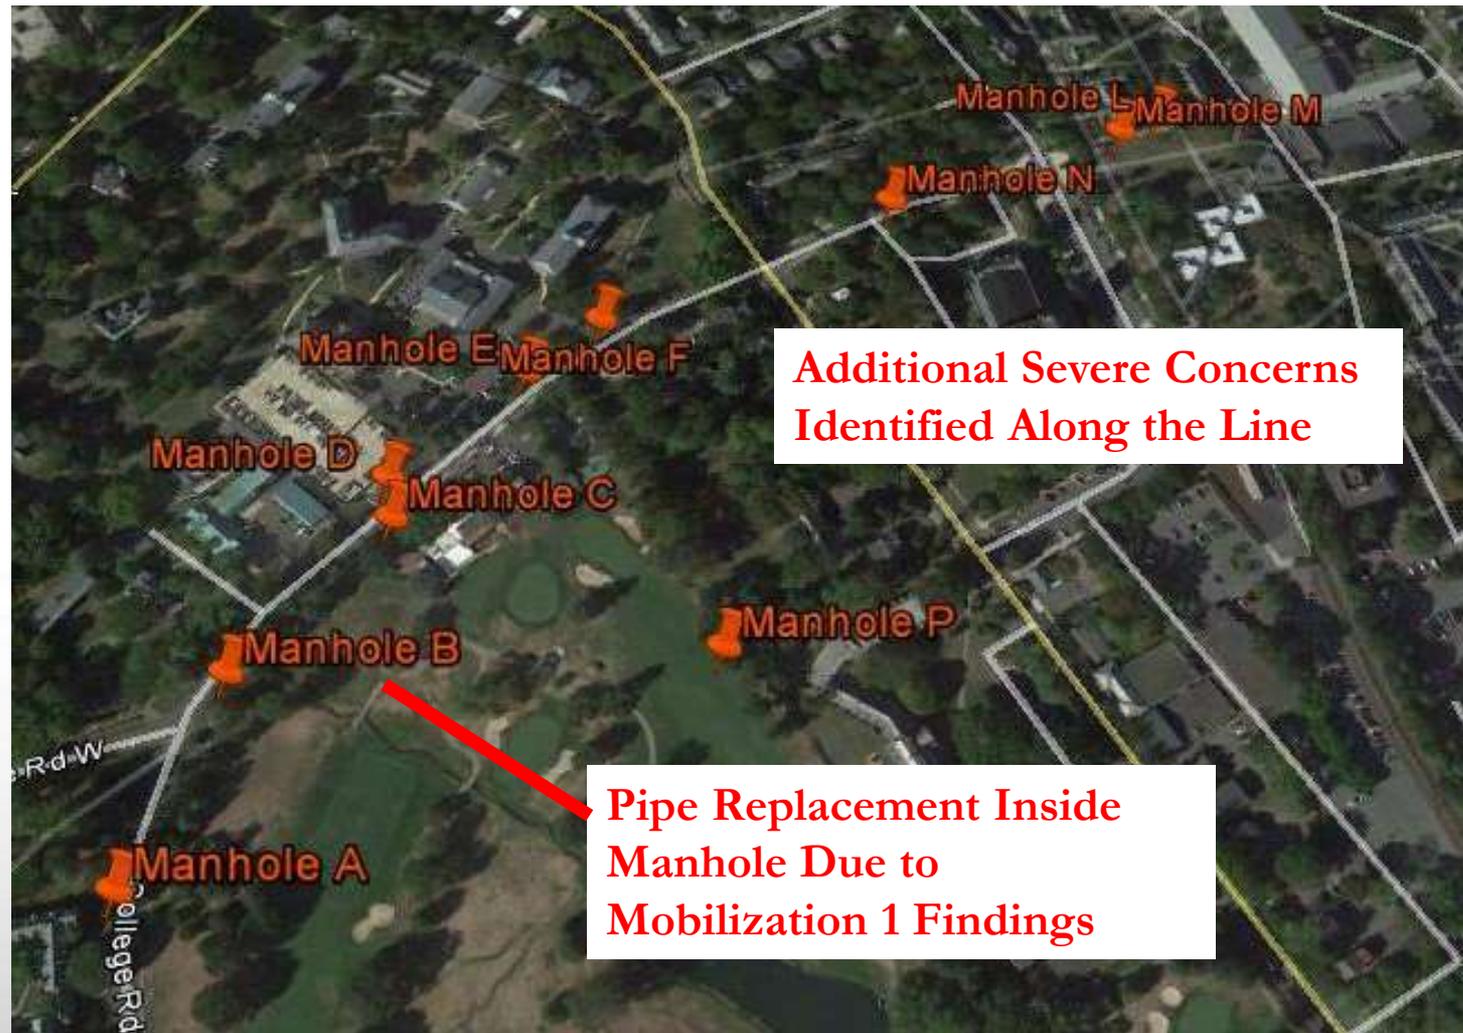
Mobilization 2 Test Locations

- GWT and UT conducted inside 9 manholes to screen 597 ft. of pipe.
