CAMPUS ENERGY 2016

USING INTELLIGENT PREDICTIVE CONDITION-BASED MONITORING FOR DETECTING & PREDICTING EQUIPMENT FAILURE AT THE UNIVERSITY OF TEXAS- AUSTIN

**UNIVERSITY OF TEXAS-AUSTIN, UTILITY &
ENERGY MANAGEMENT (UT-UEM)**

BNF TECHNOLOGY INC.

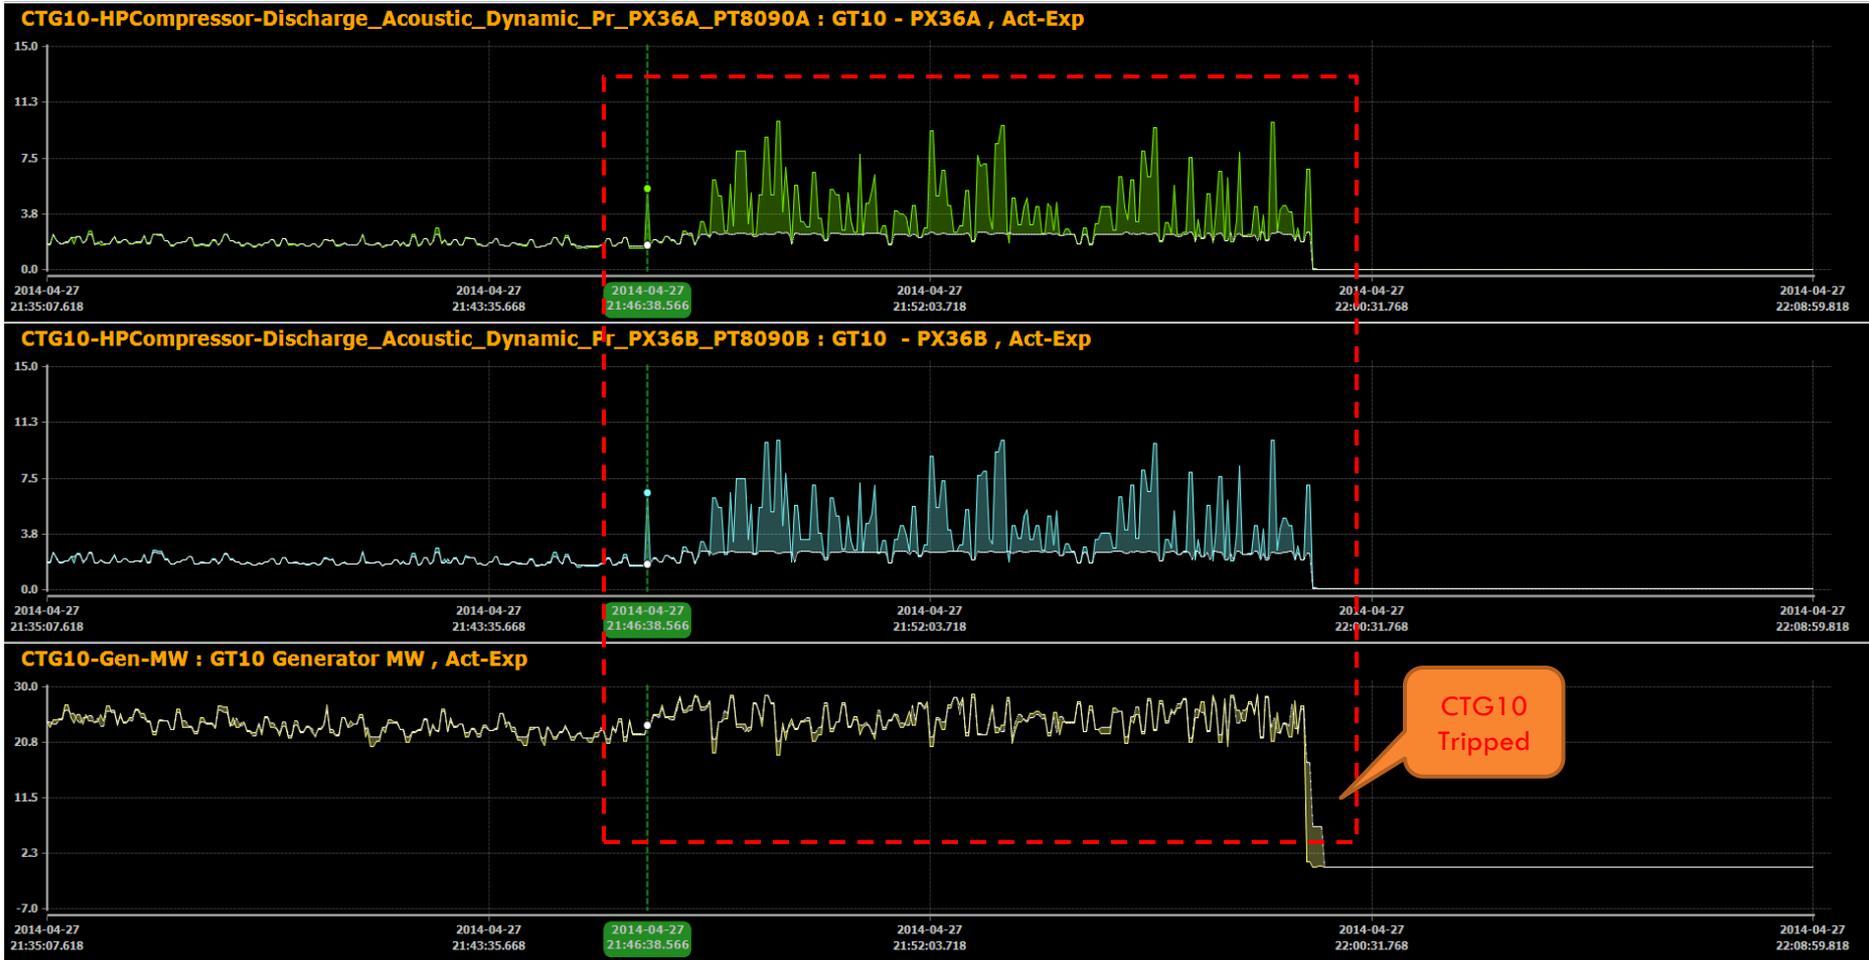
12

- **Plant :** UT-UEM
- **Issue :** CTG10 – Compressor Inlet Temperature Control – T2
- **Anomalies Observed :** HP Compressor Discharge Acoustic Dynamic Pressure was unstable and changing between 1.7 to 10.5 (PSID) during 21:45 to 22:00 hours on 27th April 2014. Large fluctuations in CTG10 speed and acoustic vibration levels were also observed. after that the CTG10 was stopped/tripped.
- **Action:** GE Aero was contacted to discuss reason for trip which was related to unit speed. According to GEK 112767 Volume I; the VSV system senses gas generator speed and compressor inlet temperature, and positions the VSV's. For any temperature and any speed, the VSV's take one position and remain in that position until the NGG or T2 changes. After the failure UT-UEM, corrected the control logic to control T2 at a steady temperature.

Select All	Tagname	Description	Act Value	Exp Value	Res Value	Low	High	Unit	Remove
<input checked="" type="checkbox"/>	CTG10-HPCompressor-Discharge_Acoustic_Dynamic_Pr_PX36A_PT8090A	GT10 - PX36A - PT-8090A - Acoustic/Dynamic Pressure Sensor A	5.4	1.7	-3.8	-1	10	psid	<input checked="" type="checkbox"/>
<input checked="" type="checkbox"/>	CTG10-HPCompressor-Discharge_Acoustic_Dynamic_Pr_PX36B_PT8090B	GT10 - PX36B - PT-8090B - Acoustic/Dynamic Pressure Sensor B	6.5	1.7	-4.8	0	10	psid	<input checked="" type="checkbox"/>
<input checked="" type="checkbox"/>	CTG10-Gen-MW	GT10 Generator MW	23.6	23.5	-0.1	-1	40	MW	<input checked="" type="checkbox"/>

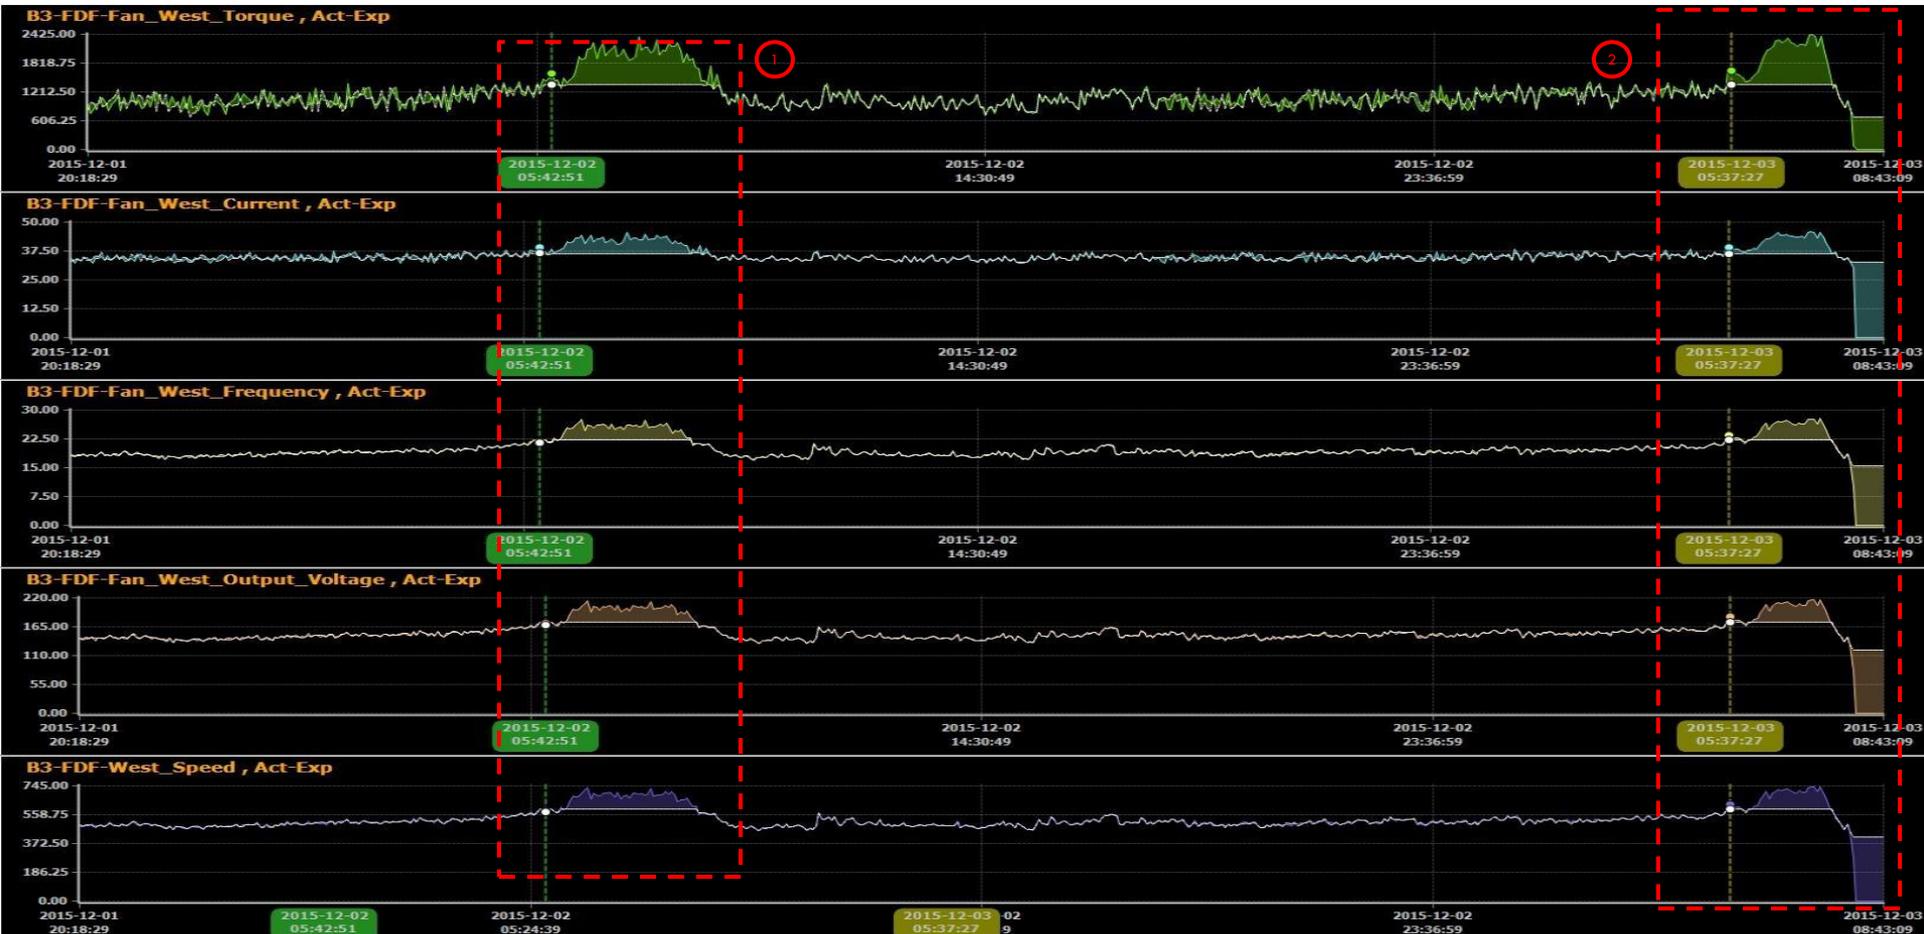
22

- System: Boiler 3 , FD Fan
- It was observed that the quality of the main trend was dropped down to 25% on November 22, 2015 again about the same time after four days. This occurrence is observed on October 12, 2015 and December 14, 2015 after the fans were swapped.

- A low health index was observed on boiler 3 and after analysis it was discovered that there were variation in west fan torque and the current as shown on actual-expected trend.
- This kind of behavior did alarm the system and was not observed in the plant historian database. According to the instrumentation team, there were two differential pressure transmitters were not in the same position hence the difference in readings.
