Boiler Tubing Failure Reduction

Joe Maciejczyk, PE
Structural Integrity Associates

**IDEA's 29th Campus Energy
Conference**

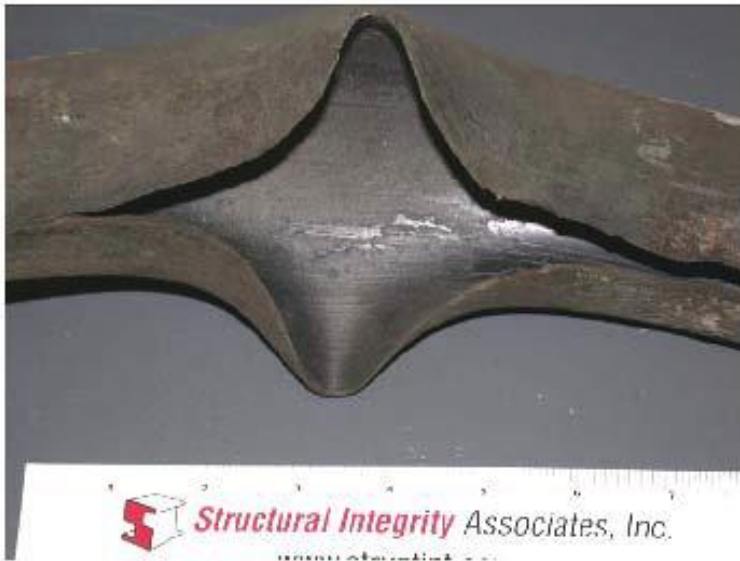
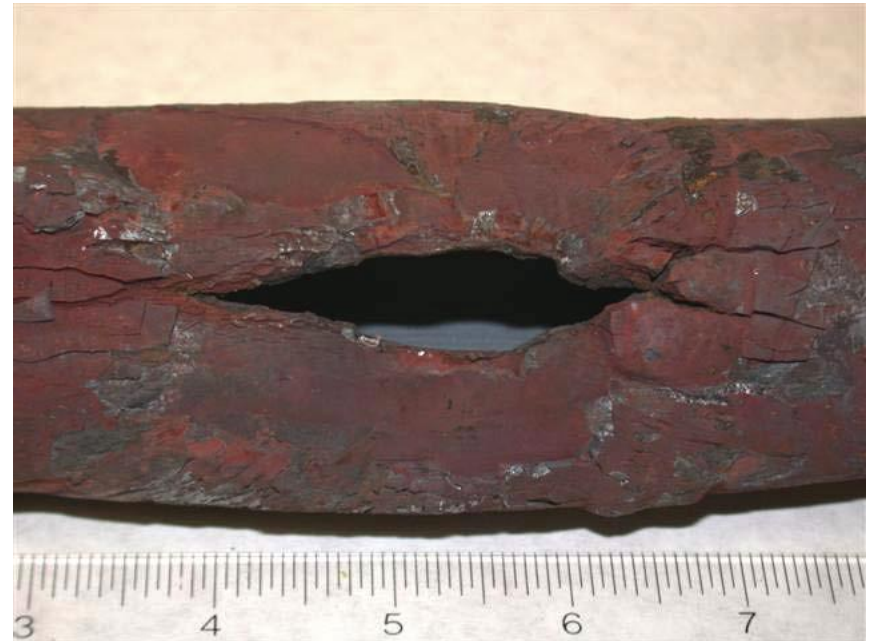
- A preliminary diagnosis of the mechanism can often be made based on visual examination of the macroscopic damage features; this will determine the number and location of specimens removed for destructive analysis.
- Photo-documentation will record distinctive features of the damage prior to sample cutting and can indicate location of specimens removed for destructive analysis

- Visual examination and photo-documentation - A preliminary diagnosis of the mechanism can often be made based on visual examination of the macroscopic damage features; this will determine the number and location of specimens removed for destructive analysis.
- Photo-documentation will record distinctive features of the damage prior to sample cutting and can indicate location of specimens removed for destructive analysis.
- Dimensional Measurements can:
 - Identify location and magnitude of wall loss
 - Identify degree of service-induced swelling, which is a measure of accumulated creep damage

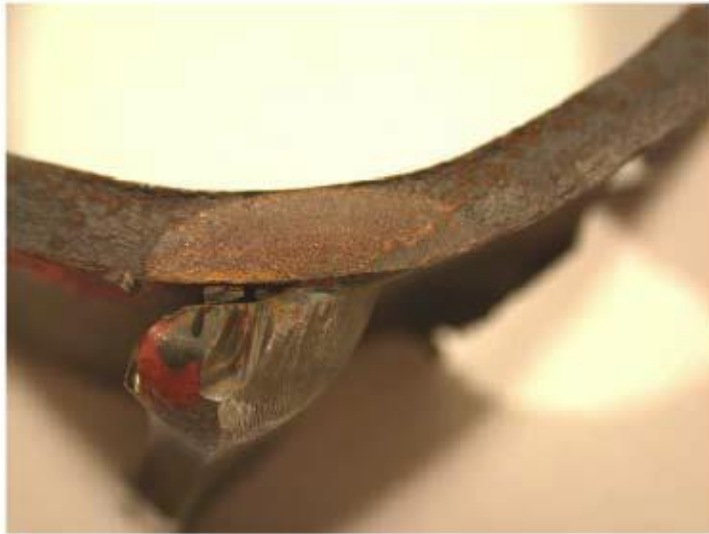
“Thumb-nail” shaped fatigue crack initiating at attachment weld on OD surface of tube.
