# IDEA 106<sup>th</sup> Annual Conference 2015

## *Acoustic Pipe Wall Thickness Testing and Leak Detection in Aging Water Mains*

**Water Efficiency, Capital Efficiency, and System Resiliency**

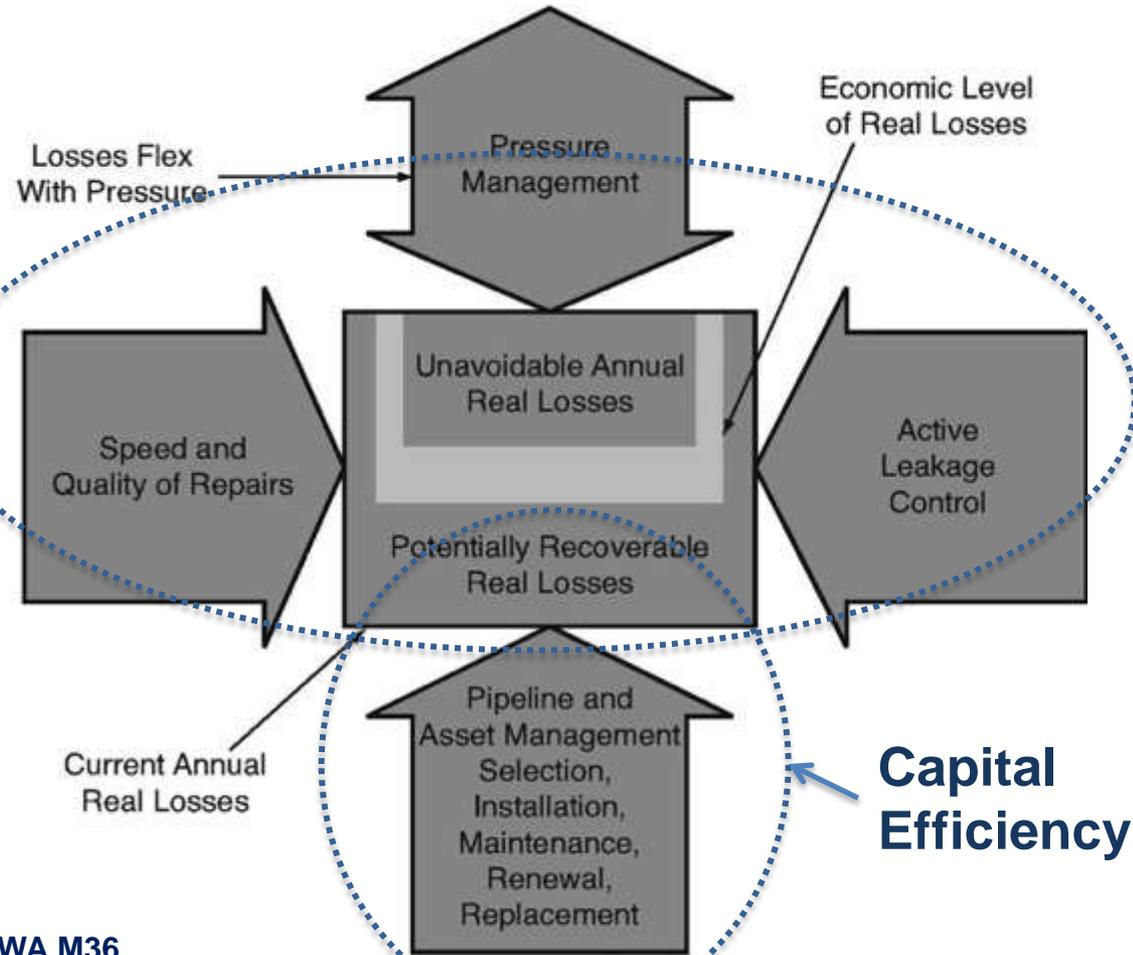
Reference: AWWA M36

Figure 5-1 The four-pillar approach to the control of real losses

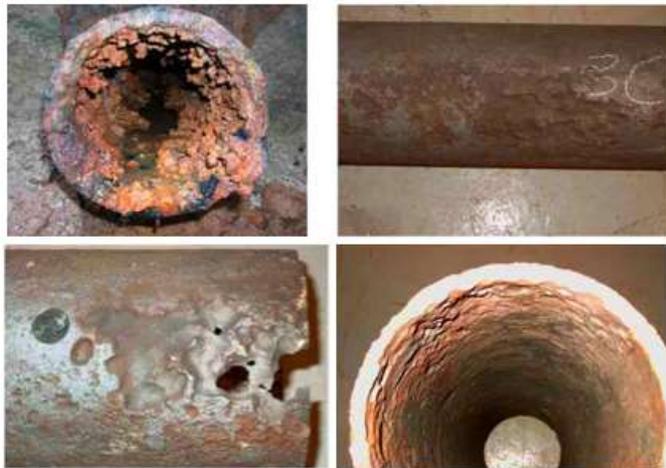
Pipeline 1	Pipeline 2
Installed 1860	Installed 1860
Brown clay soil	Brown clay soil
Corrosive soil	Moderately corrosive soil
6" Cast Iron Pipe	6" Cast Iron Pipe

**47.3% Measured Loss**

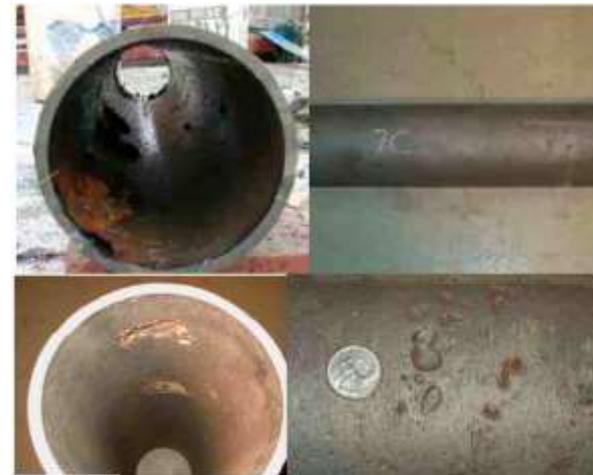
**0.5% Measured Loss**

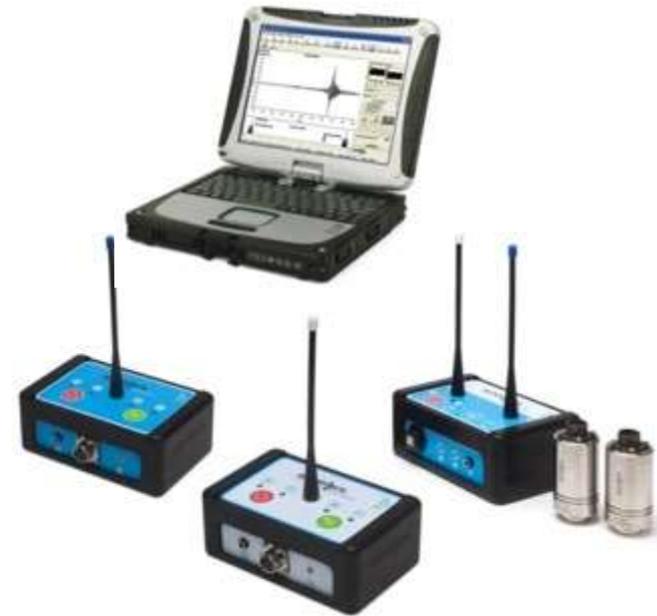
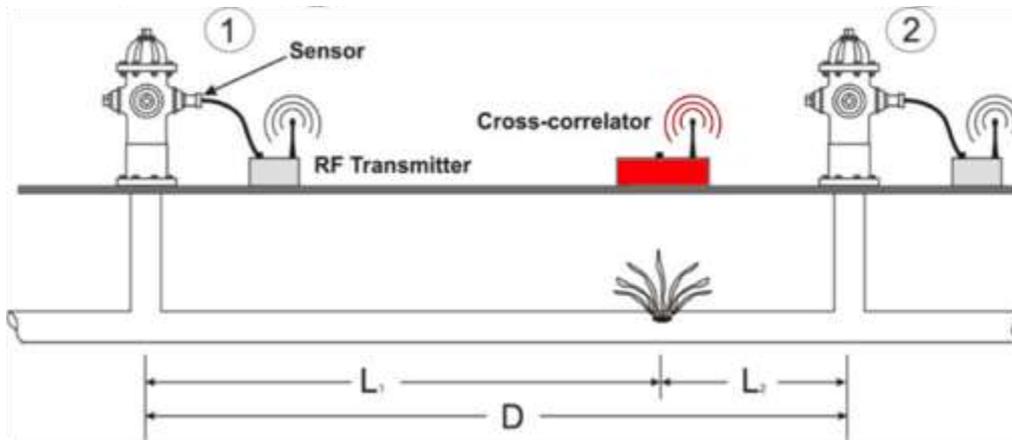
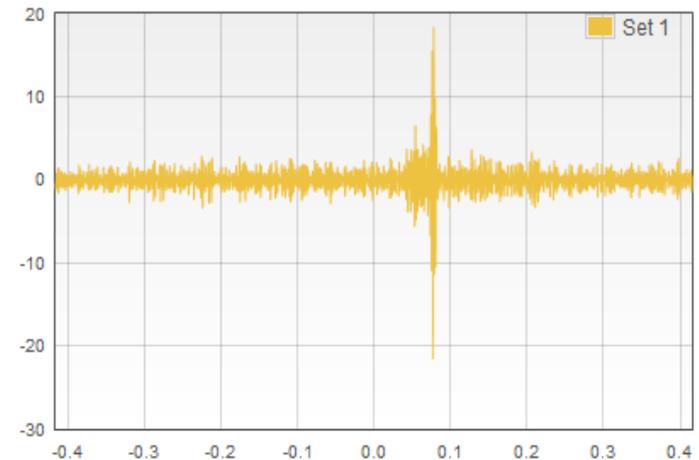
# Acoustic Leak Correlation Analysis

1. Bracket the leak with two sensors
2. The leak sound propagates in both directions
3. Correlator measures the time difference to reach each of the sensors to determine the exact leak location

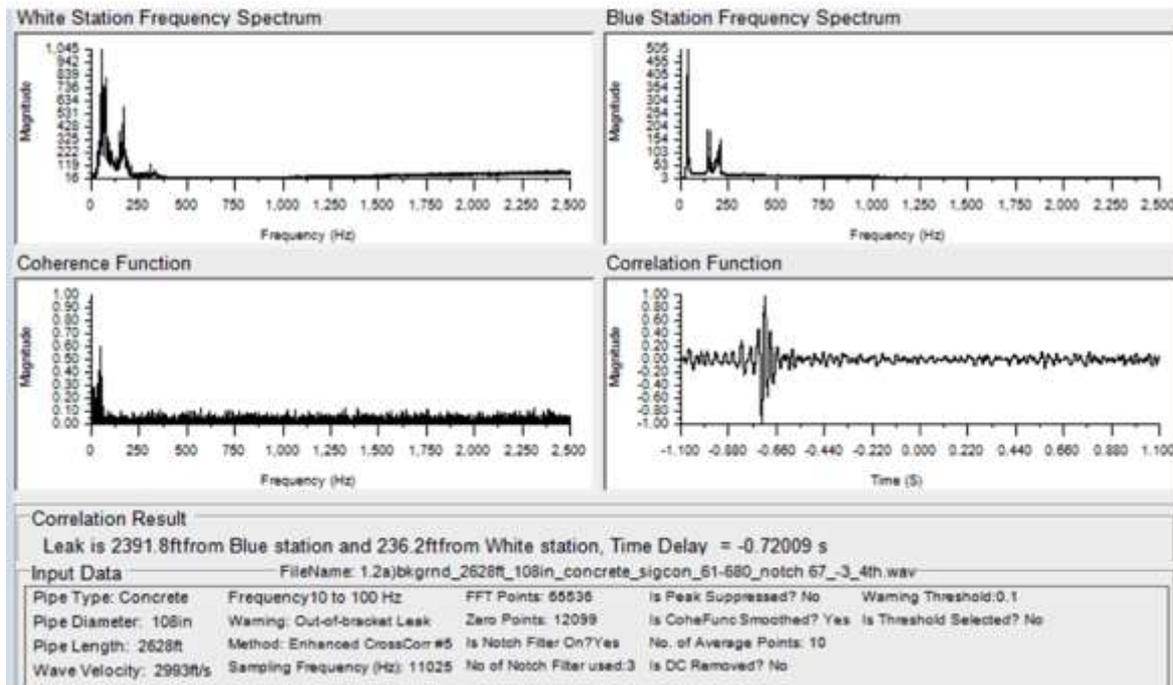
# Transmission Main Leak – Confirmed: 108” Concrete 2,627’ Between Sensors

**Utility:** East Bay Municipal Utilities District

**Pipeline Diameter:** 108”

**Correlation Plot Number:** 3

**Material:** Concrete

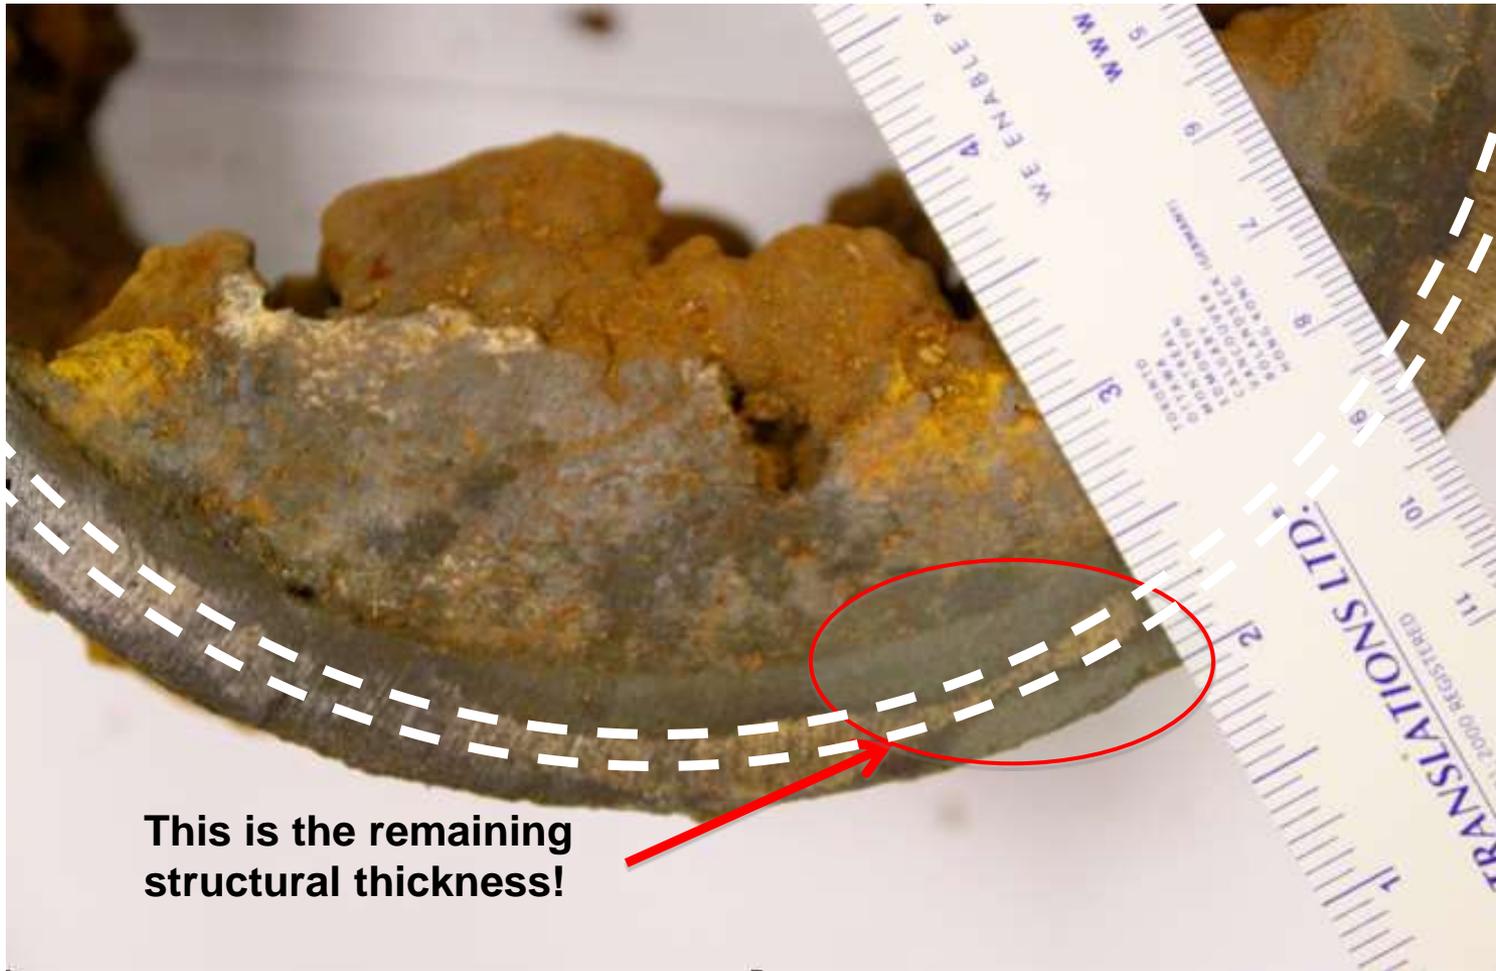
# Case Study: City of Newark

**This is the remaining structural thickness!**

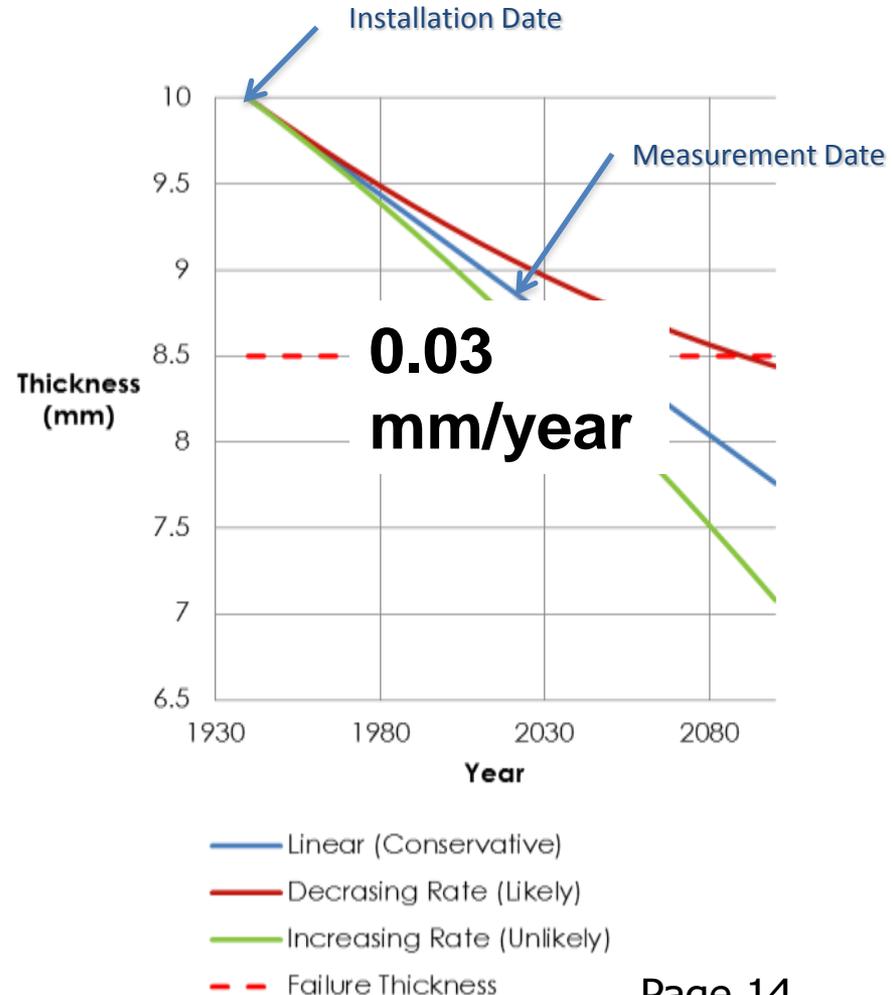
# Remaining Service Life Analysis

- The current thickness of the pipe is measured using APWTT
- A linear extrapolation is performed by using the measured thickness, the nominal thickness and the installation date
- The Failure thickness is predicted by calculating the minimum required thickness to carry the given loads
- The loads include: internal pressure from the water column and external pressure from the soil and traffic loads

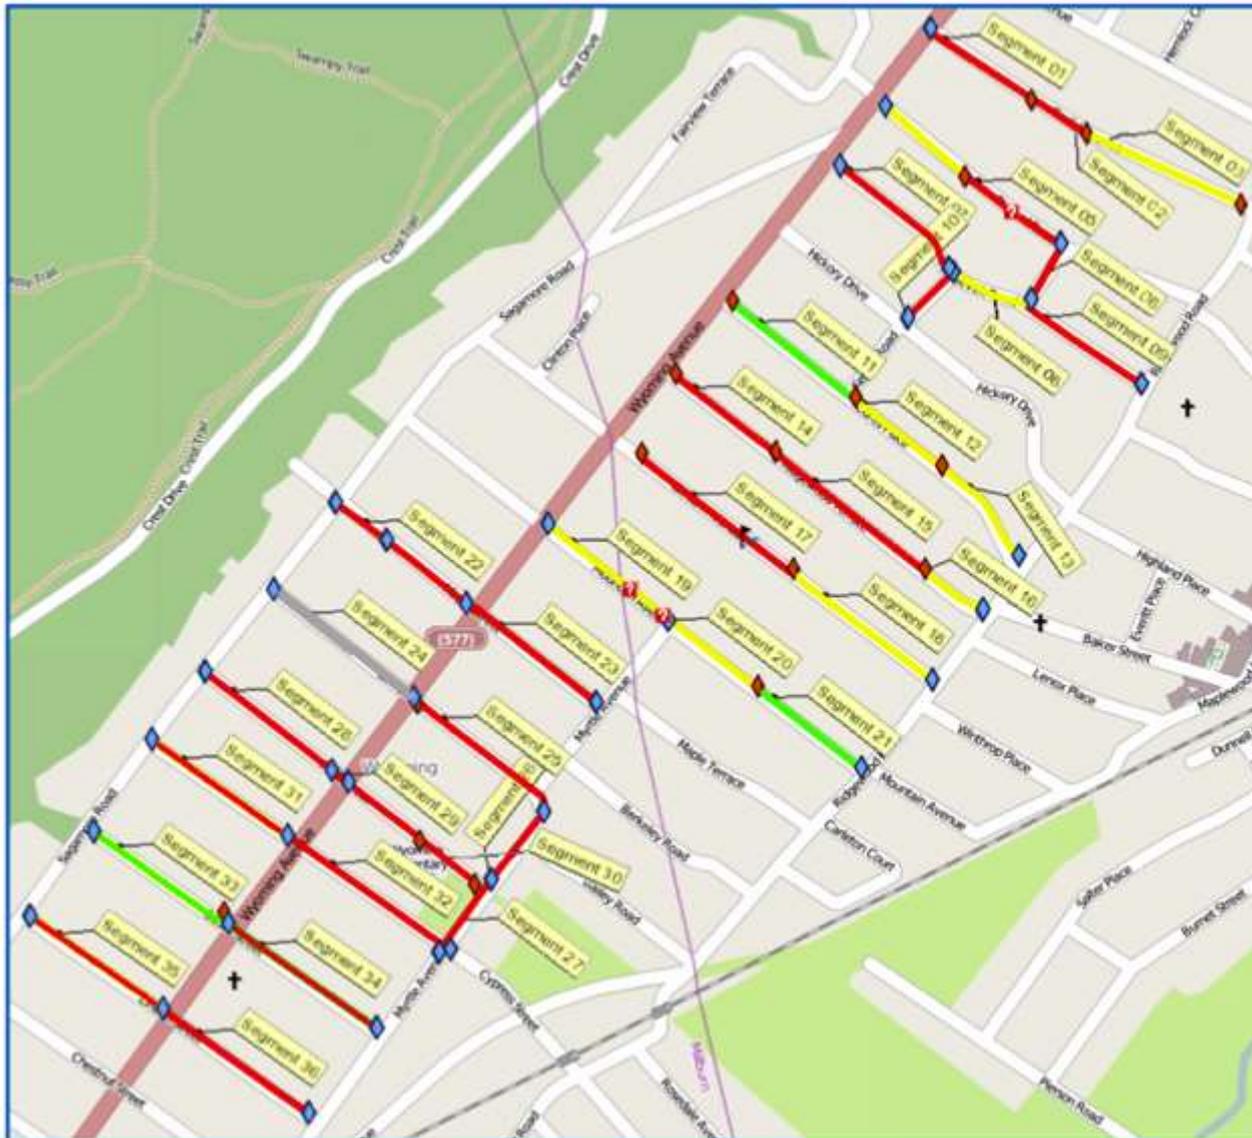
# Condition Map: NJAW C&L Project

## *Good Pipe, Rehabilitate, or Replace?*

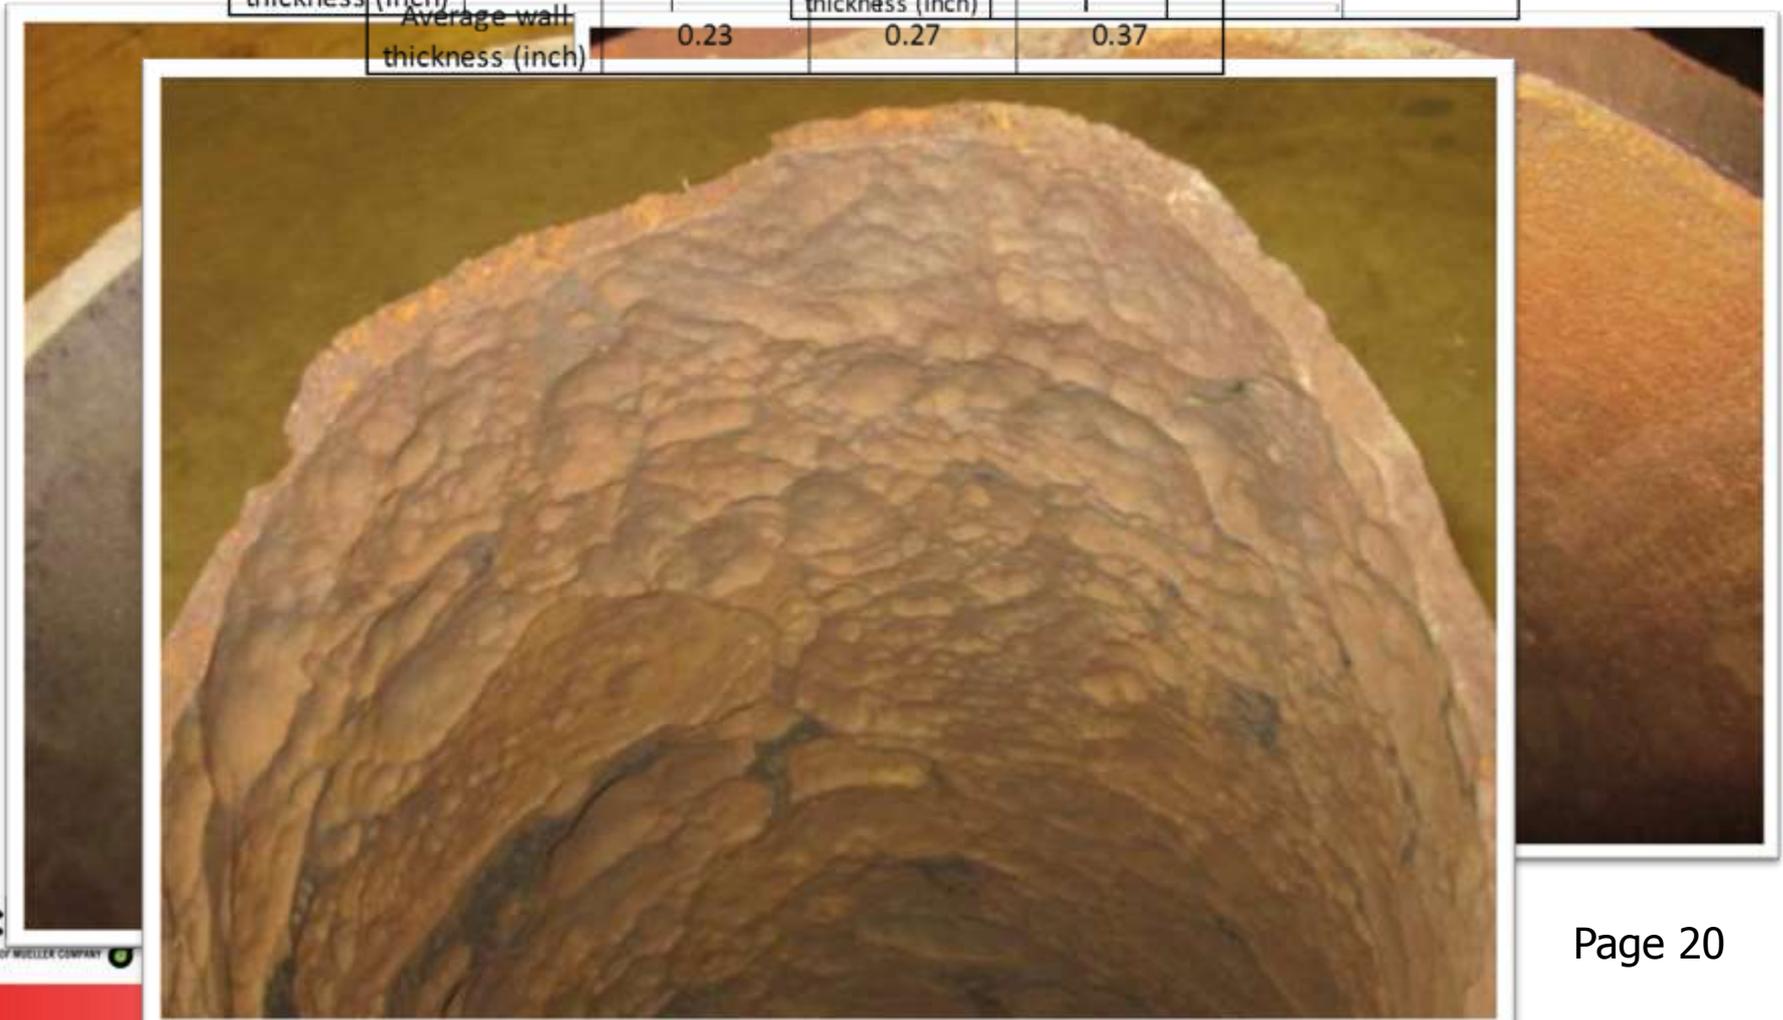
# Example Measurement Comparisons

Cooper 1-3:		Sheridan 1-3		
	Echologics	Correng Ladd 2-13	Dacco	
% loss	8.1			
Average wall thickness (inch)	0.35	53.6 0.34	0.35	0.32
Average wall thickness (inch)		0.23	0.27	0.37

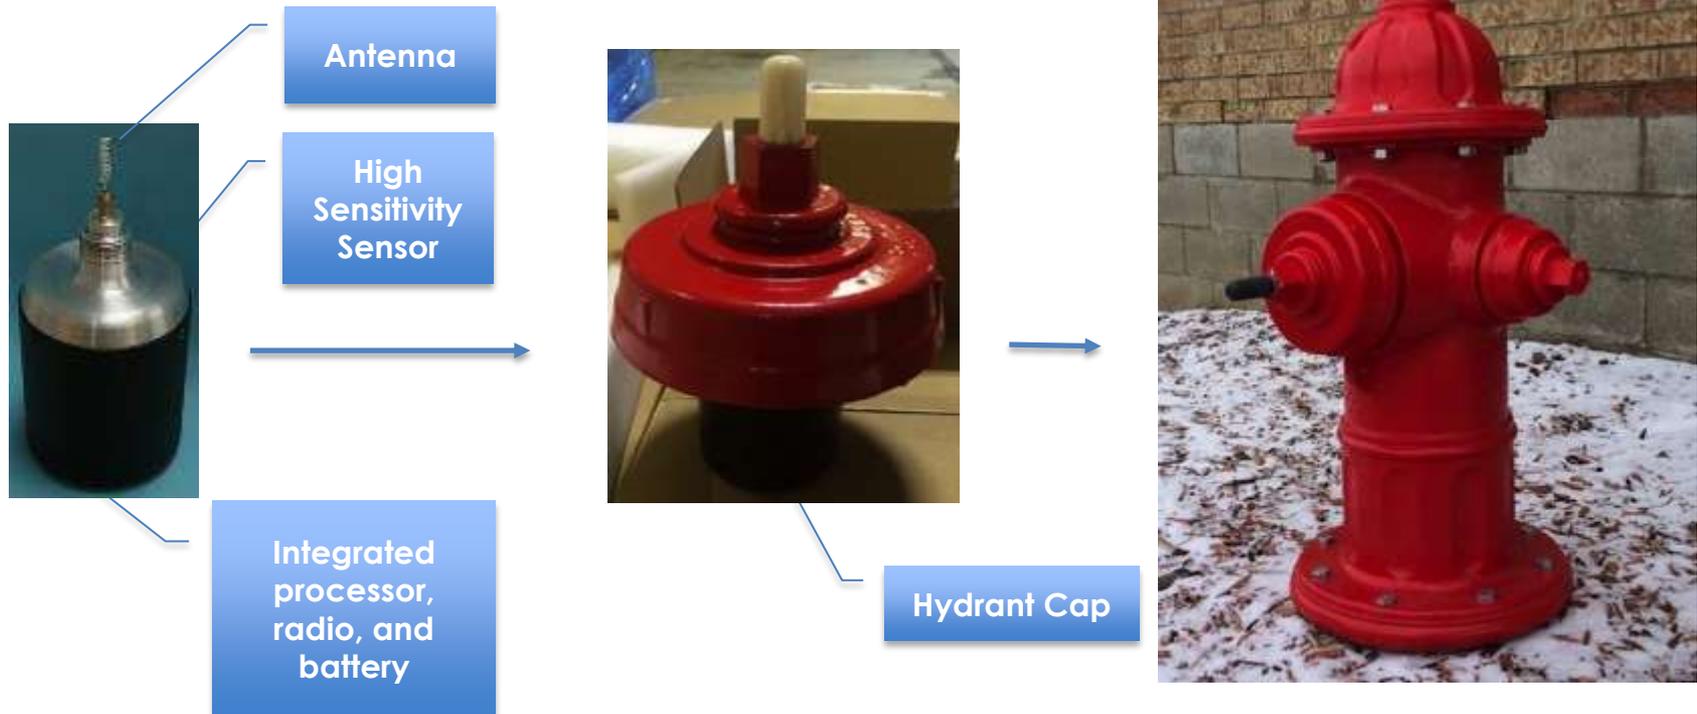
# Fixed Leak Monitoring

## Sampling node installed in standard hydrant cap

Based on the next-generation proven LeakFinder™ technology

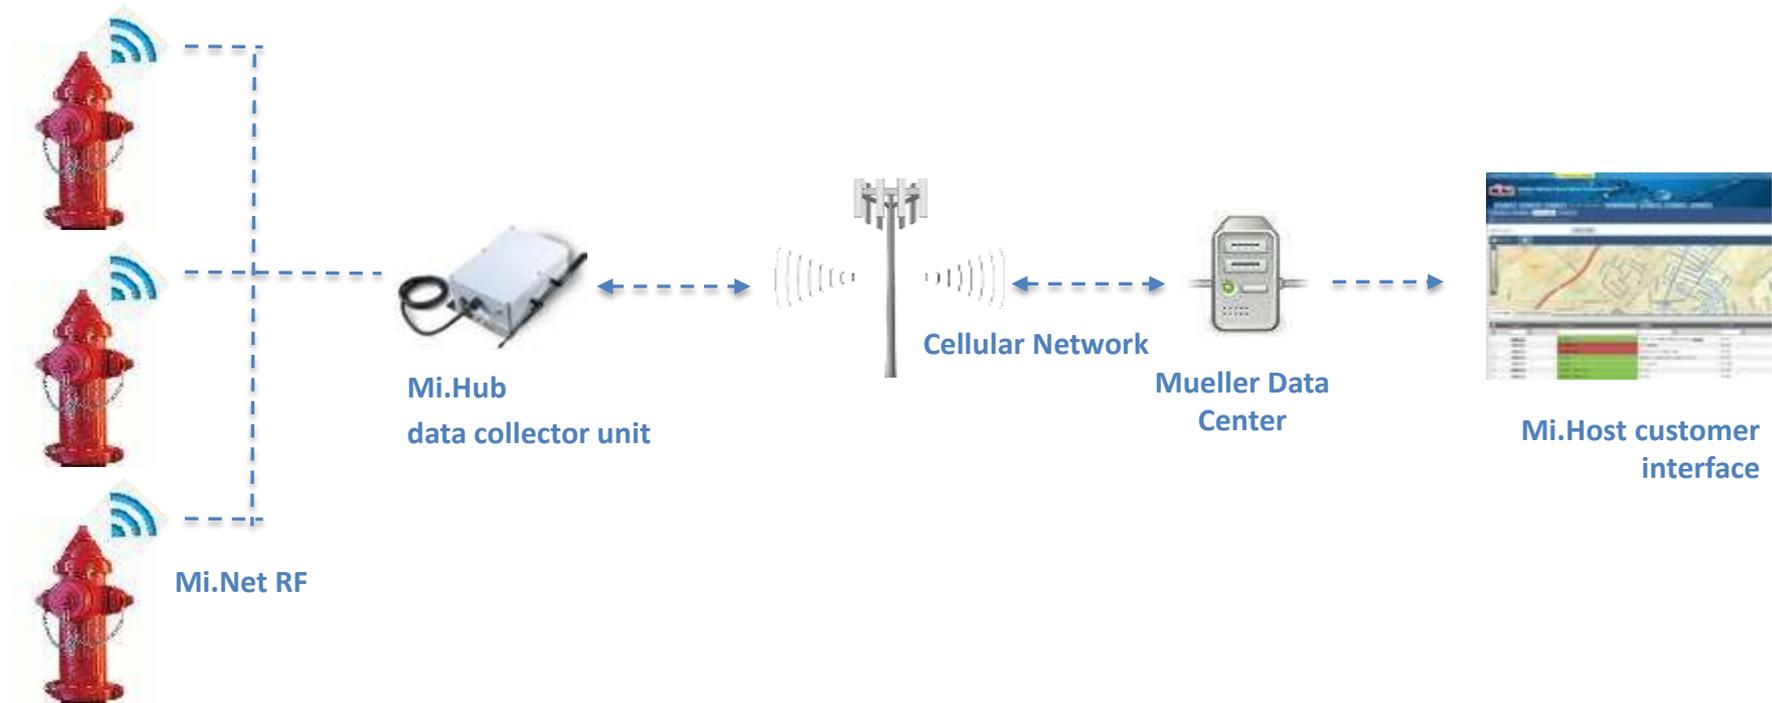
# System Description

System comprised of a series of nodes and radio infrastructure:

Network of interconnected nodes monitors a service area

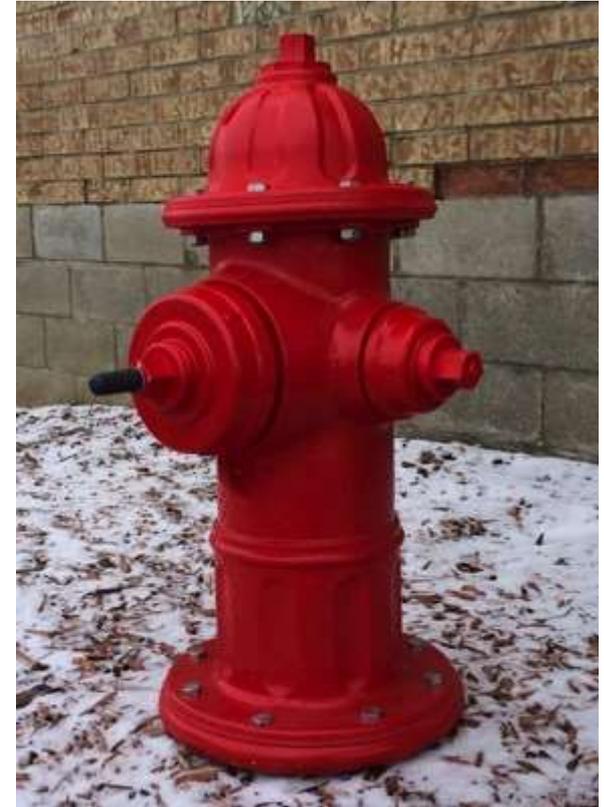
# Primary Detection

1. Node collects data over a 2-hr period
2. Node processes the data
3. Nodes determines leak likelihood

- Leak likelihood score
- Node vitals

Node-level intelligence reduces false positive rate and extends battery life

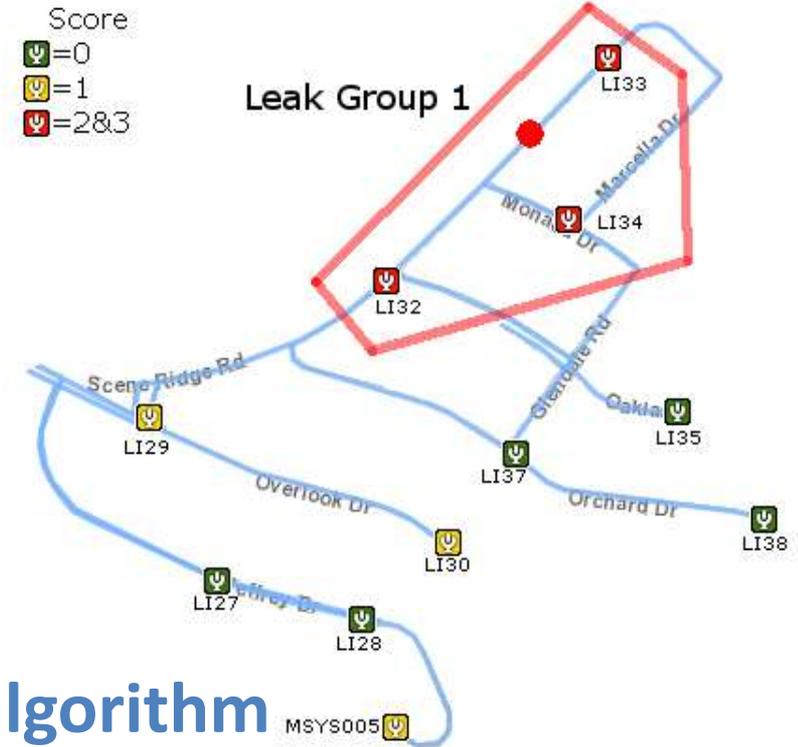
# Secondary Leak Detection

1. EAM identifies leak groups
2. EAM requests data files from the leak group
3. Nodes compress and transmit data files [MB  $\rightarrow$  kB]
4. EAM performs correlations on all node pairs in the leak group

### Autonomous LFRT correlation algorithm

EAM-level intelligence increases LD probability and conserves radio bandwidth & battery life

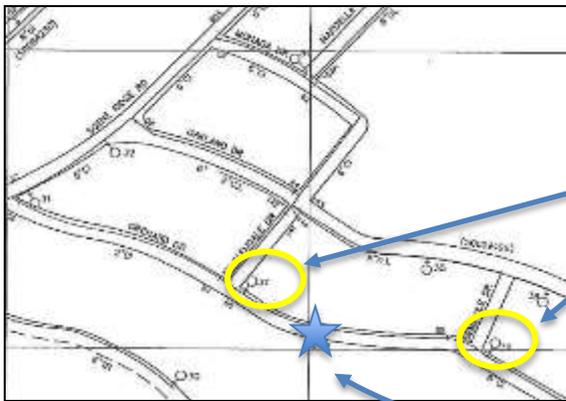
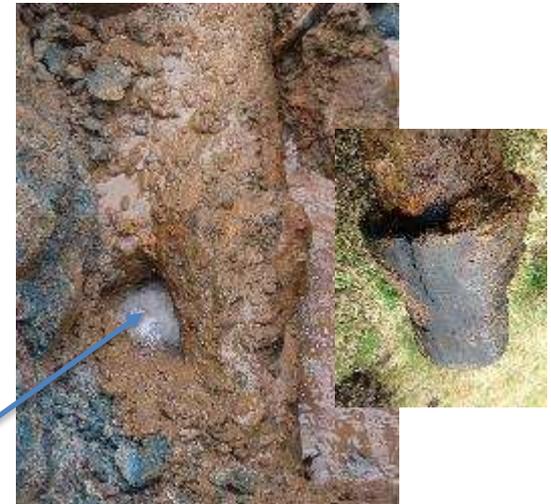
## *Case Study: Liberty, Pennsylvania*

*Correlating  
hydrant nodes  
961 ft. apart*

*Leak  
location at  
337 ft.*

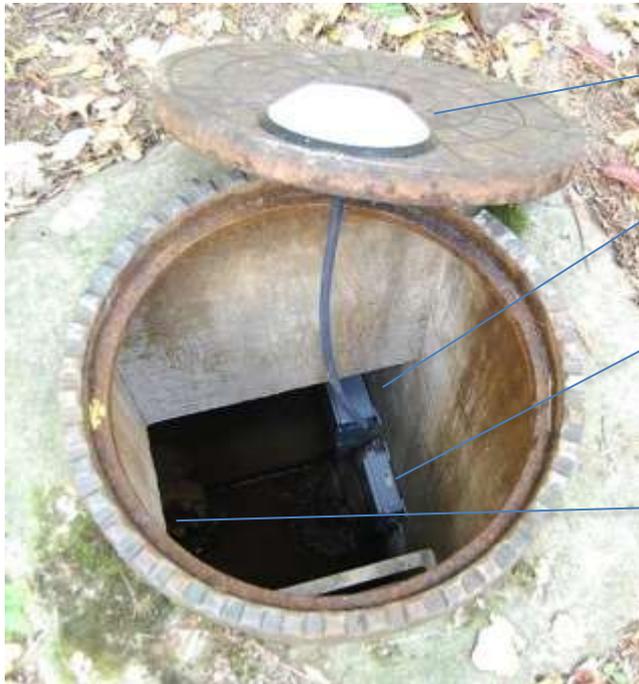
Start with a sampling node:

Antenna

Power Source

Processor &  
Comm.  
Hardware

Hydrophone

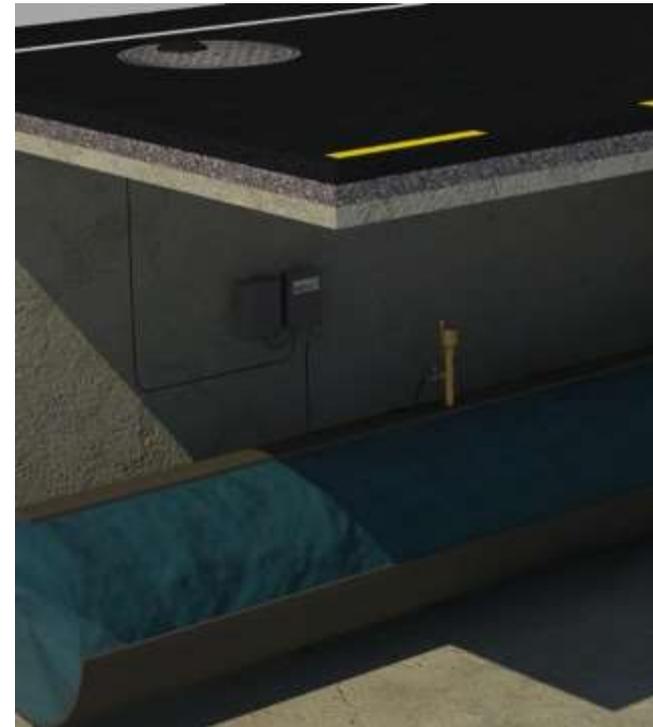
EchoShore node installed in an access chamber

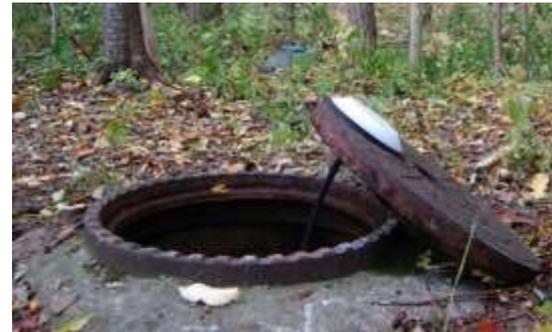
Traffic Rated Dome

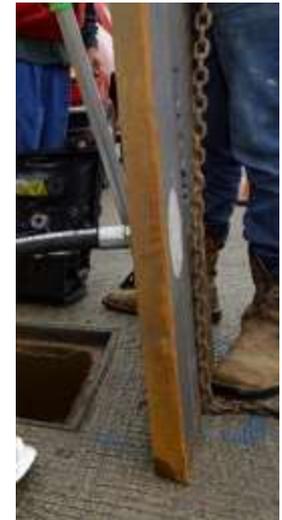
Traffic Rated Flush

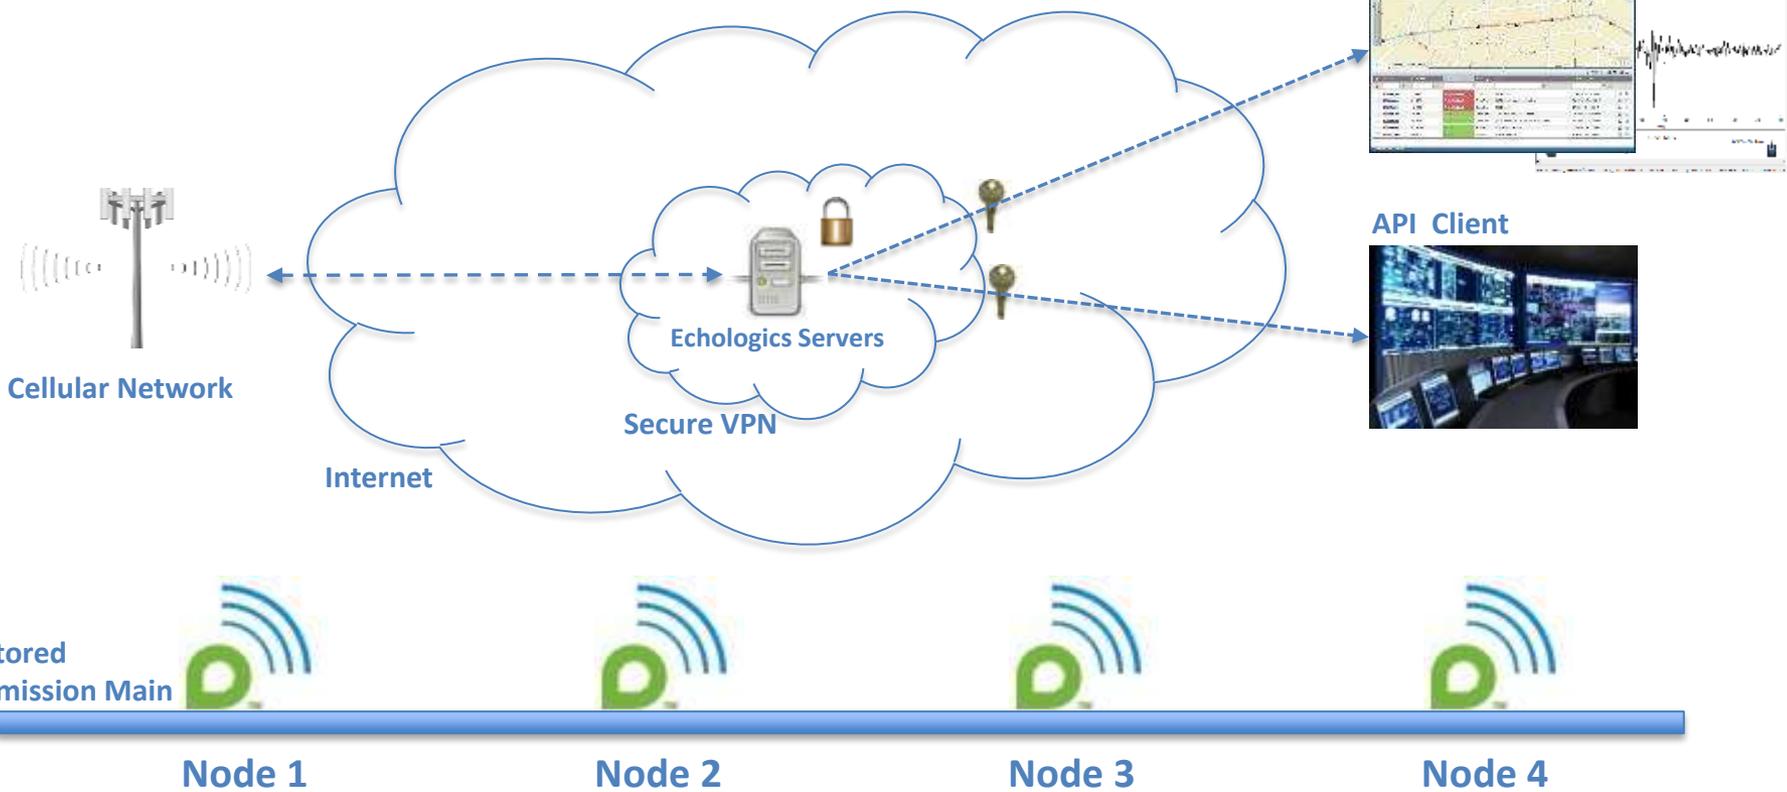
**Network of interconnected nodes monitors a service area**
