IDEA Campus Energy 2015

Acoustic Pipe Wall Thickness Testing and Leak Detection in Aging Water Mains

John Marciszewski, Director of Biz Dev

Echologics LLC

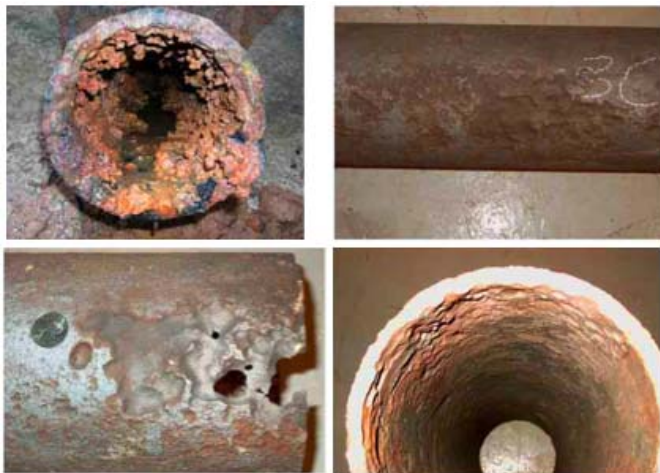
Pipeline 1	Pipeline 2
Installed 1860	Installed 1860
Brown clay soil	Brown clay soil
Corrosive soil	Moderately corrosive soil
6" Cast Iron Pipe	6" Cast Iron Pipe

47.3% Measured Loss

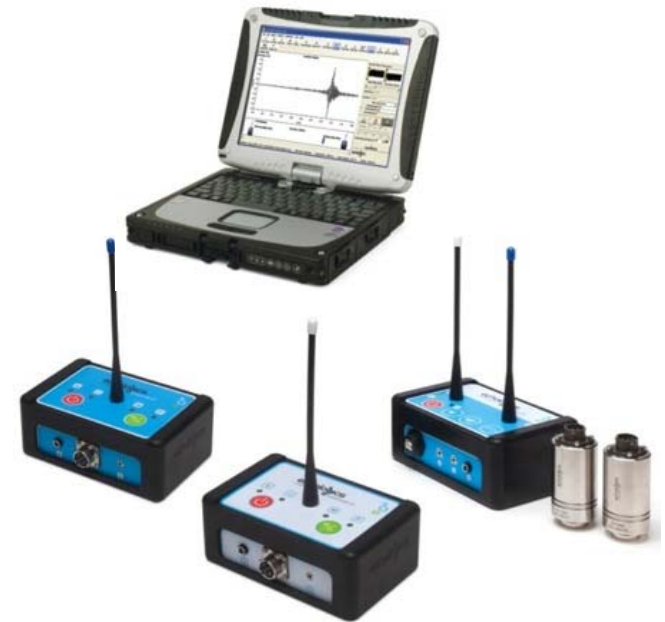
Principle of Operation

1. Bracket the leak with two sensors
2. The leak sound propagates in both directions
3. Correlator measures the time difference to reach each of the sensors to determine the exact leak location

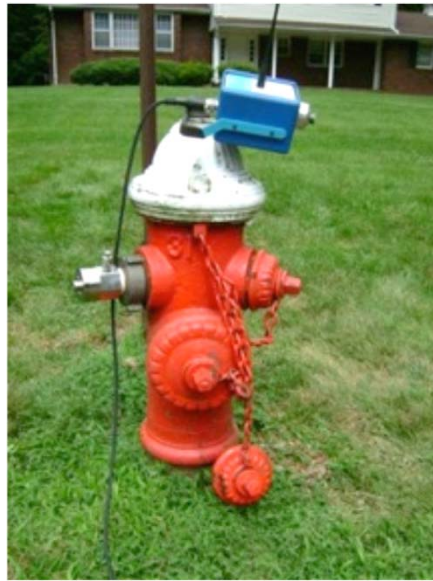
**Hydrophone -
Connection to
Fire Hydrant**

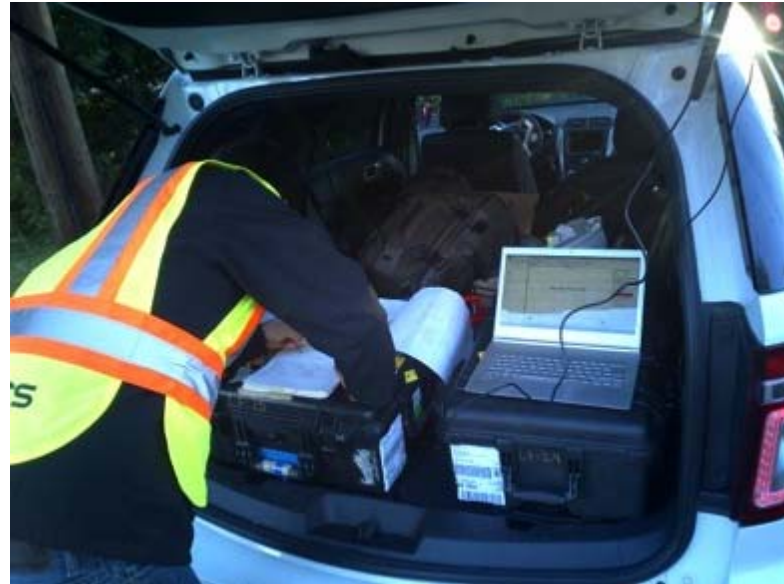
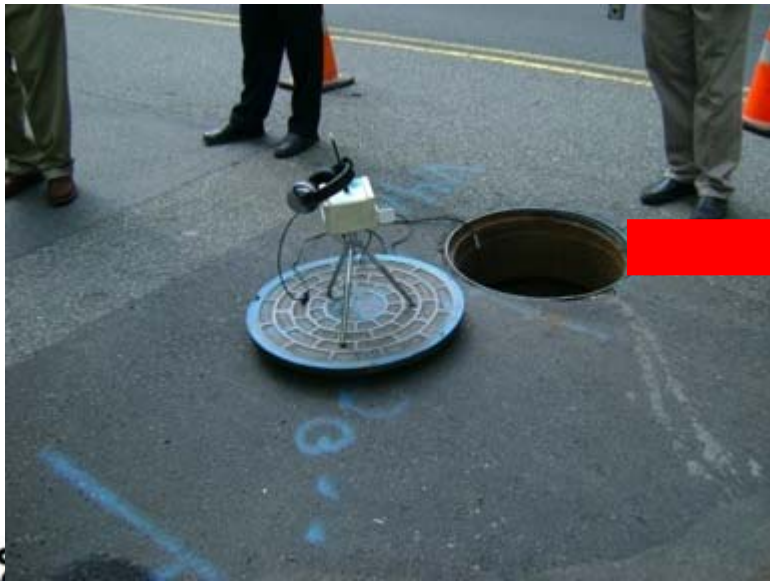
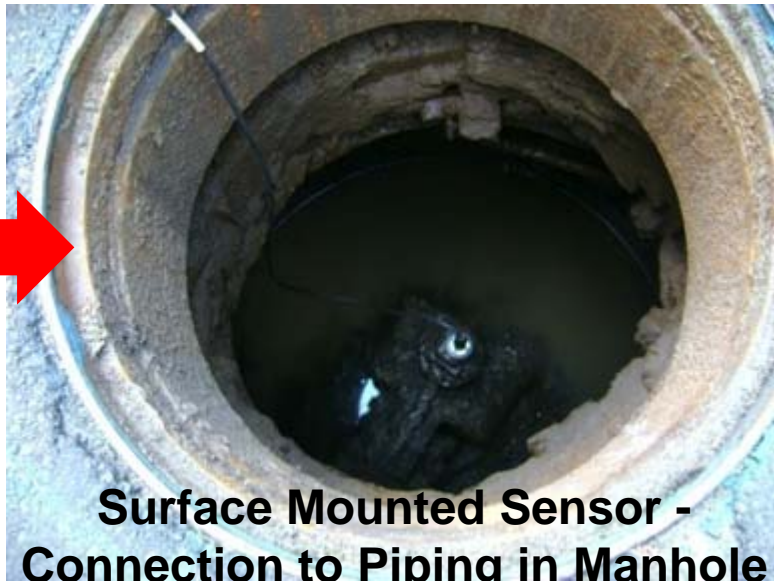
**White Station
Radio
Transmitter**

**Surface Mounted Sensor -
Connection to Piping in Manhole**

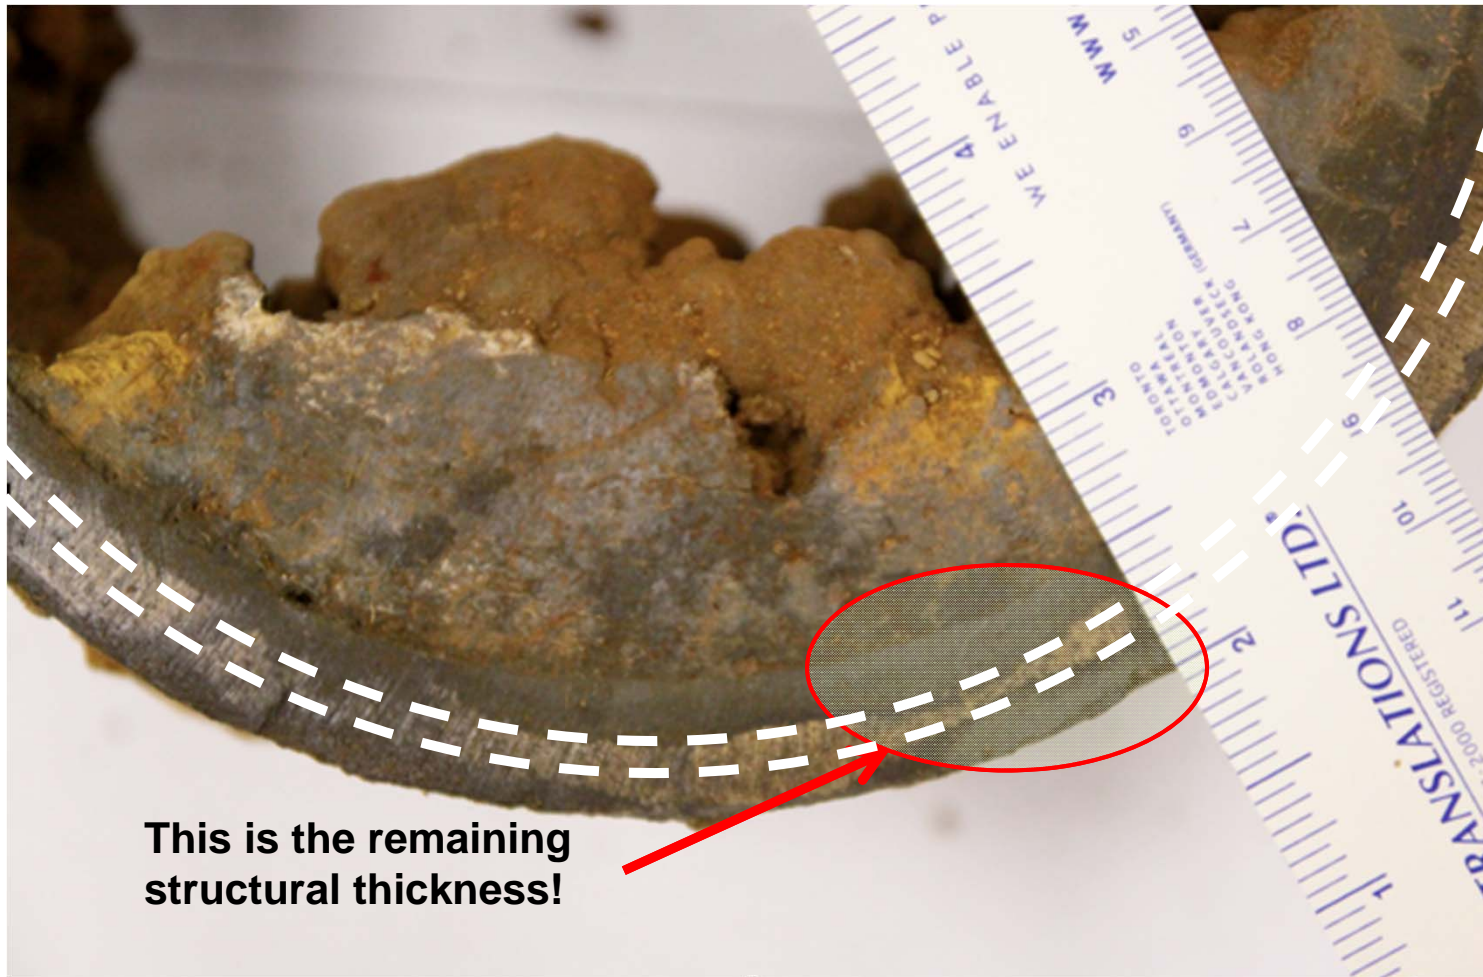
Case Study: City of Newark

This is the remaining structural thickness!

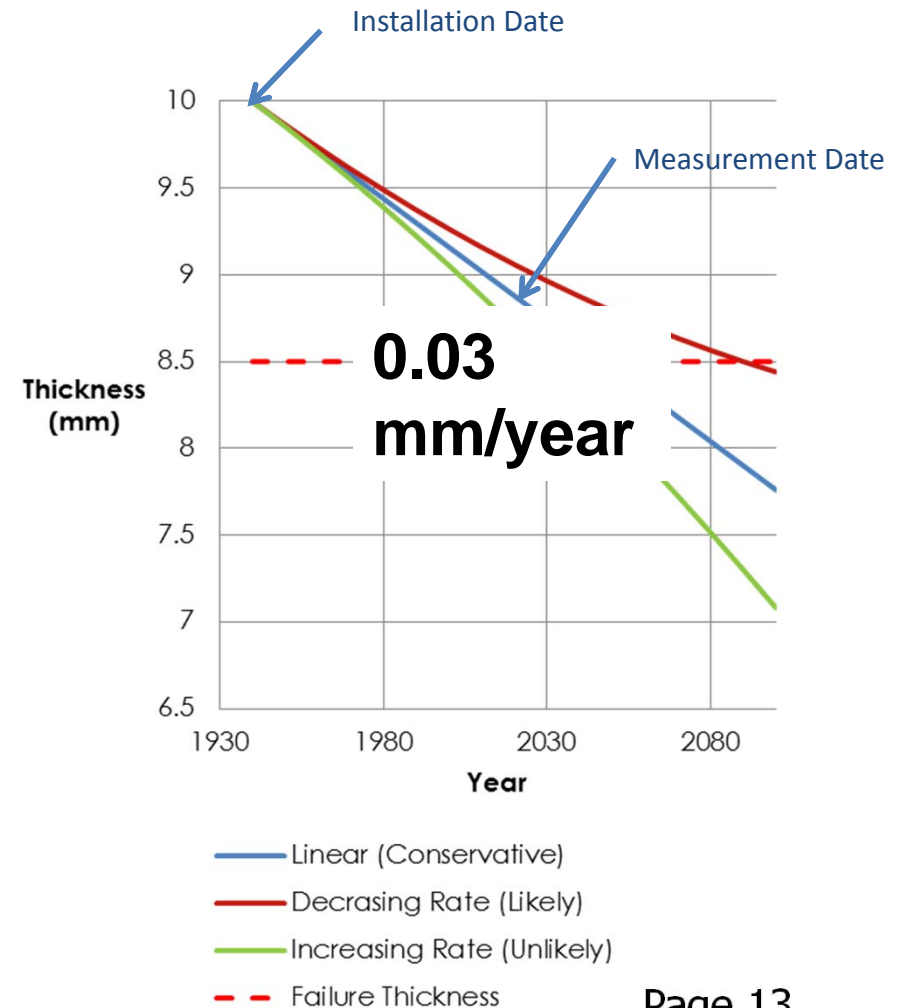
Remaining Service Life Analysis

- The current thickness of the pipe is measured using APWTT
- A linear extrapolation is performed by using the measured thickness, the nominal thickness and the installation date
- The Failure thickness is predicted by calculating the minimum required thickness to carry the given loads
- The loads include: internal pressure from the water column and external pressure from the soil and traffic loads

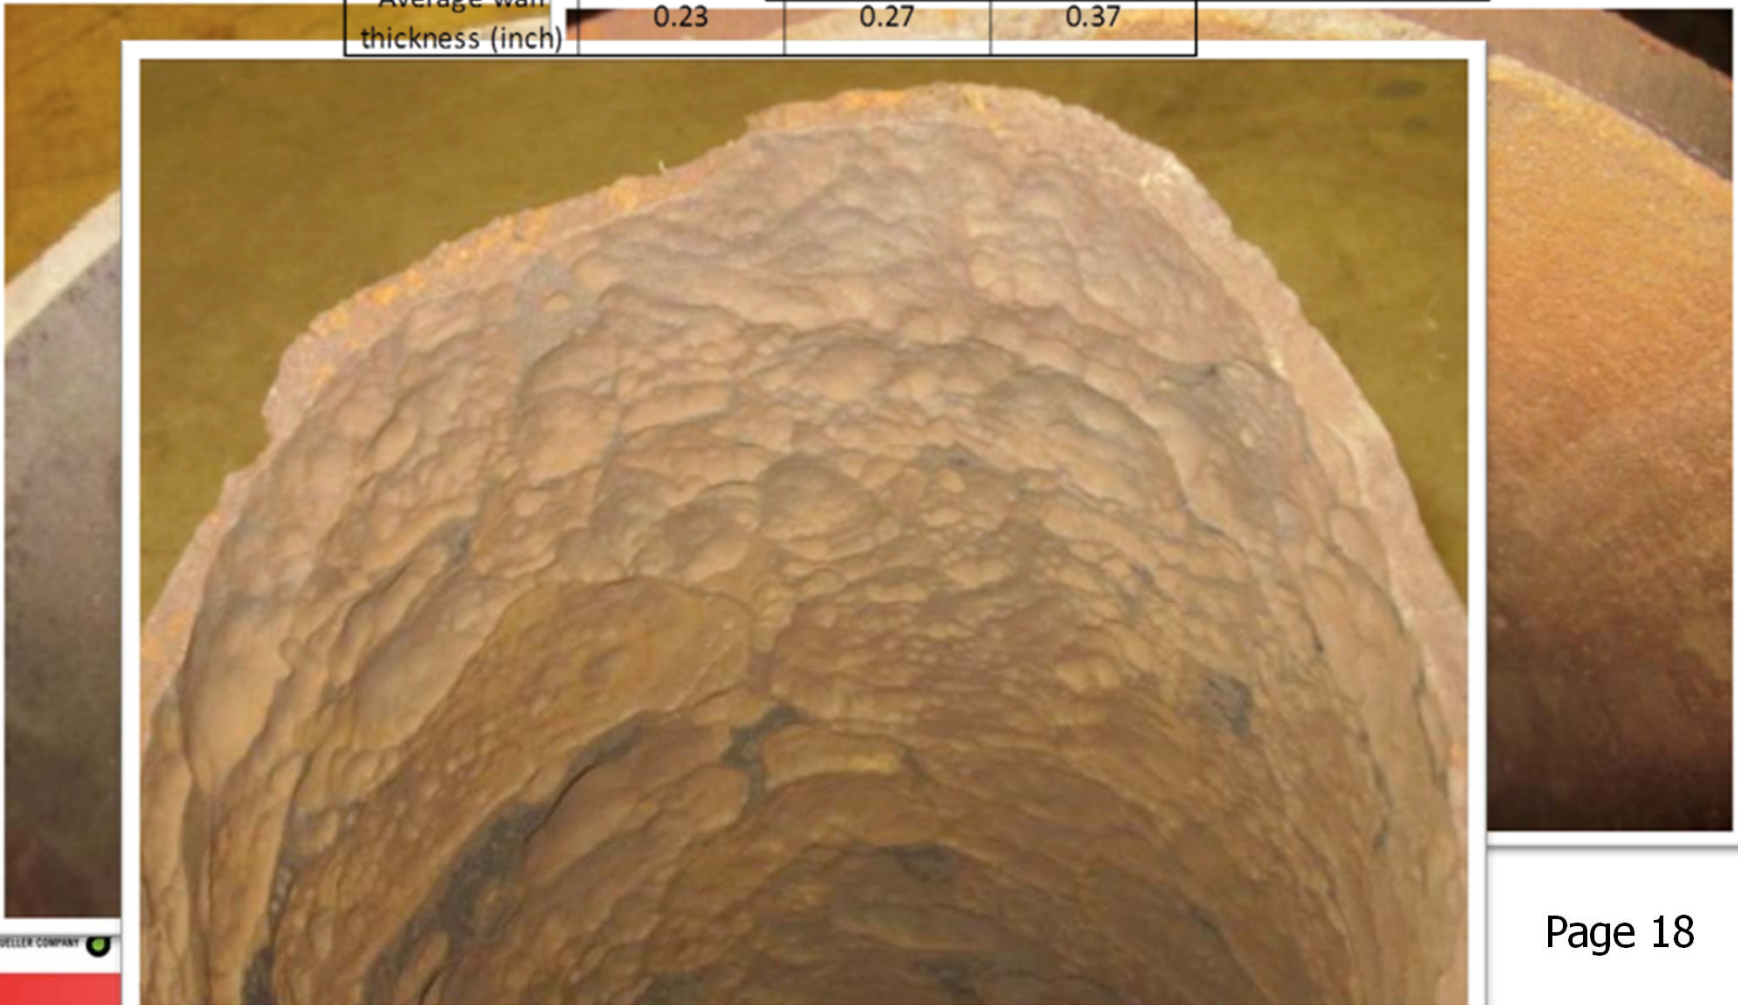
Example Measurement Comparisons

Cooper 1-3:				Sheridan 1-3:			
		Echologics		Correng		Dacco	
		Ladd 2-13		Echologics		Correng	
% loss		8.1		11		Dacco	
Average wall thickness (inch)		0.35		0.32		0.31	
Average wall thickness (inch)		0.23		0.27		0.37

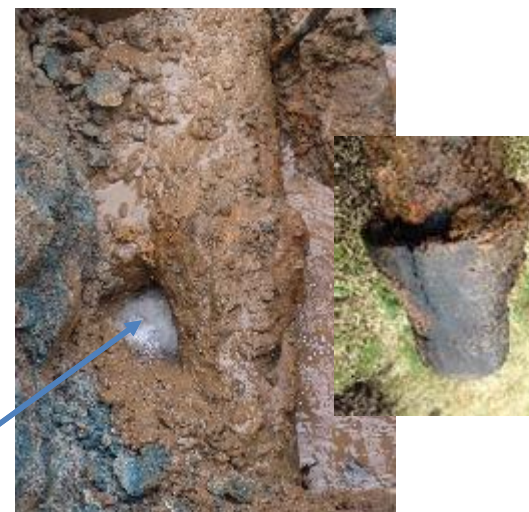
Case Study: Liberty, Pennsylvania

Confirmed leak occurrence on May 1, 2014

- PA American Water first informed of the possible leak on April 4
- PA American leak detection crew investigated the area using other leak detection products – could not confirm the leak.
- Based on proprietary indicators, the fixed monitoring system registered the progressive severity of the leak over 4 weeks.

*Correlating
hydrant nodes
961 ft. apart*

*Leak
location at
337 ft.*

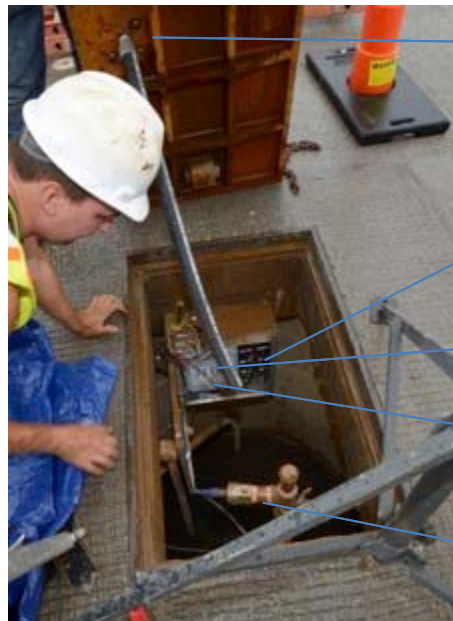
Transmission System Monitoring *Sampling Node**

Cover-mounted antenna (optional)

Power Source

Data Logger

Comm. hardware

Hydrophone

EchoShore node installed in an access chamber

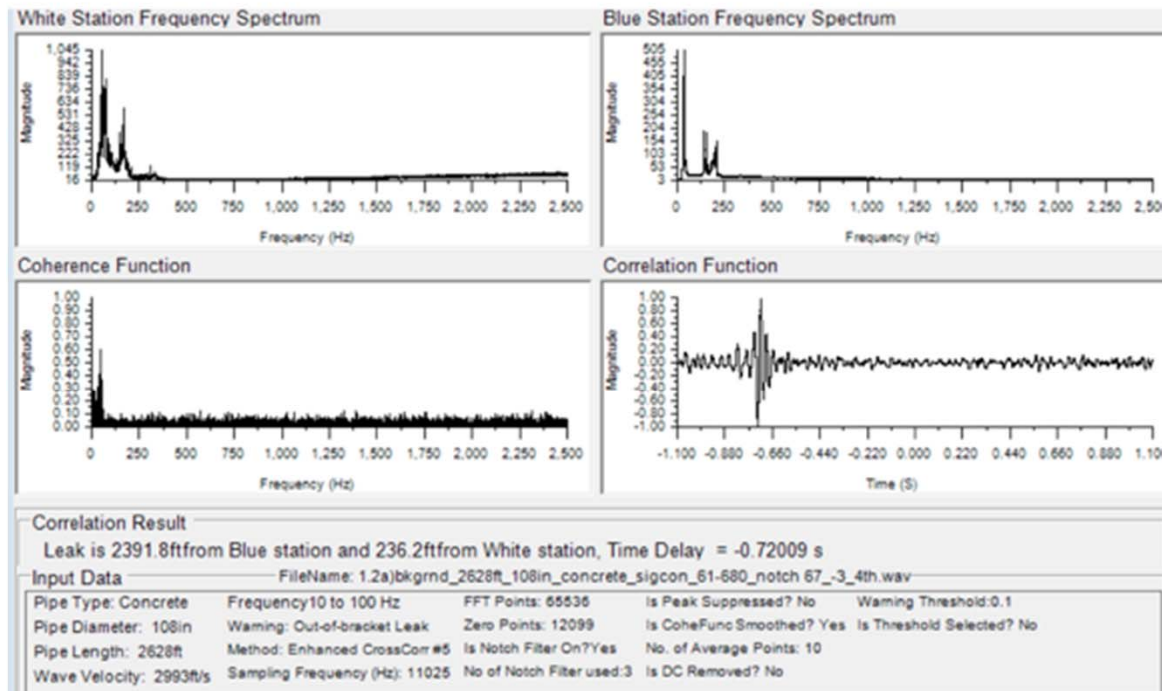
Transmission Main Leak – Confirmed: *108" Concrete 2,627' Between Sensors*

Utility: East Bay Municipal Utilities District

Pipeline Diameter: 108"

Correlation Plot Number: 3

Material: Concrete
